STATE FIRE MARSHAL'S OFFICE

Firefighter Fatality Investigation

Investigation Number FY 08-02

Chief Robert Leland Knight

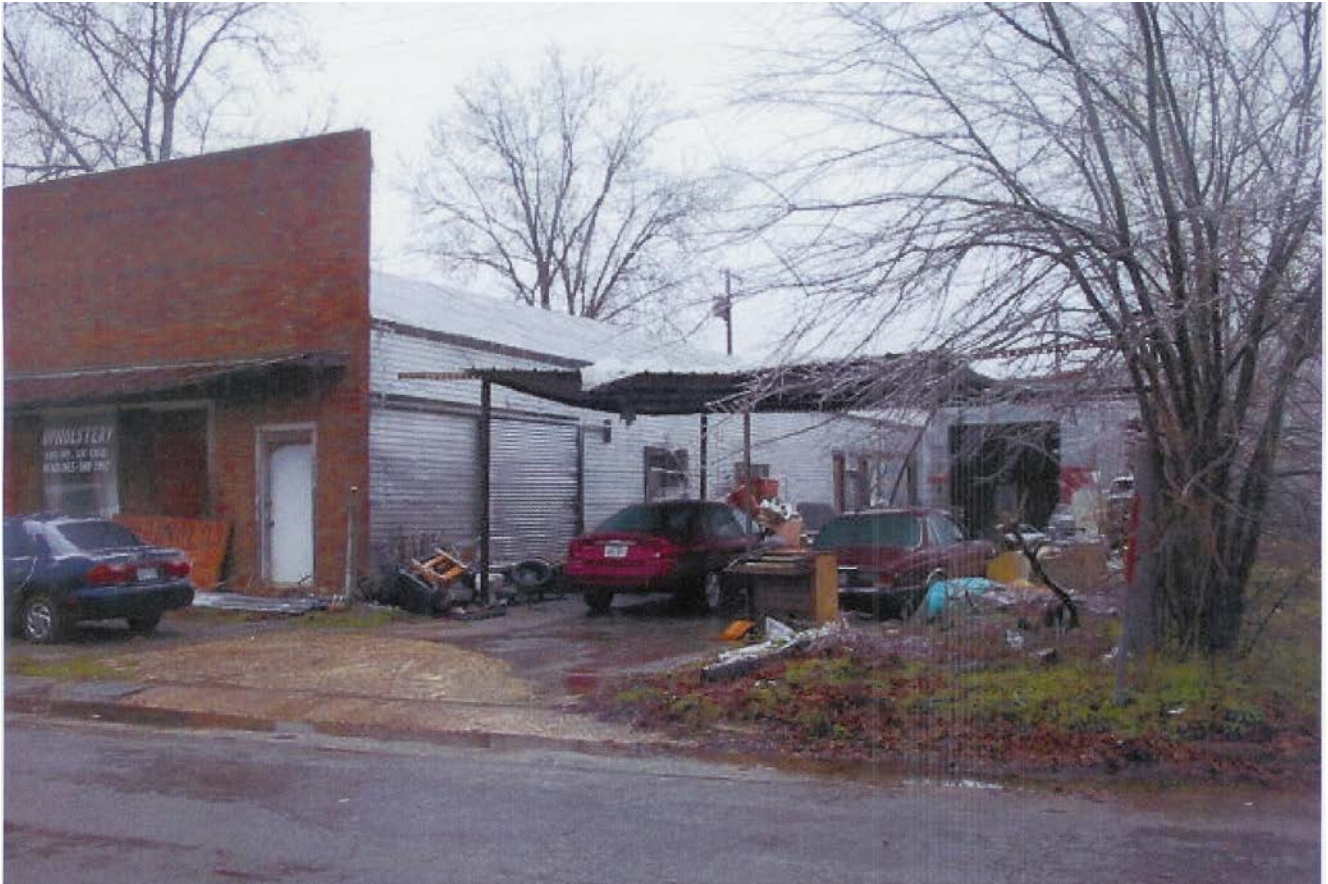
The construction type and condition of the building is shown in this 2003 photograph provided by the Freestone County Appraisal District.

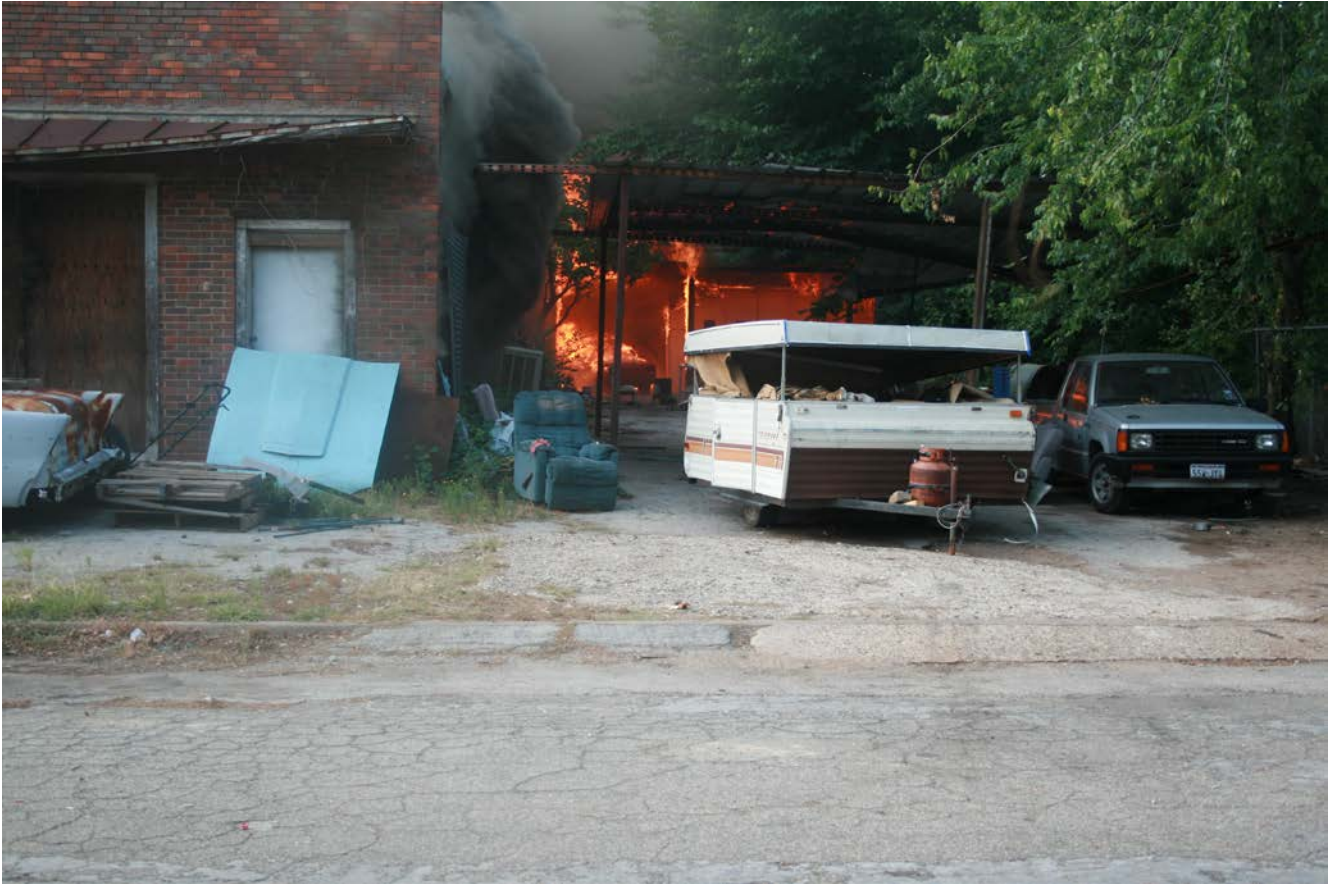
5:53 PM Photograph of the east side of the structure from the front southeast corner prior to fire unit arrival. (Photo courtesy of Dennis Martin, Teague VFD)

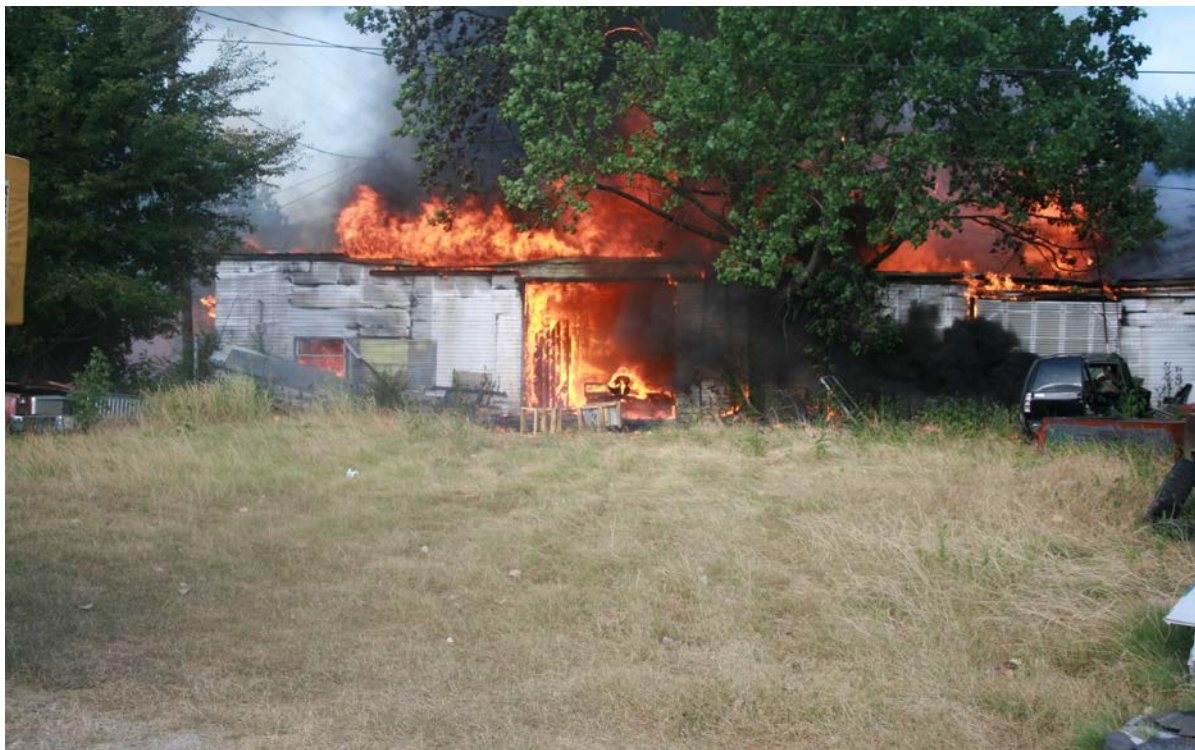
***5:56 PM This photo shows the extent of involvement of the west side of the structure.
(Photo courtesy of Teague VFD)***

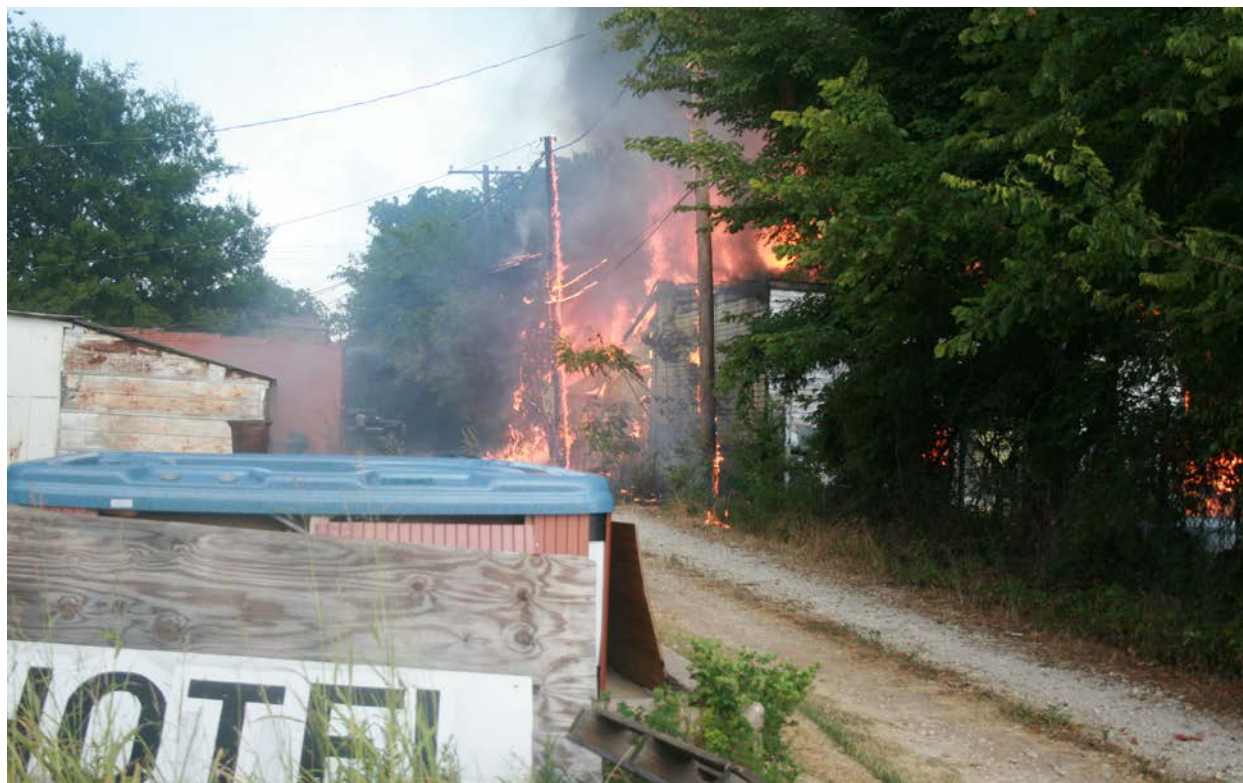
***5:57 PM This photo shows the condition of the fire at the north end of the building.
(Photo courtesy of Teague VFD)***

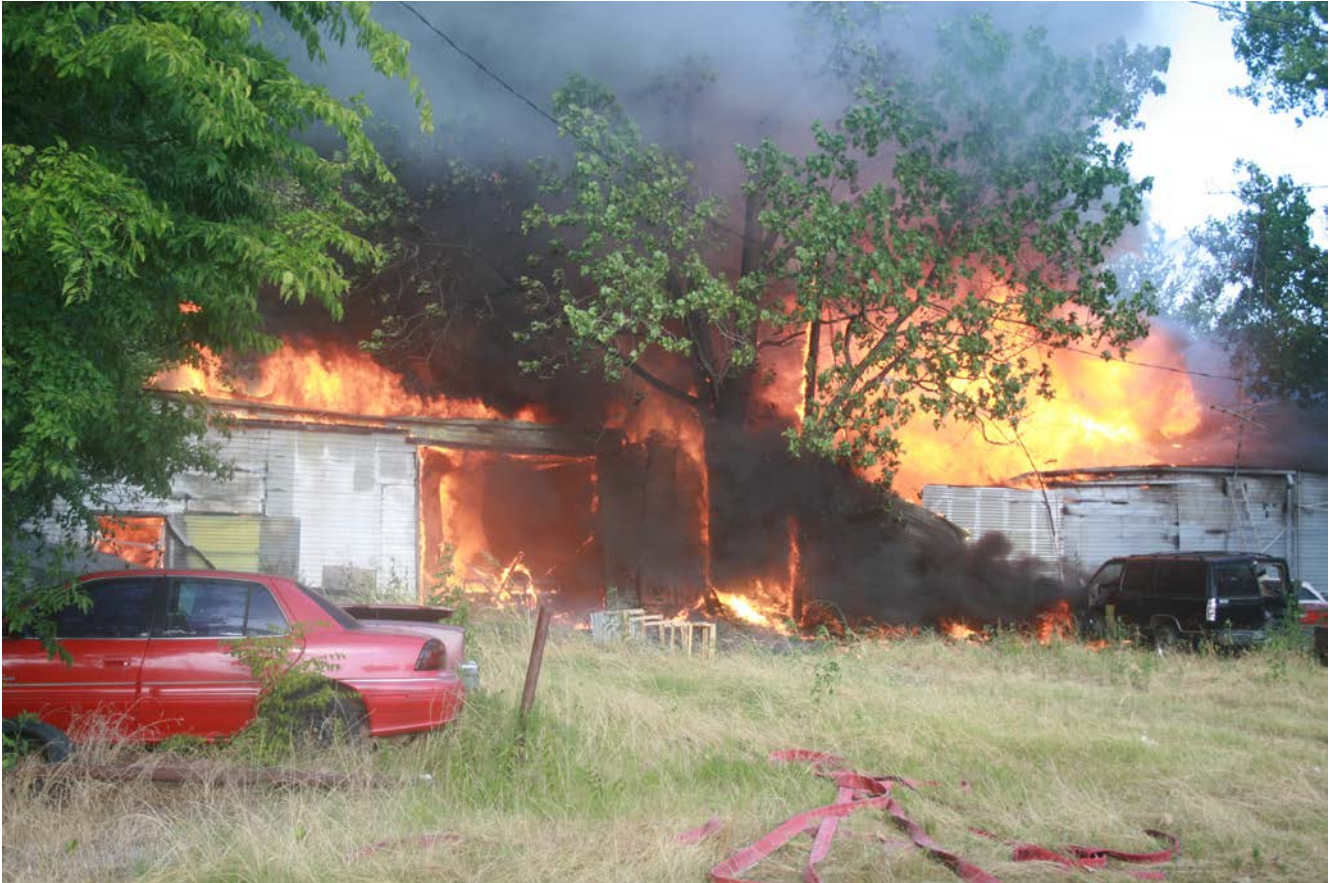
***5:58 PM Engine 91 arrived and pulled lines for the west side and alley. The structure is fully involved and the fire has moved to the south end. Partial collapse has occurred.
(Photo courtesy of Teague VFD)***

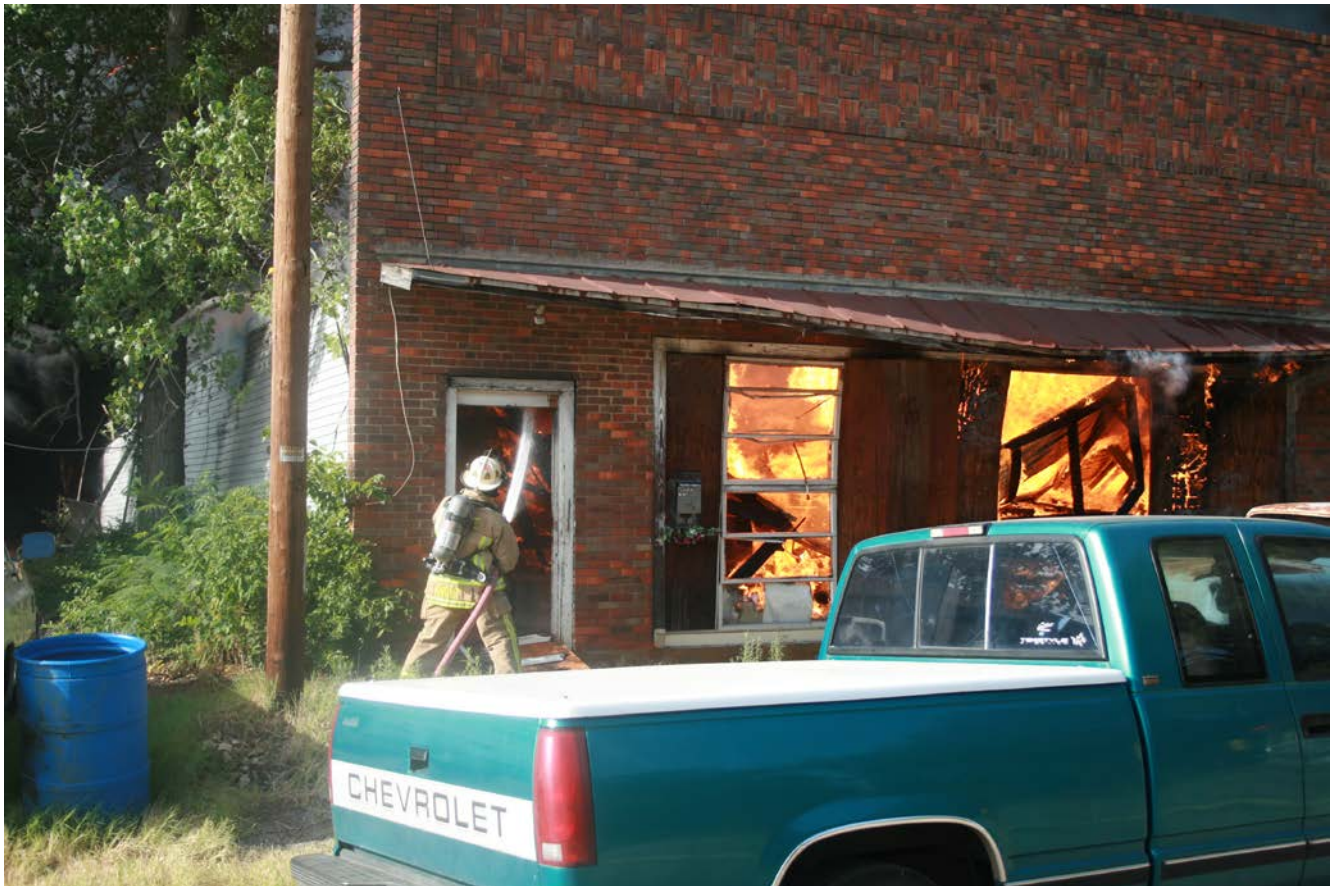
***6:04 PM Chief Knight is at the SW doorway of the structure.
(Courtesy of Teague VFD)***

Recommendation: With the limited number of personnel on the scene and the condition of the building at the time, a defensive attack, with all personnel clear from the collapse zone, which is defined as one and one-half times the height of the wall, would have been a more effective strategy for protecting exposures and conducting safe firefighting operations. No firefighters' lives should be put in jeopardy where no possibility of saving property and lives exists.

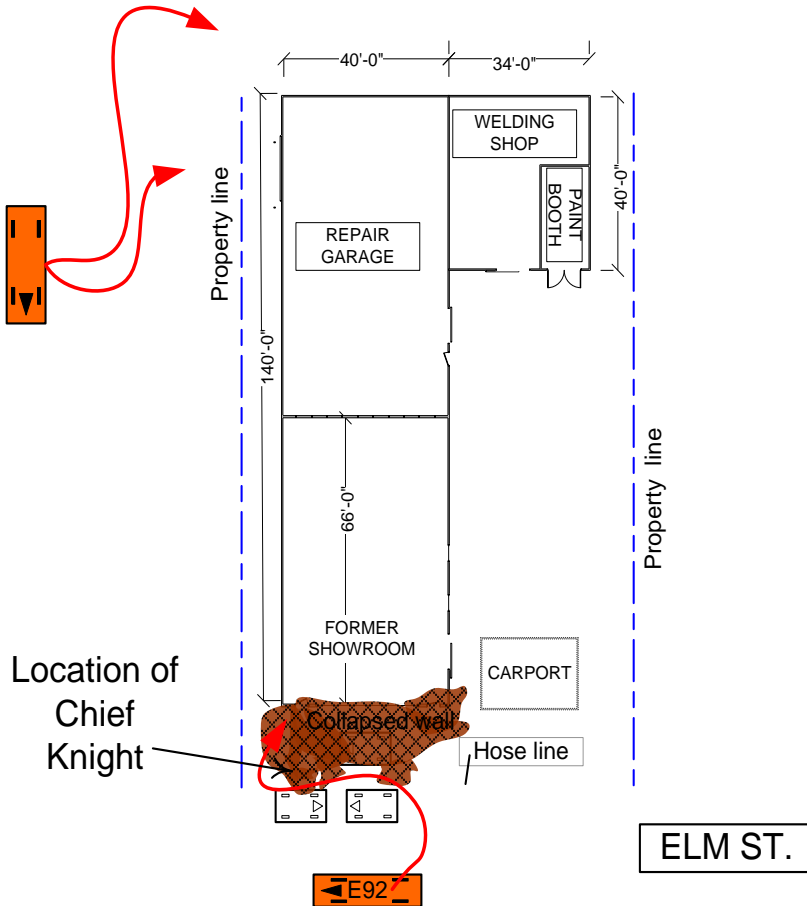
Diagram 3

Just prior to the collapse, Lt. Teer and Firefighter Lester were located at Engine 92 and observed the wall move. Lester shouted to warn Chief Knight of the danger. Firefighter Lester stated in an interview that Chief Knight seemed to look up, turn and try to run directly away from the wall toward the street. Chief Knight was caught by the collapse and pinned by bricks and debris on the western end of the area in front of the fire building between the structure and a parked pickup truck.

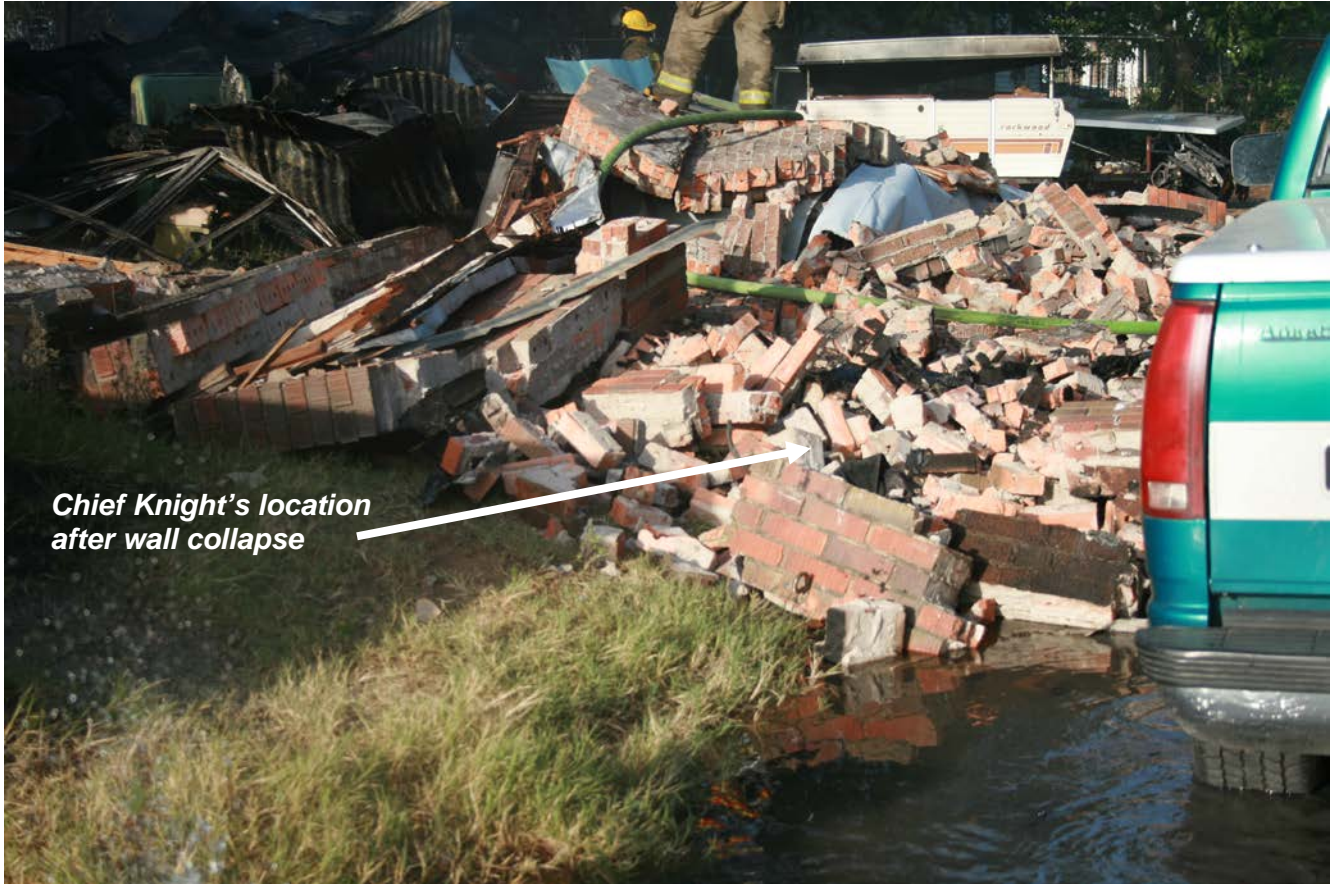
***This photo shows the site of the collapse at Chief Knight's location.
(Courtesy of Teague VFD)***

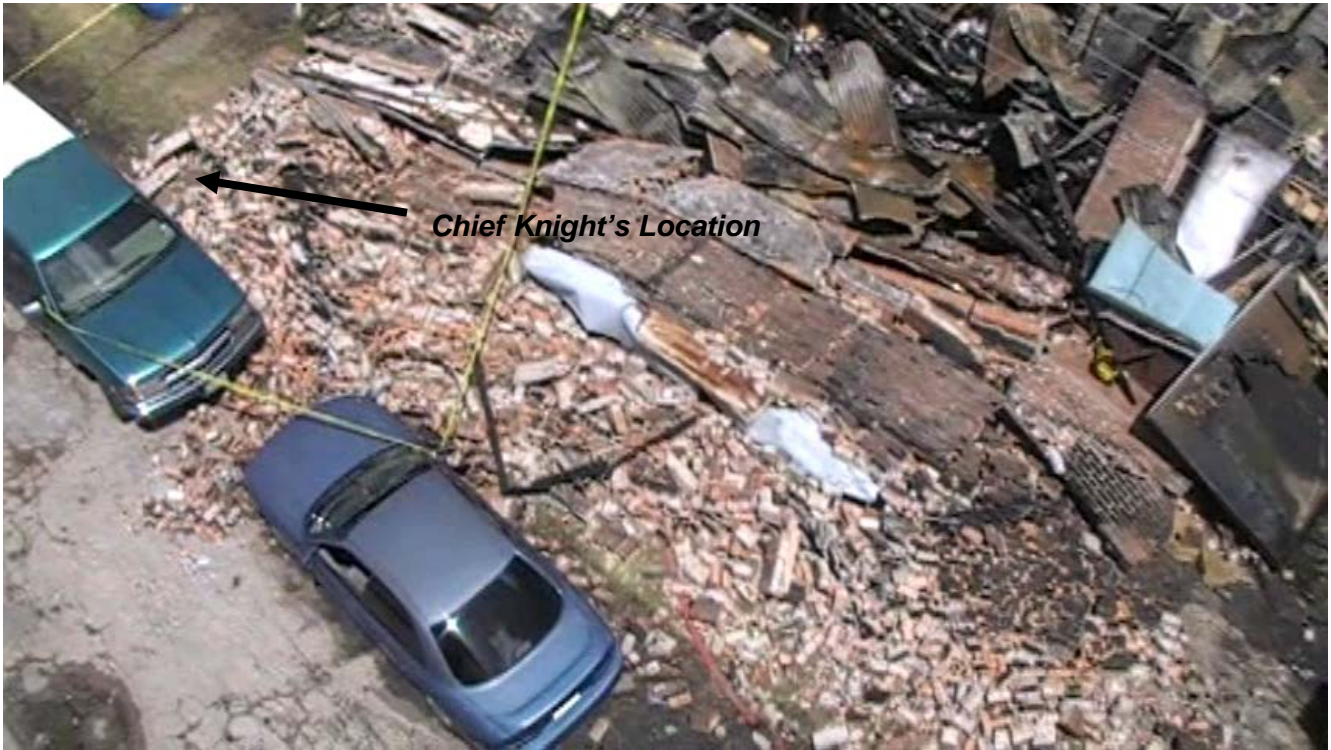
Photograph of the south end collapse zone

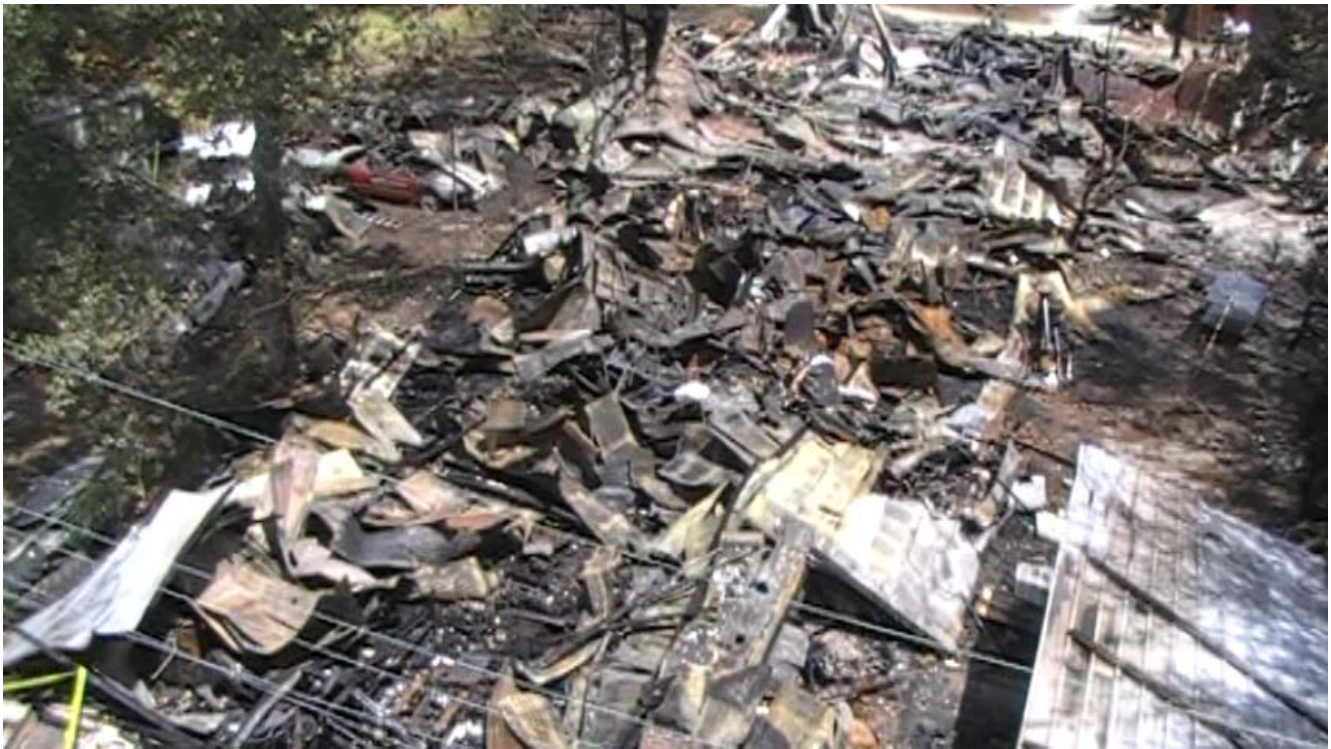
Overhead photograph from the south end of the site.
