Firefighter Fatality Investigation

**Firefighter Stanley Wilson
Dallas Fire-Rescue Department**

Investigation FFF FY 13-07

Dallas, Texas
May 20, 2013

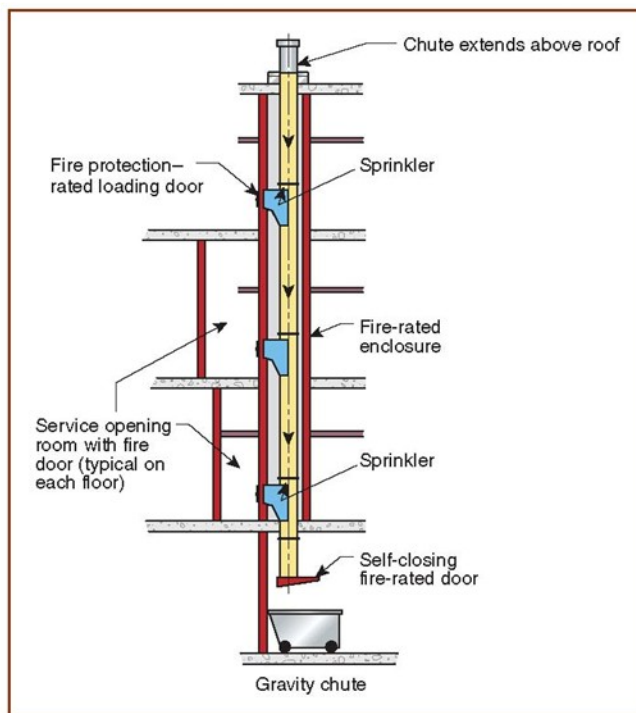
Exhibit A.1 Typical gravity rubbish chute (current codes)

Current code standards require a trash chute to terminate a minimum of three feet above the roof line of a structure (see Exhibit A.1).

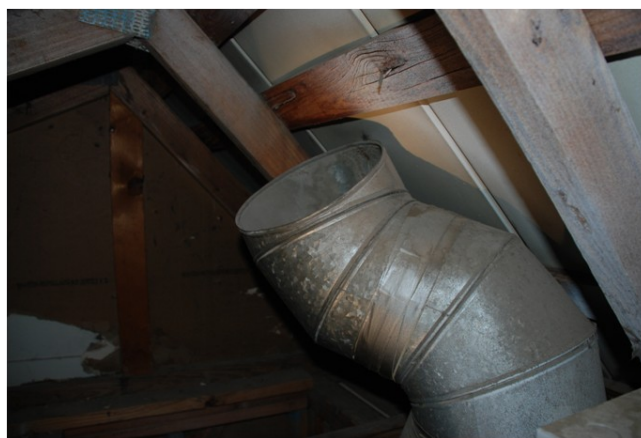
*Bldg. 6 trash chute vented into the attic space.
Bldg. 5 reported to be similar. (ATF Photo)*

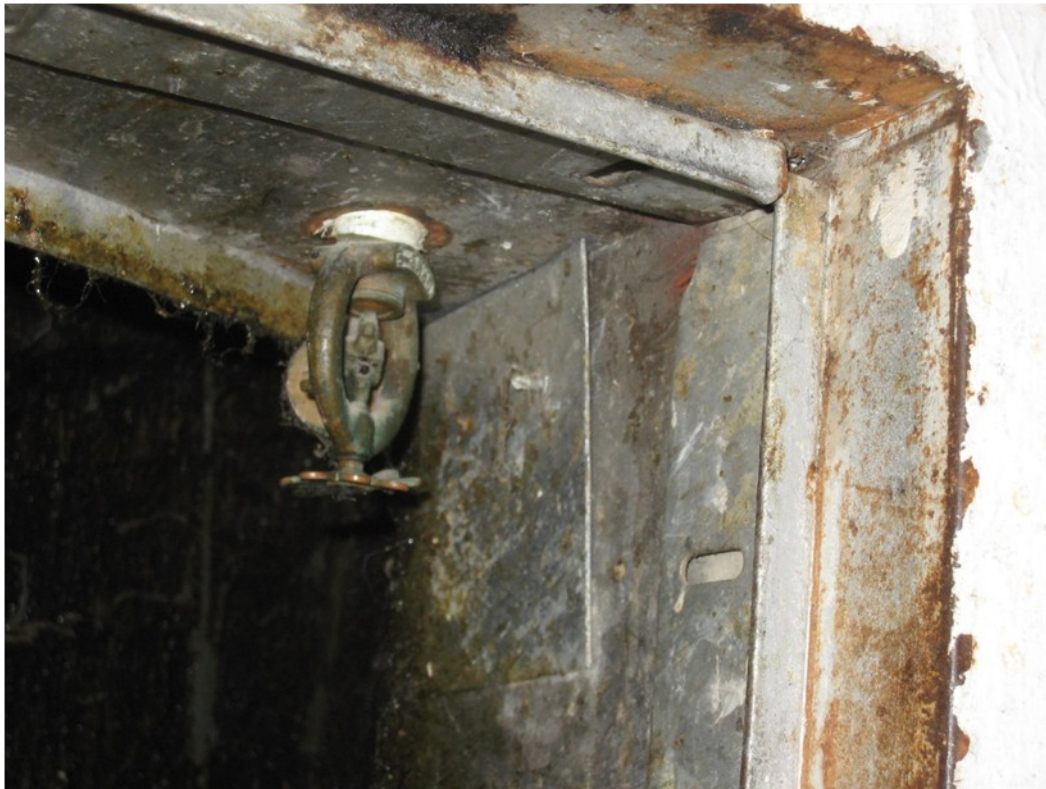
Valves that controlled water supply to the trash chute sprinklers were not electronically supervised through the fire alarm system, nor were the valves secured by other means to prevent closure by unauthorized personnel. Investigation of the building's water supply system determined that shutting off the domestic water supply to the building would effectively cut off water supply to the sprinkler system serving the trash chute.

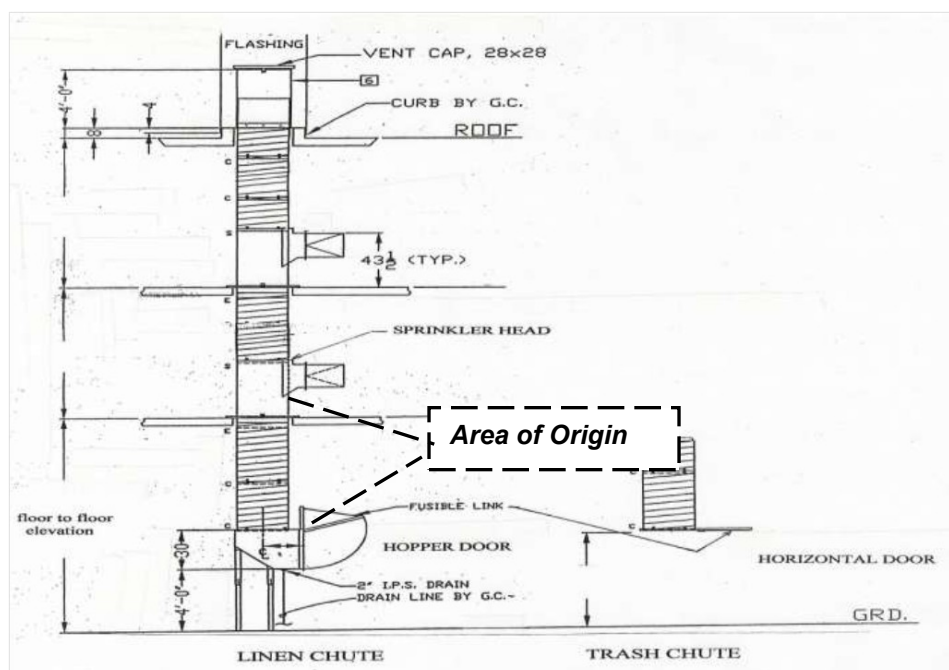
Area of origin

The fire originated in the interior tube of the trash chute below the trash chute door to the second floor and above the spring-loaded trap door to the trash collection room. A specific ignition source could not be determined, because of the amount of fire damage to the trash chute tube, the trash dumpster and the surrounding environment.

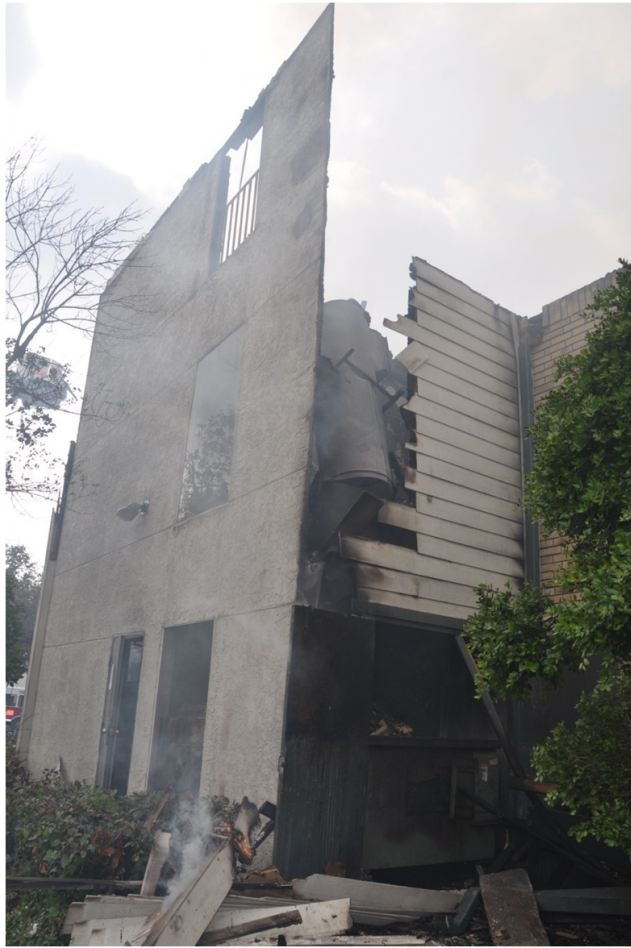
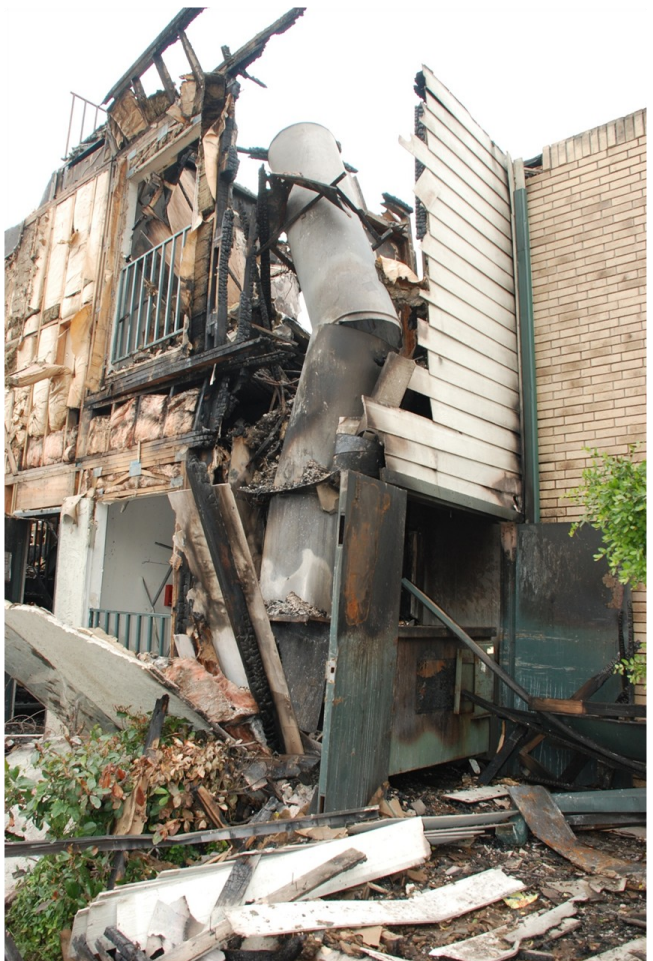
Area of origin

Examination of the trash chute revealed that the entire interior of the tube was cleared of debris, which was the result of an intense fire spreading upward and within the trash chute. Exemplar trash chutes within the complex were found to be heavily greased and coated with residual trash debris at all levels.

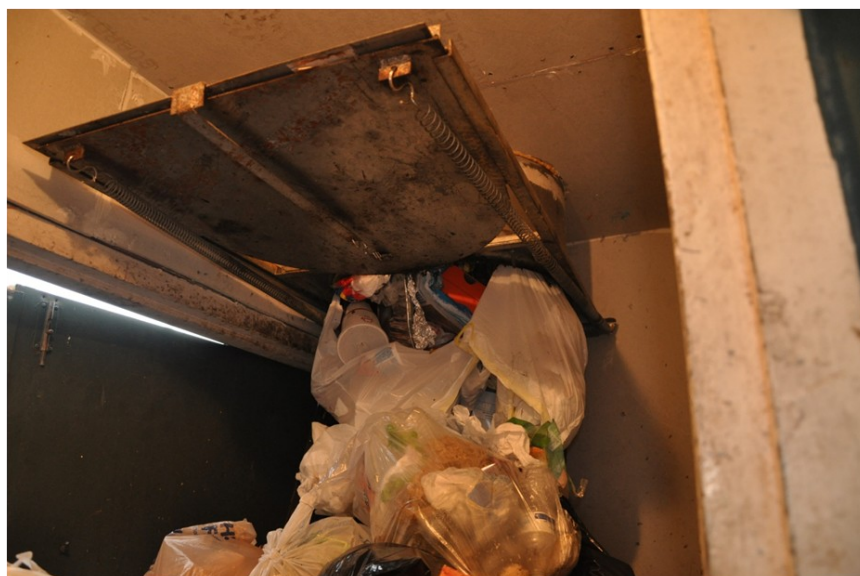
Condition of trash chute spring-loaded door at first floor in exemplar building

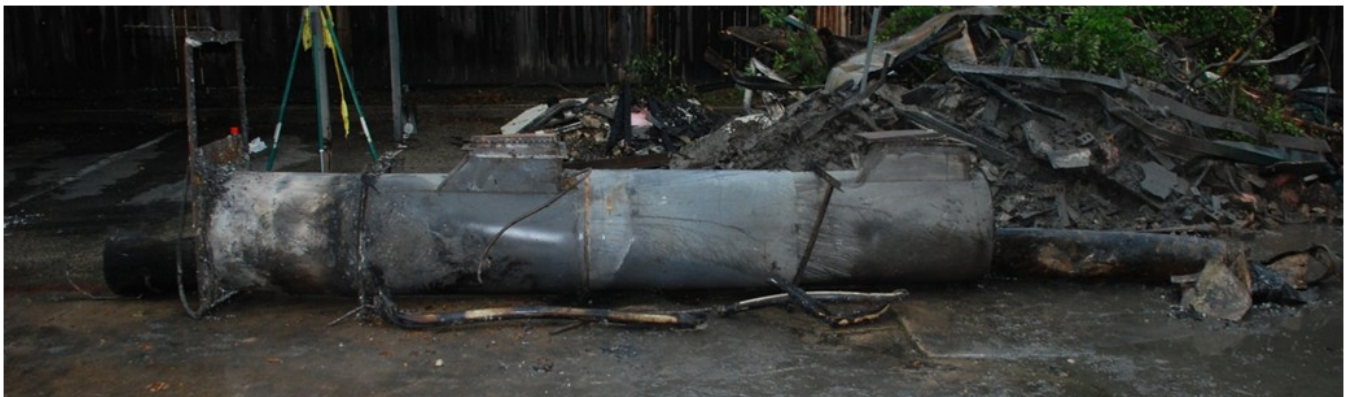
Trash chute with first floor at left and attic vent at right
