# TEXAS STATE FIRE MARSHAL'S OFFICE

## Firefighter Fatality Investigation

Investigation Number FY 10-01

**Captain Thomas Araguz III**

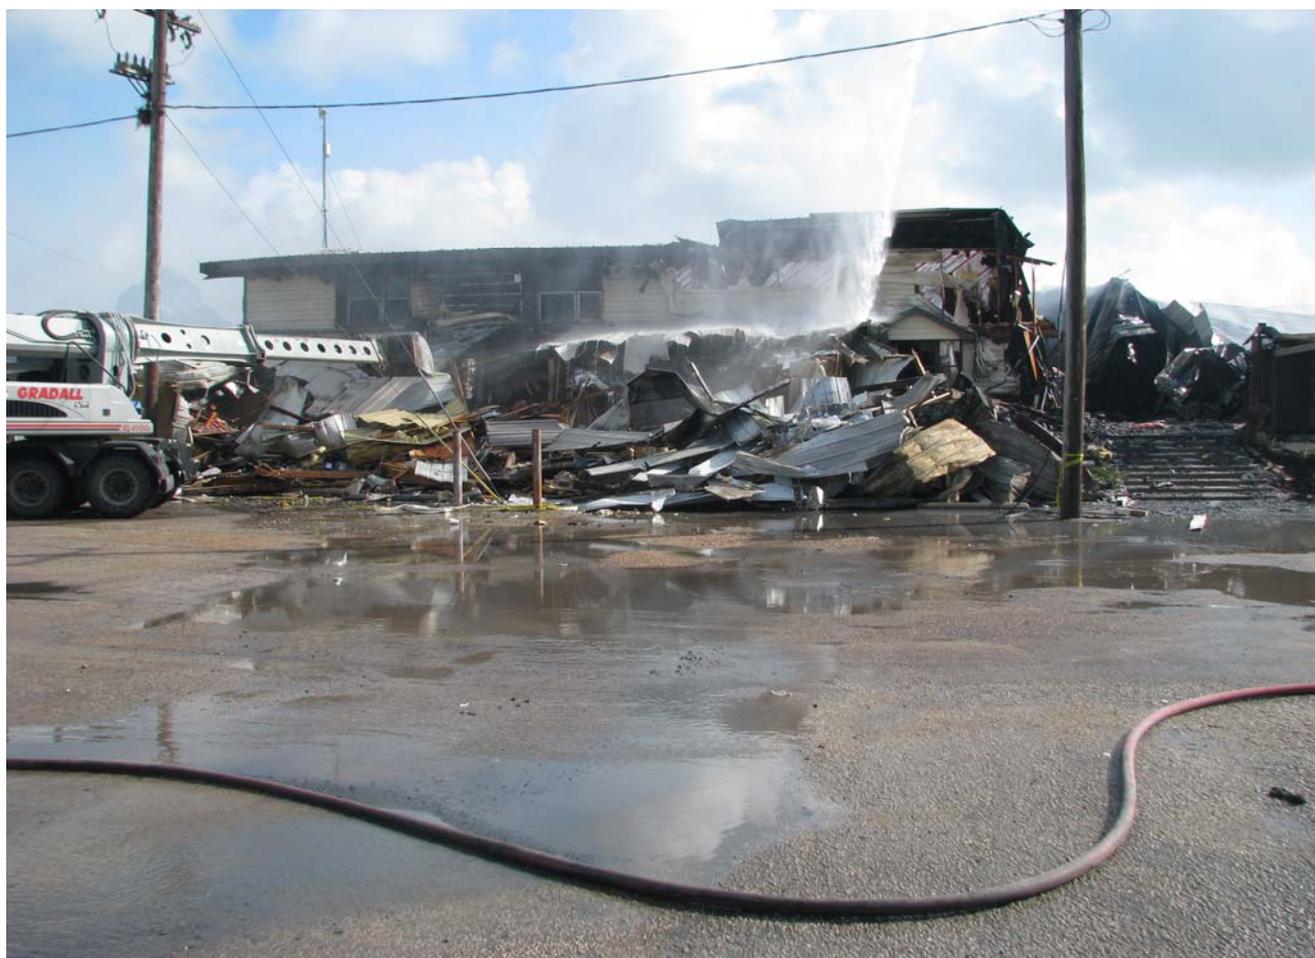
### ***Business office building***

The **business offices** at the southwest corner of the building were heavily damaged during the extinguishment and overhaul operations. The fire damage in this area was due to the extension of the fire through the processing room from the east. Heavy equipment was used to remove the walls to allow access to the fire by the aerial during fire ground operations.

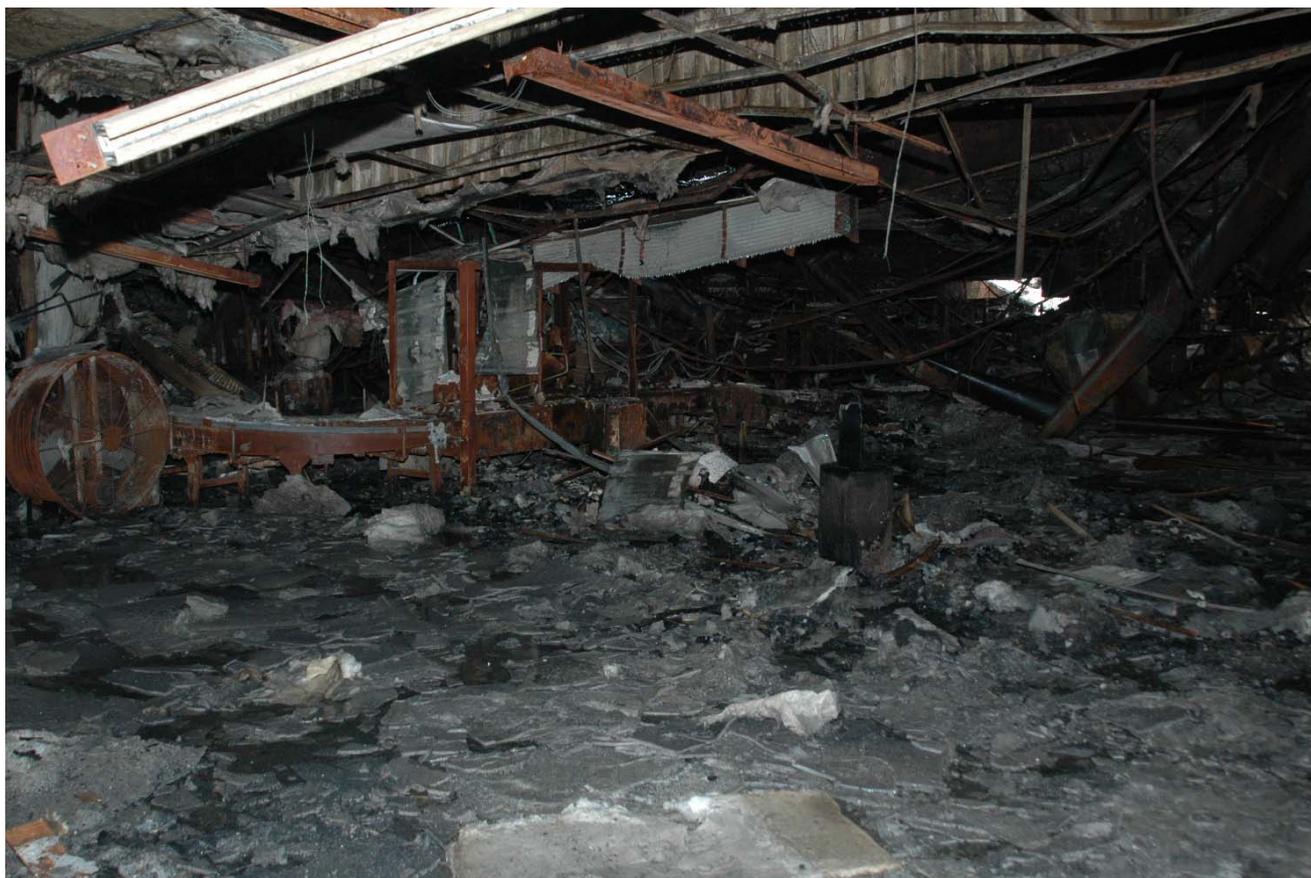
***Main egg processing room***

The **processing room** exhibited extensive fire damage including partial collapse of the roof and the south exterior wall. The south exterior wall collapsed inward toward the center of the building as the roof collapsed. The northeast corner extension into the area of the East Hallway and Dry Storage 3 exhibited the most fire damage of the processing room, consuming the wood framing and Hardy board wall. The remains of a 1.75 inch hose line were uncovered along the south wall of the processing room. The nozzle was found in a closed condition near the southeast corner just short of the swinging double doors leading to Dry Storage 3.

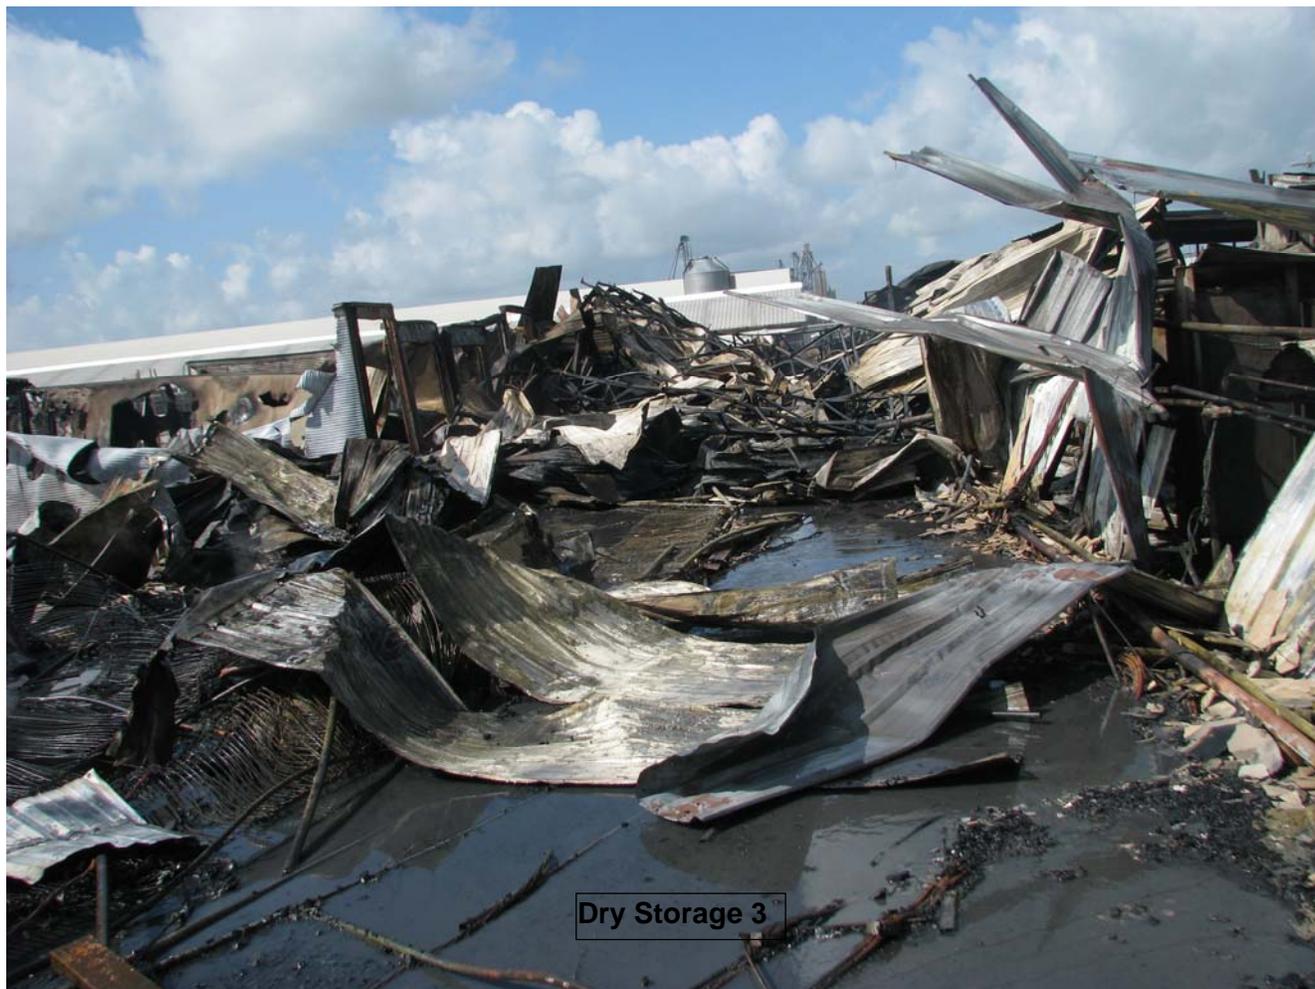
**Dry Storage 3** was severely fire damaged, causing the metal roof to collapse. The electrical service entrance to the building was at the west side of this area. The exterior walls partially collapsed. The west wall collapsed toward the west. The damage in Dry Storage 3 resulted when fire extended into the area and then burned unabated after rescue efforts halted and defensive tactics commenced. An opening cut into the west exterior wall near the north end indicated the location of rescue where Captain Cano was banging and kicking the wall. Outside the west wall was an ice machine and employee break area. Several items recovered from this location included Captain Cano's fire helmet,

visor, hood, gloves, SCBA face piece, and a fire damaged, gas powered chainsaw used to cut through the wall.

***Dry Storage 3 looking south from the swinging double doors of the processing room at the area where Captain Cano was rescued***

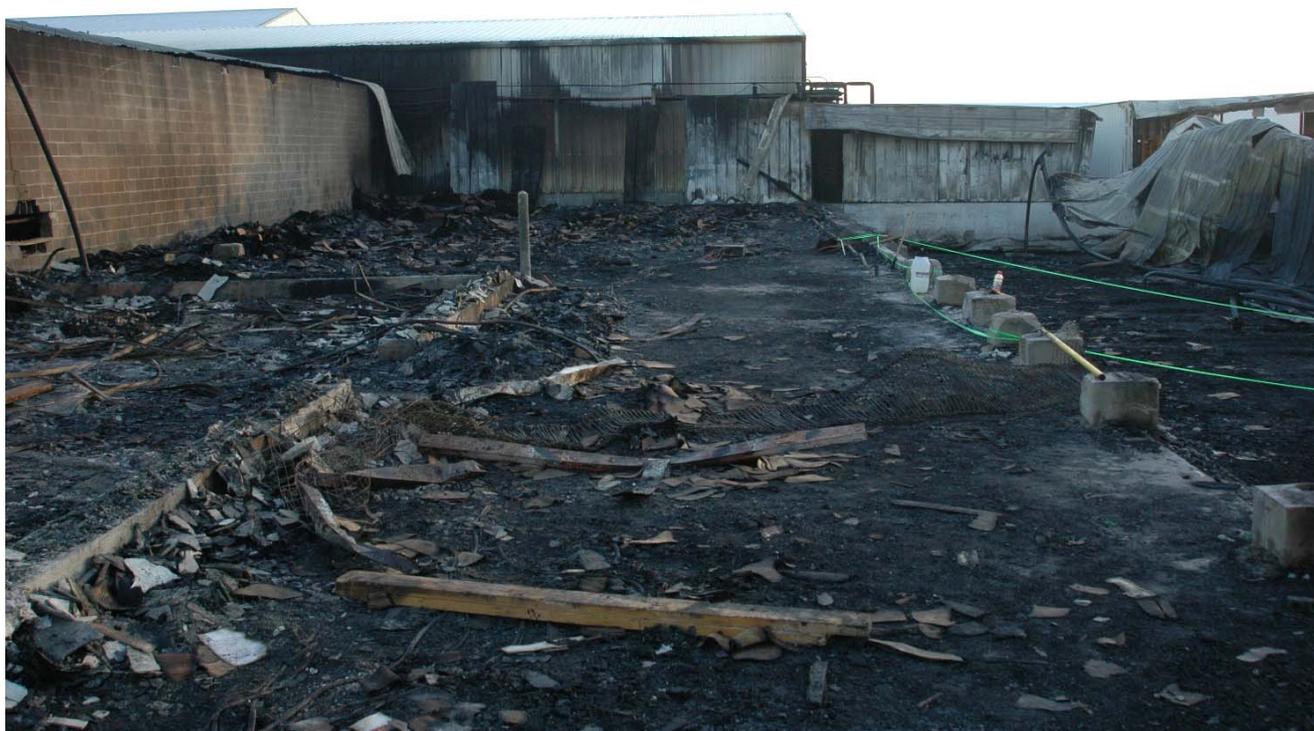
**Dry Storage 2** was severely fire damaged, causing roof collapse. The pallets of cardboard boxes were consumed nearer the south end and more cardboard material survived nearer the north end. Pallets of stock at the north end continued to smolder and burn until completely exposed as the roof panels were removed and water was applied. The 4 inch x 4 inch wood support columns along the east side of Dry Storage 2 were consumed.

The electrical system main conductors fell to the floor and the PVC conduit and insulation of the conductors were consumed. The electrical conductors above the south end exhibited melting and bubbling on the conductors.

***Dry Storage 2 with the processing room extension on the lower left and Dry Storage 1 on the right***

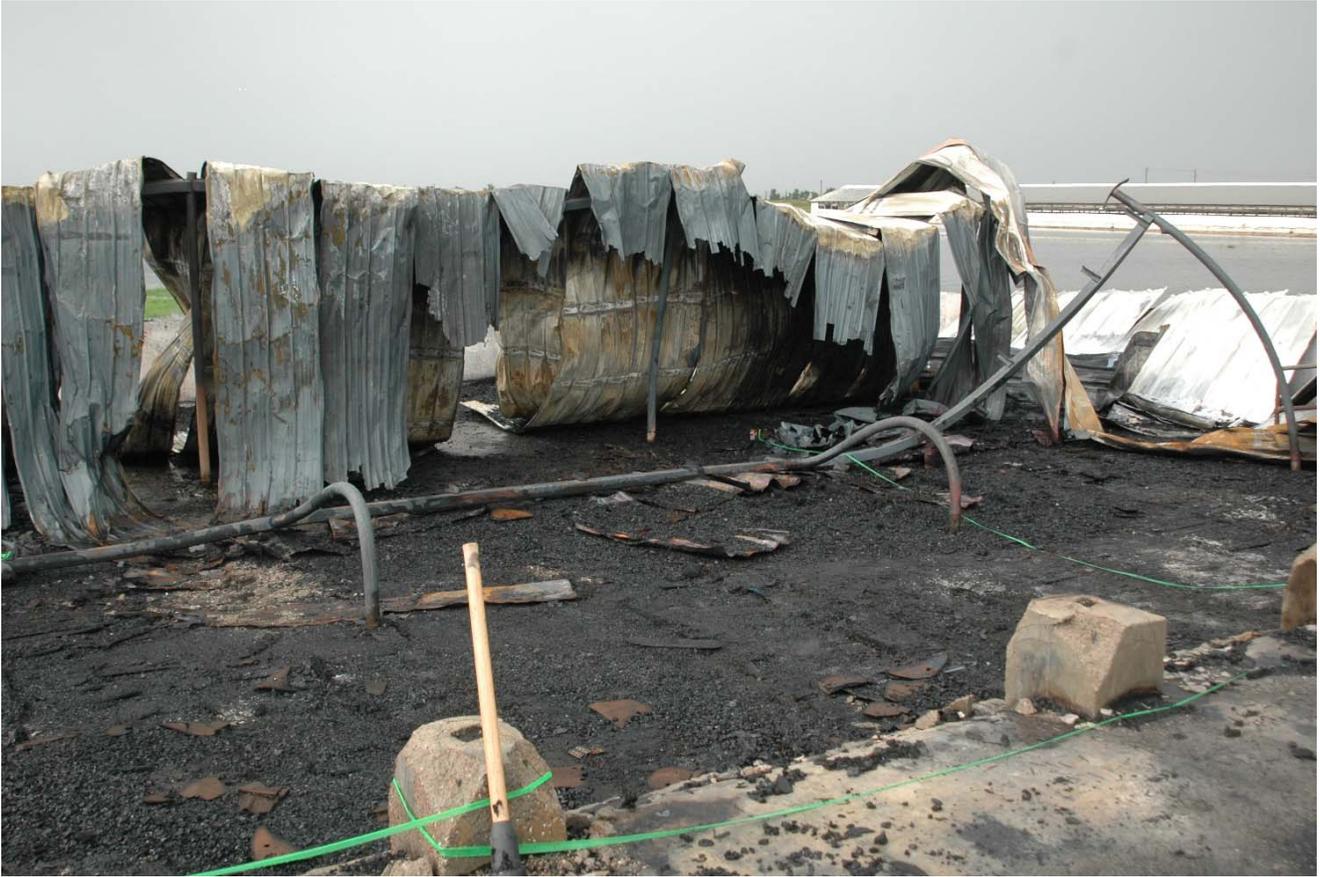
**Dry Storage 1** was severely fire damaged, causing the roof to collapse. Witness information from employees at the plant and first responding firefighters provided information indicating the area of fire involvement. Firefighters stated that the fire was showing through the roof near the south end of Dry Storage 1 when they arrived.

***Dry Storage 1 south end showing damage to the metal roof panels and the metal support columns***

The two rows of metal support columns inside the storage room were severely damaged. The west row of supports nearly folded at their base and tilted toward the east. The south end of the west row of support columns twisted and tilted to the east more than the north end. The east row of support columns tilted inward toward the west. The east columns did not exhibit as severe a tilt as the west row of columns. The panels of metal roof were more damaged toward the south end of the space. The pallets of stock were consumed.

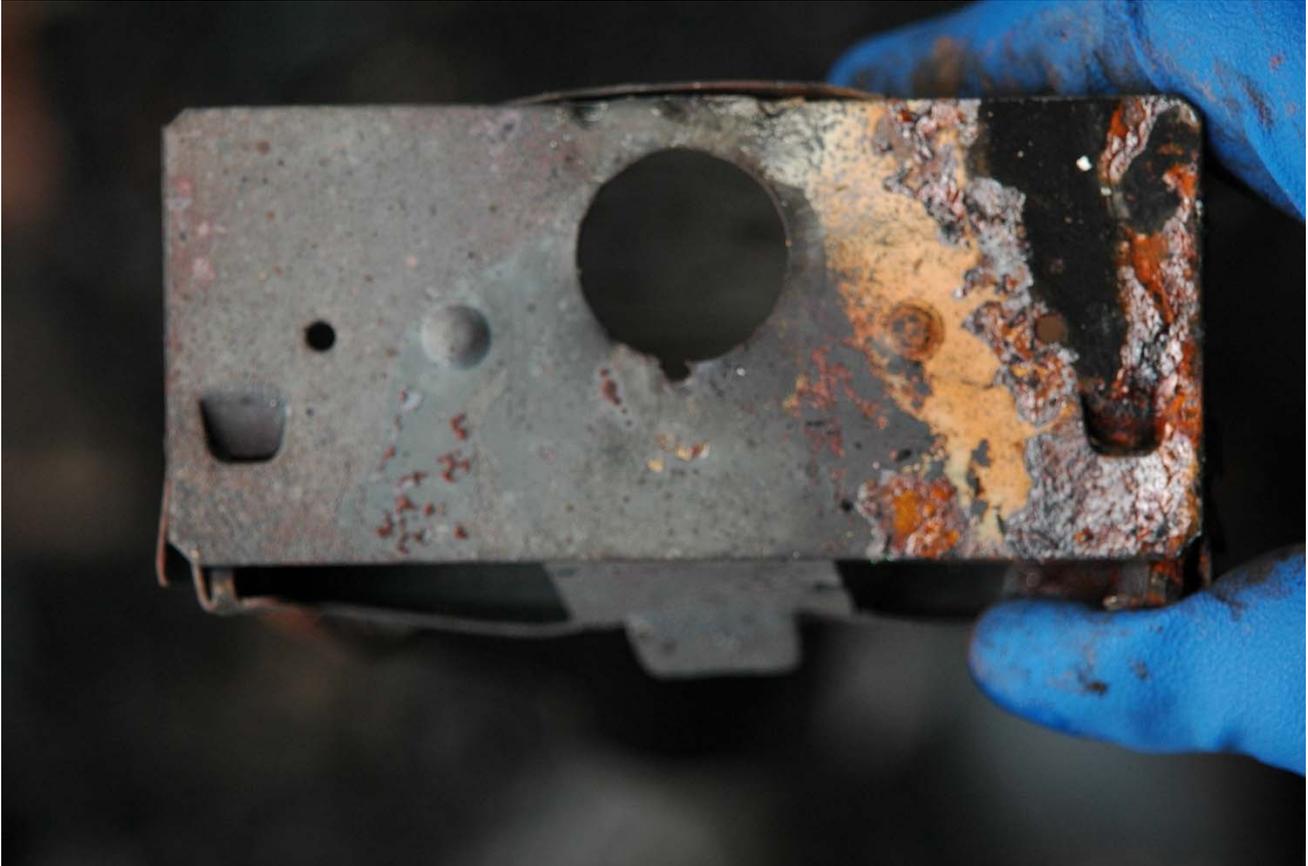
The fluorescent light fixtures were examined, revealing a loss of mass to the north end of the metal housing of the southernmost fixture. Conductors inside PVC conduit connected to the fixture through the north end. Whether mechanical damage to the light fixture or conduit occurred, or from the natural vibrations of the building, the insulation of the conductors was damaged, allowing contact or intermittent contact with the metal housing. Arcing across a small gap resulted in a resistive heating condition and loss of mass of material occurred over an undetermined length of time while eventually heating the supporting wood rafter to ignition temperature. The resulting combustion of the rafter resulted in burning embers that dropped down and ignited the shrink-wrapped egg crates stored below.

*End cap of fluorescent light fixture showing loss of material at contact point with conductors*

This fire cause is determined to be **ACCIDENTAL**.

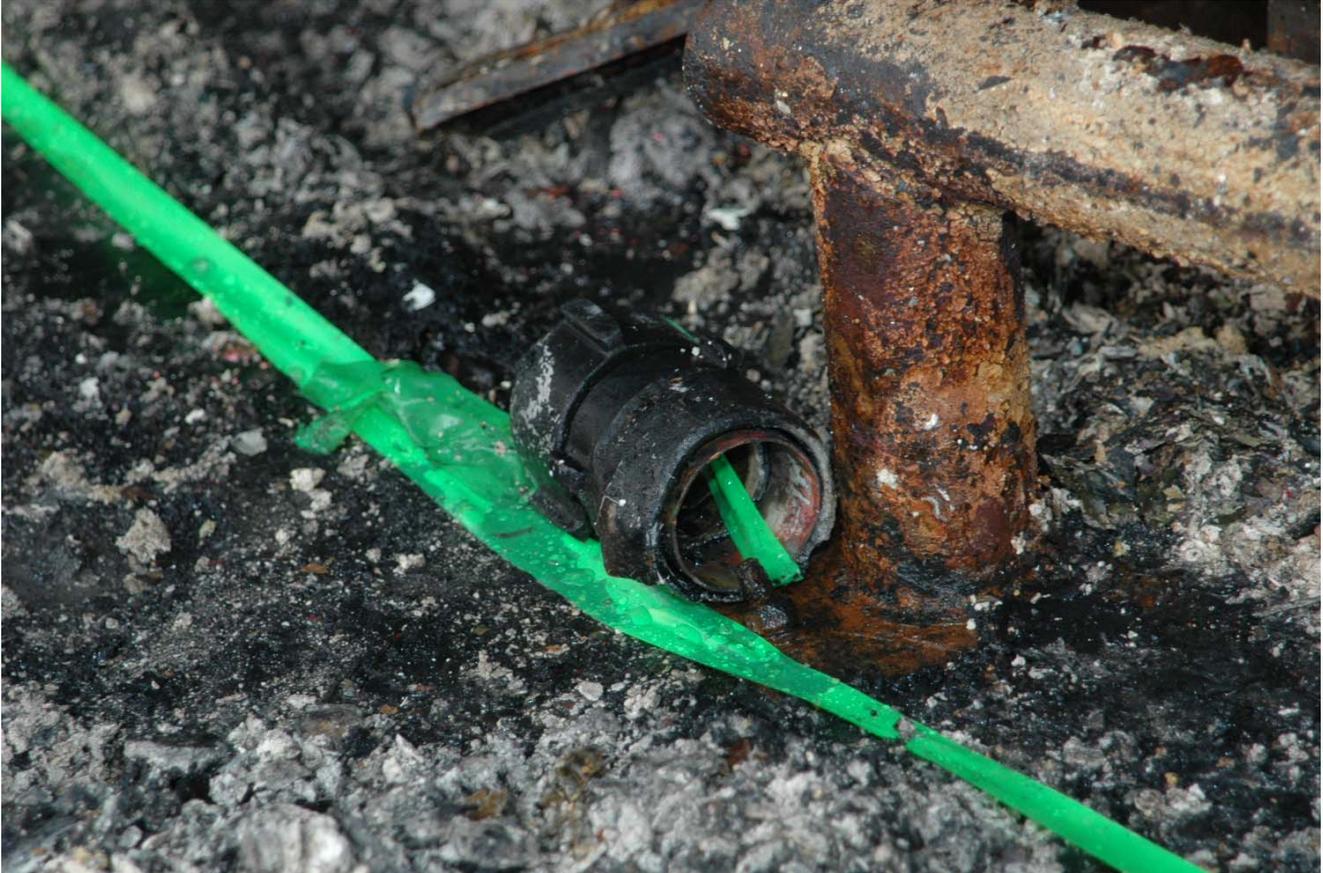
Captain Araguz took the nozzle and Captain Cano advanced with him holding onto Araguz’ bunker gear. The crew advanced along the south wall of the processing room toward the double doors to Dry Storage 3 and lost contact with the hose line. The investigation found the couplings between the first and second sections of the hose lodged against a threaded floor anchor (see photo) preventing further advancement of the line. How the team lost the hose line remains uncertain.

***This hose coupling is lodged against a floor bolt***

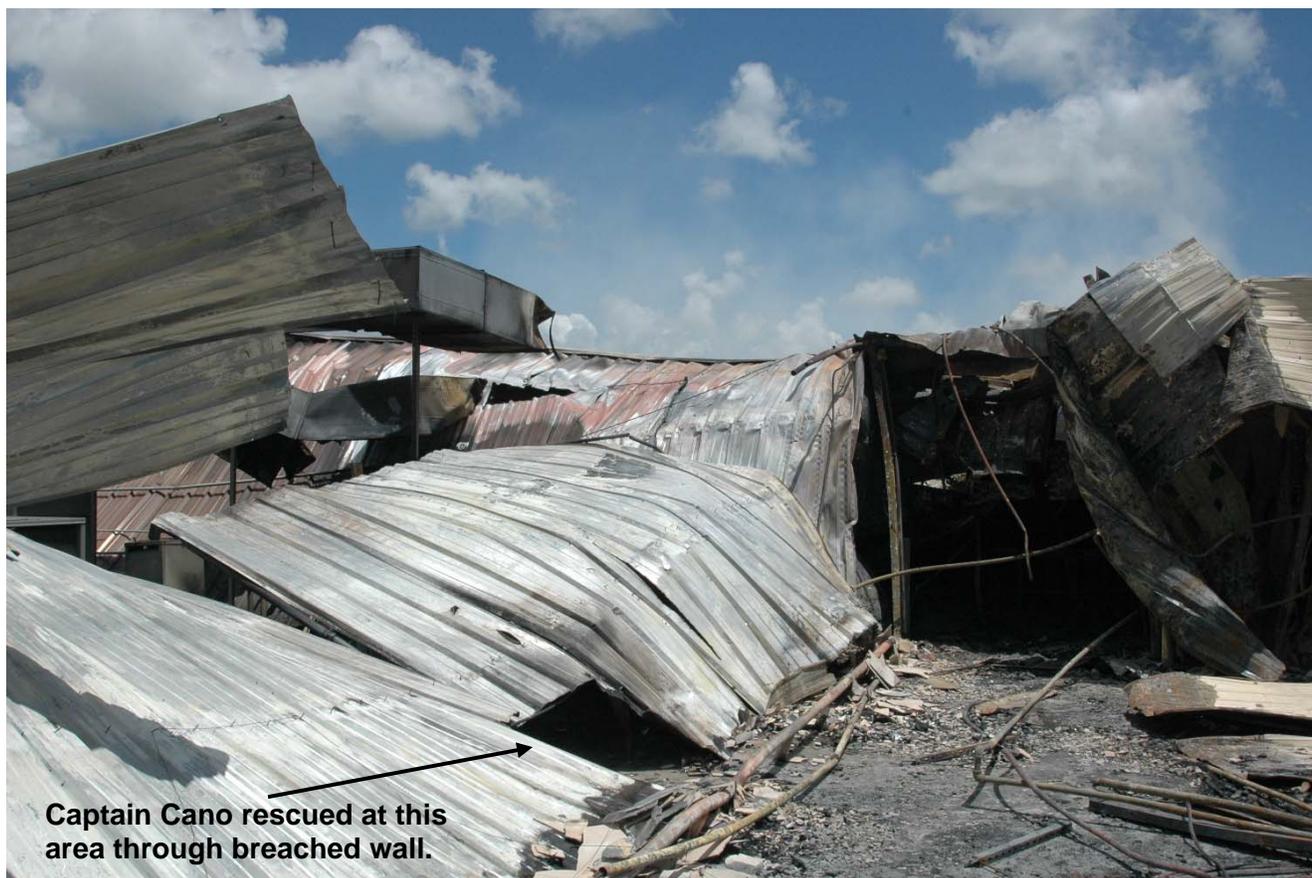
Captain Cano stated in his interview that they made several large circles in an attempt to locate the fire hose. Cano became entangled in wiring, requiring him to doff his SCBA. After re-donning his SCBA, Captain Cano noted he lost his radio, but found a flash light. He remembered that his low air warning was sounding as he and Araguz searched for the hose. Cano stated that they made it to an exterior wall and decided to attempt to breach the wall. Working in near zero visibility, Captain Cano reported losing contact with Captain Araguz while working on breaching the wall. Shortly after he lost contact, Captain Cano ran out of air and removed his mask. Captain Cano continued working to breach the exterior wall until he was exhausted.

***North end of Dry Storage 3 where Captain Cano was rescued***
