STATE FIRE MARSHAL'S OFFICE

Line of Duty Death Investigation

Investigation Number 02-251-02

Fire-Rescue Officer Vincent Davis

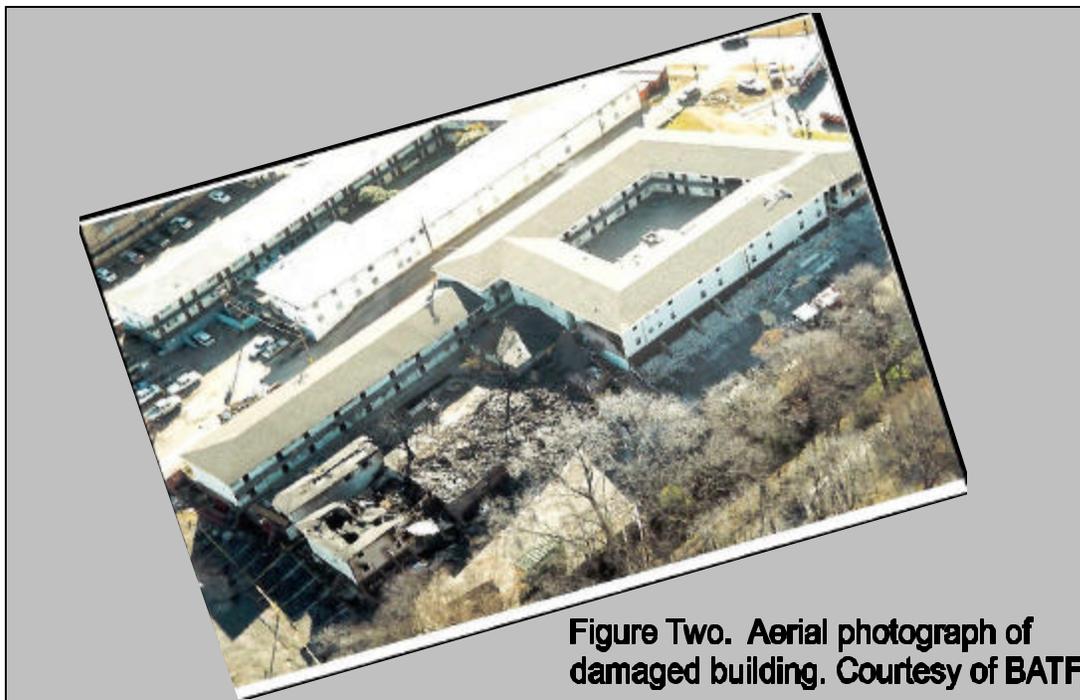
**Figure Two. Aerial photograph of
damaged building. Courtesy of BATF**

Section 2, north of the breezeway had totally collapsed. A portion of Section 1, north of the grade change, was standing but was heavily damaged. **(Figure Two)** Sections 8 and 9, located north and south of the open courtyard/play area sustained extensive damage from radiant heat.

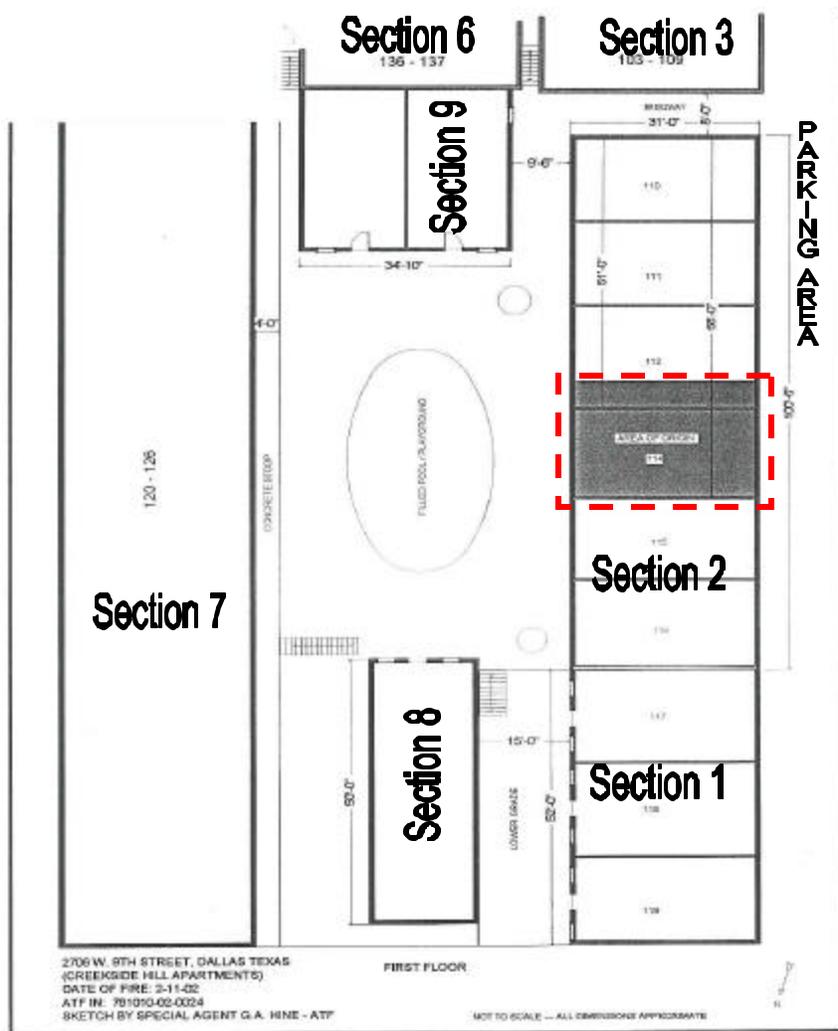
Investigators determined the fire originated in the area of apartment 114 in section 2 of building 2. **(Figure Three)** This building was undergoing extensive renovation. Cutting of metal guard rails with cutting torches and pipe soldering operations using open flame torches had been conducted in the building in the areas of apartments 114 and 214 on the afternoon of the day of the fire.

**Figure Three. Building Floor Plan
Courtesy of BATF.
Notations by SFMO.**

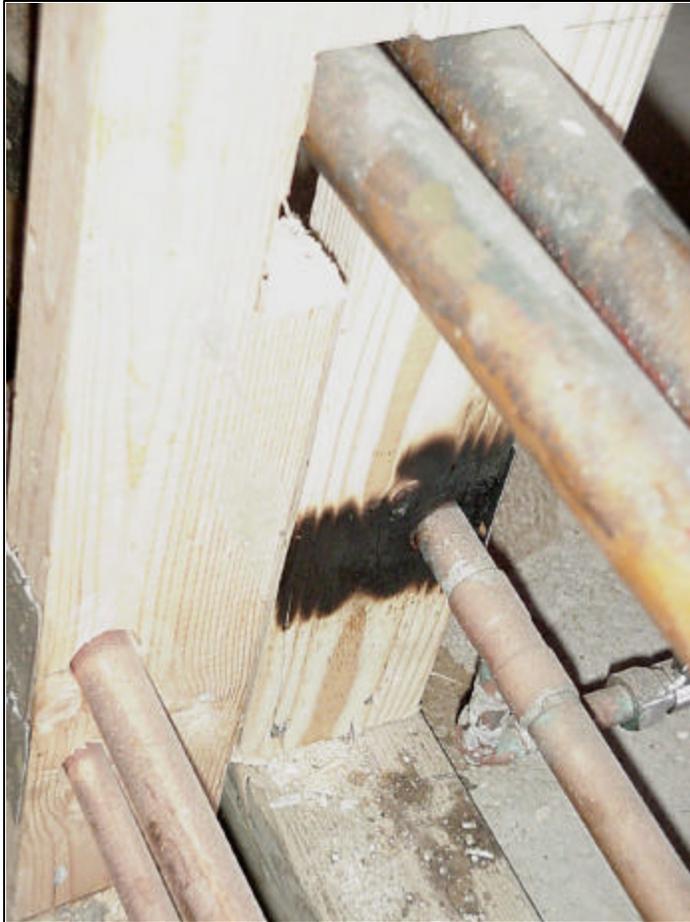
Figure Four. Charred wood observed in adjacent building undergoing renovation.

Evidence of careless cutting and pipe soldering operations was observed in adjacent buildings under renovation by the same contractor. **(Figures Four and Five)** Many areas of charred wood were observed where copper pipes had been sweat-soldered by the renovation contractor's employees. These areas of charred wood had the potential for smoldering for long periods before breaking out into open flame. Pipe soldering operations with open flame torches have been attributed to the fire cause of many large-loss fires.

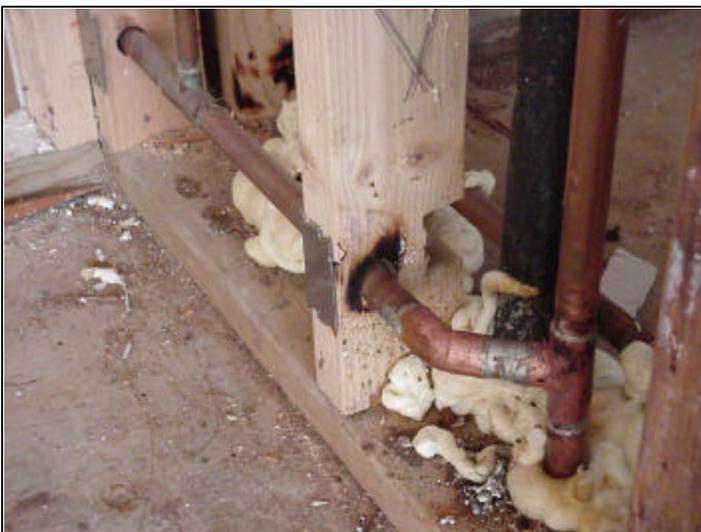
Figure Five. Charred wood observed in adjacent building undergoing renovation.

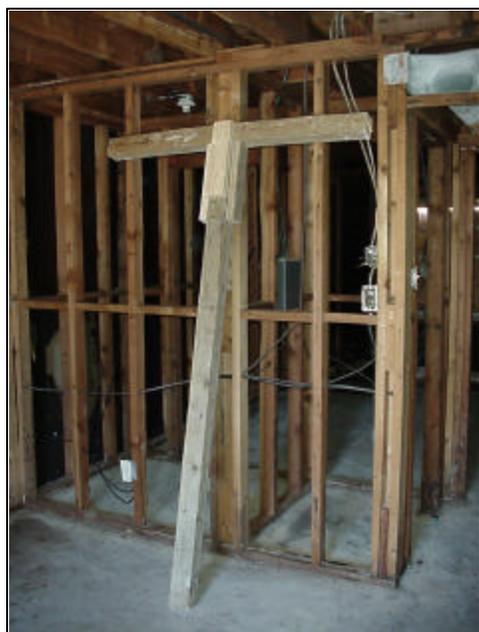
The walls of the apartments were originally covered with gypsum drywall, but the drywall had been removed from many apartments during the renovation process, exposing the wood structural members of the building. Replacement of deteriorated load bearing wood structural members was in progress and temporary "T"-shaped floor jacks were in use. **(Figure Six)** At least one burned "T-jack" was recovered from the fire debris.

Figure Six. "T"-shaped floor jack found in area adjacent to fire.

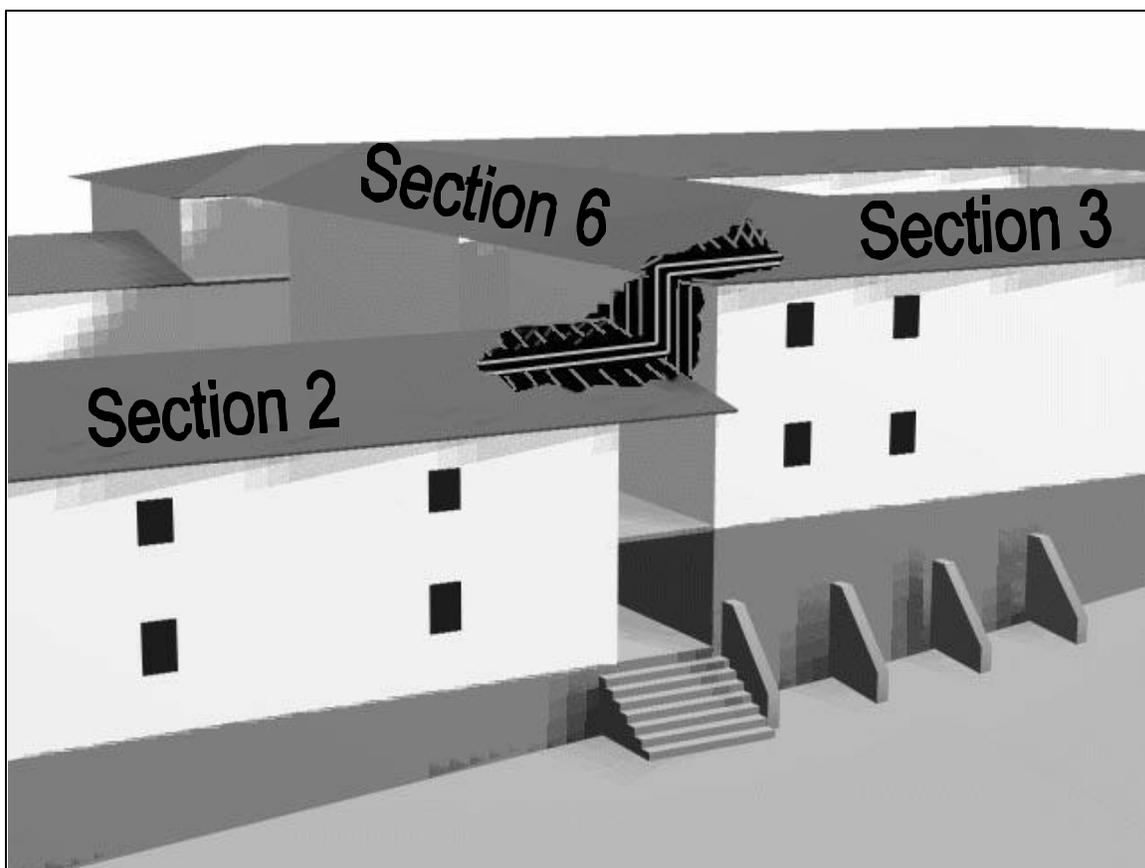
There is a significant change of grade from the south end of Section 2 to the north end of Section 3. Proceeding south from Section 2, the water supply piping first passed through a double wythe (Each continuous vertical section of masonry one unit in thickness) veneer brick wall, extended horizontally through a continuation of the peaked roof over the breezeway between Sections 2 and 3, and entered a double wythe brick veneer wall of adjacent section 3. The piping made a 90-degree turn to the vertical and continued vertically in a void behind the double wythe brick veneer wall toward the attic area of Section 3, where the piping turned again and took on a horizontal aspect. **(Figure Seven)**

Figure Seven. Arrangement of HVAC piping in attics and wall. Illustration provided by Dallas Fire-Rescue. Notations by SFMO

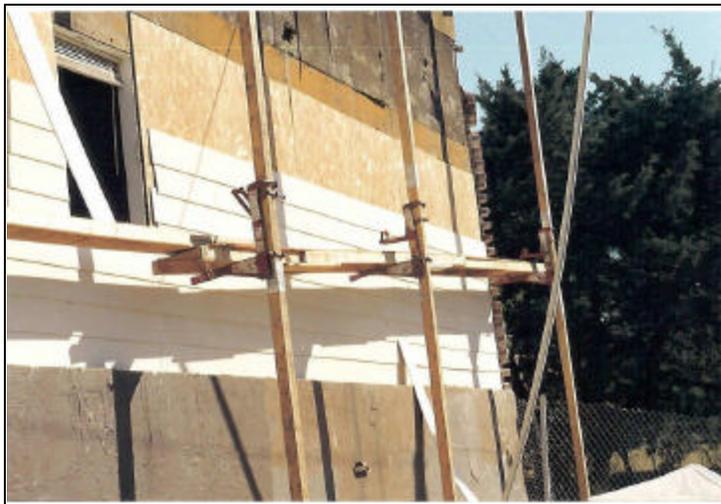
As part of the renovation project, all brick had been stripped from the west side of Section 3 and had been replaced by composition siding. **(Figure Eight)** This eliminated the tie-in between the double wythe brick veneer wall on the north end of Section 3 and the double wythe brick veneer on the west side of Section 3 that provided some structural stability. This created a freestanding double wythe wall over 15 feet tall that was separated from the structural members of Section 3 by a void of several inches.

Figure Eight. Southeast end of Section 3 showing brick removal. Photo by BATF.

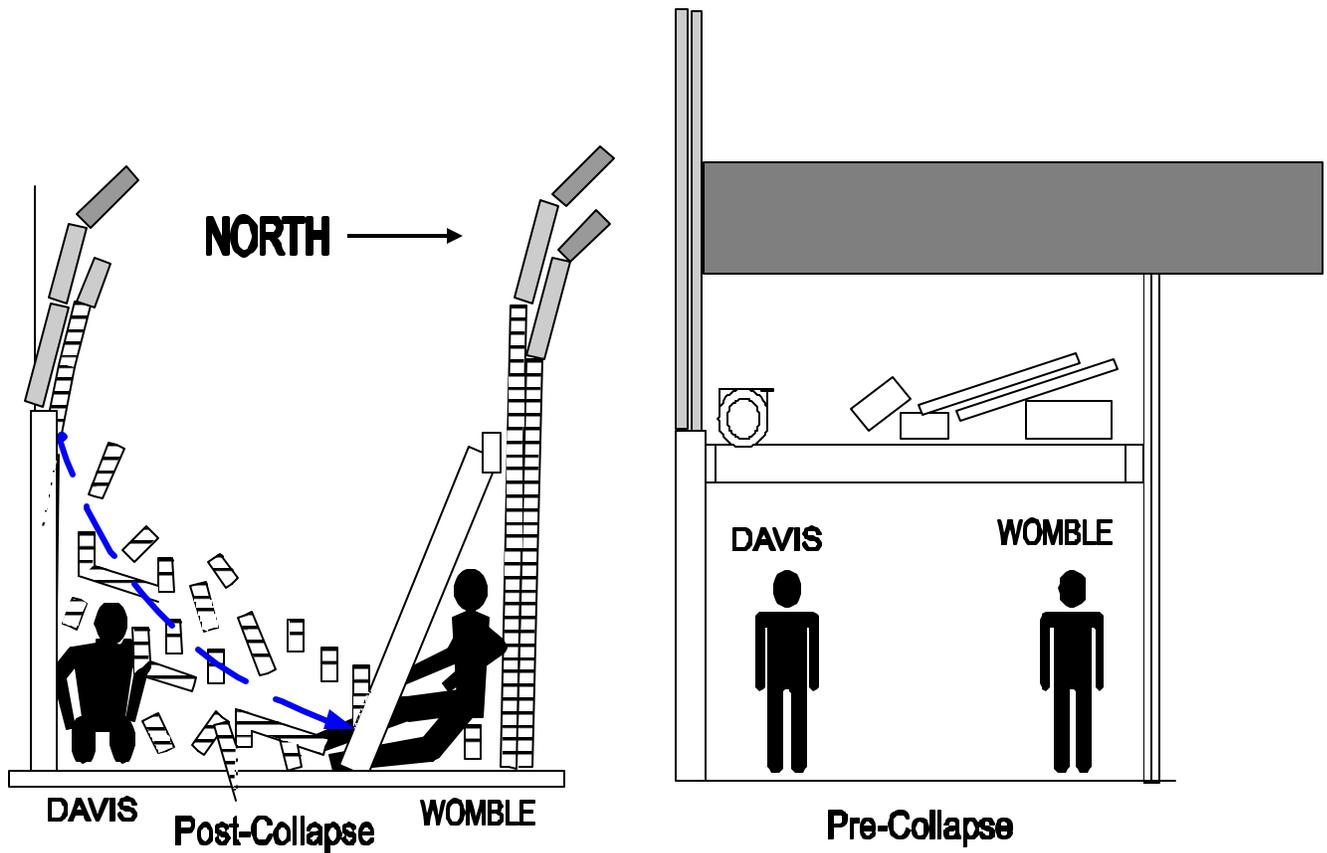
The falling bricks impacted upon the breezeway roof, shearing the ribbon board from the west end of the south wall causing a lean-to type collapse as the breezeway roof, still firmly attached on the north side, rotated downward. **(Figure Nine)** The falling breezeway roof impacted upon E 33's Vincent Davis' head and shoulders, driving him to a sitting position. Bricks continued to fall, completely covering Davis with bricks and wood. The falling breezeway roof knocked down E33's Chuck Womble and pinned his leg. Womble was located in the void space of the lean-to collapse and was shielded from most of the bricks. **(Figures Ten/Eleven)** E33 Captain Creager was grazed by the falling bricks and knocked down the breezeway steps, and onto his knees in the west parking area.

Figure Nine. Graphic depicting wall and breezeway roof collapse.

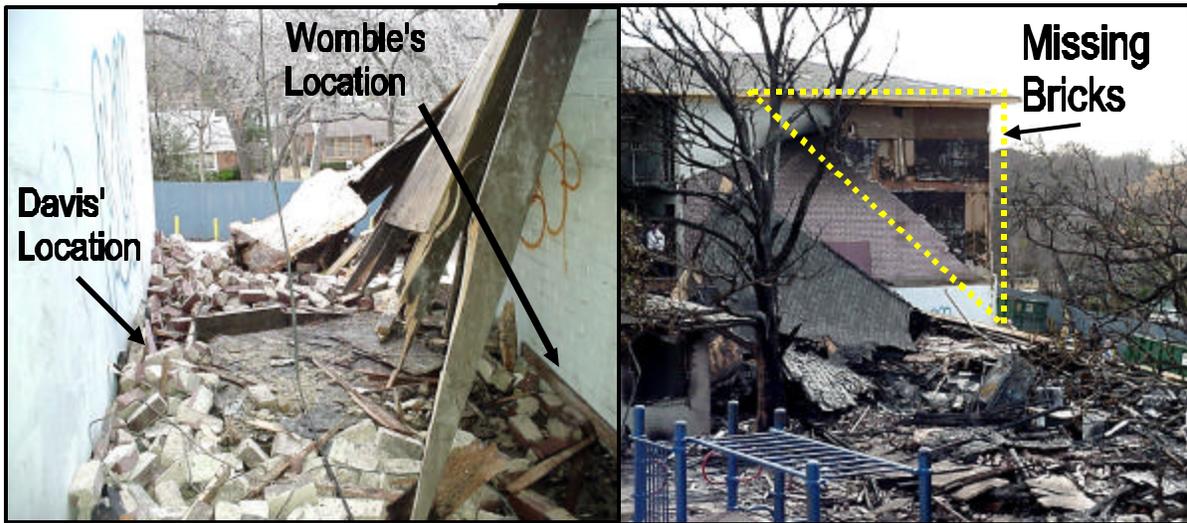
Figure Ten. Breezeway collapse area

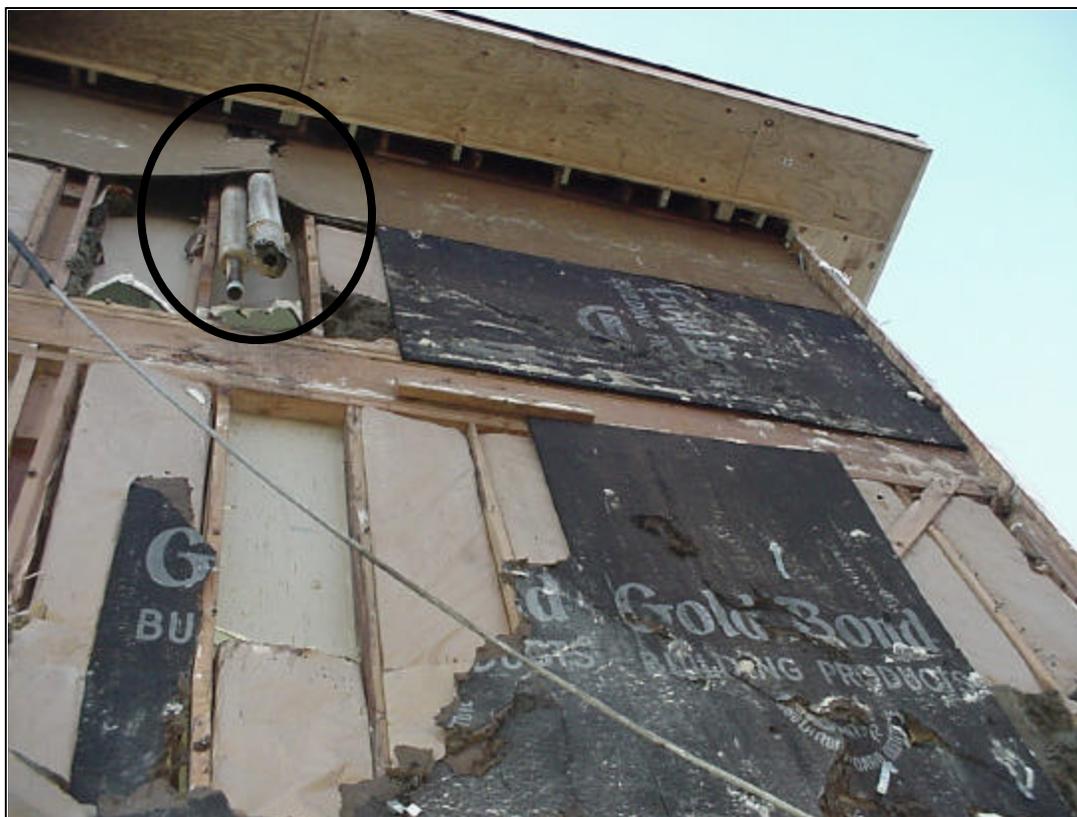
Figure Twelve. HVAC pipes on north end of Section 3.

Section 2 progressively collapsed from fire damage and as it collapsed, the framework of Section 2 shifted toward the north. The shifting of the collapsing section to the north exerted a lateral tension on the horizontal water supply piping for the ventilation system. When the south part of Section 2 collapsed, the south double wythe brick veneer wall fell to the north and impacted on the horizontal piping. This suddenly increased the tension on the water supply piping where it entered the double wythe brick veneer wall of Section 3. The lower part of the vertical section of piping was suddenly pulled several inches toward the north. **(Figure 12)**

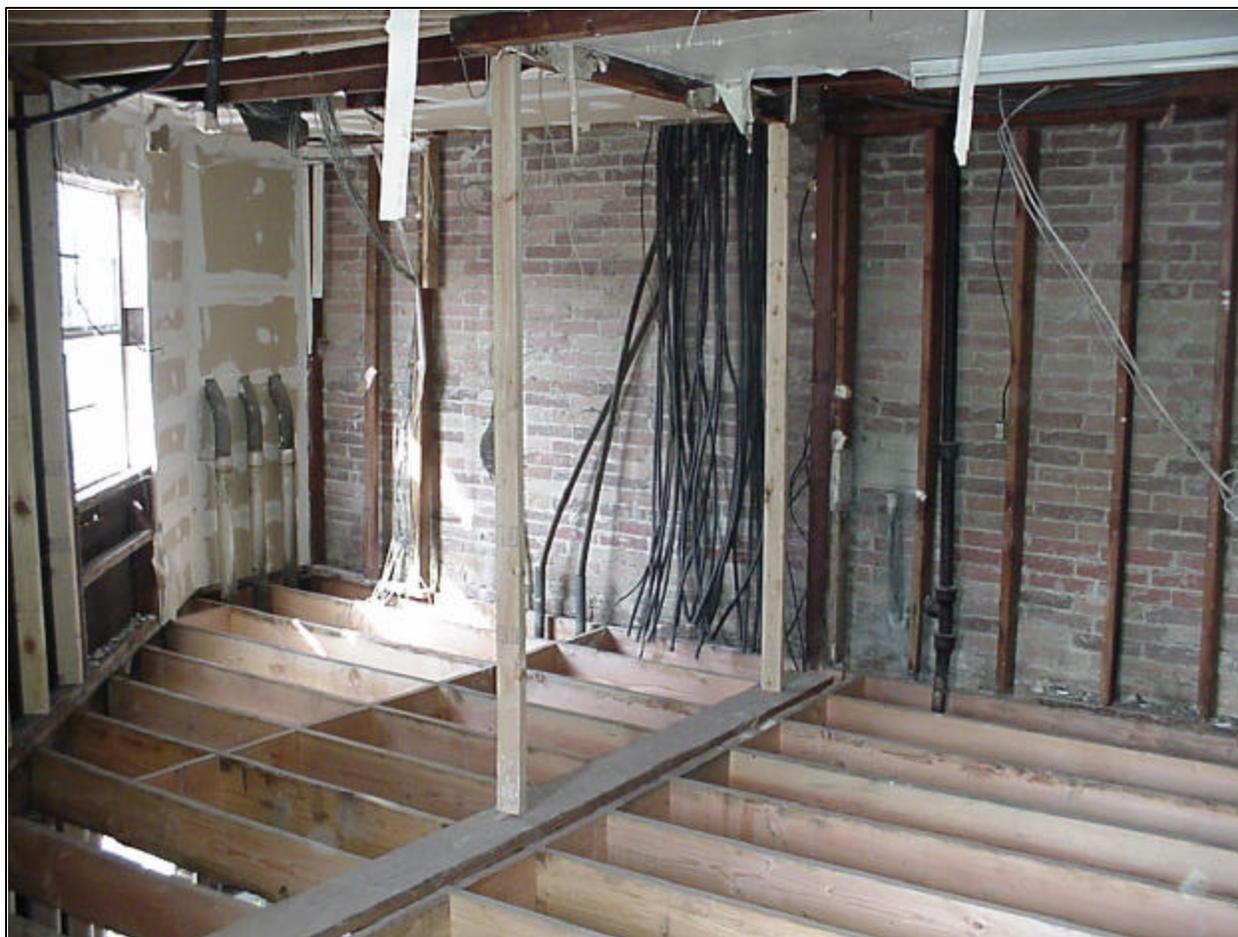
The fire was determined to have originated in the area of apartment 114 of Section 2. Apartments in this area had gypsum drywall removed as part of the renovations of electrical and plumbing systems. Wood structural members were exposed to direct flame contact. Some load bearing structural members may have been temporarily replaced with jacking posts as rotten studs were replaced. The jacking posts that were observed in other areas undergoing renovation provided only minimal support for the building. **(Figure Thirteen)**

Figure Thirteen. Jacking posts used in second floor of adjacent building undergoing renovation.

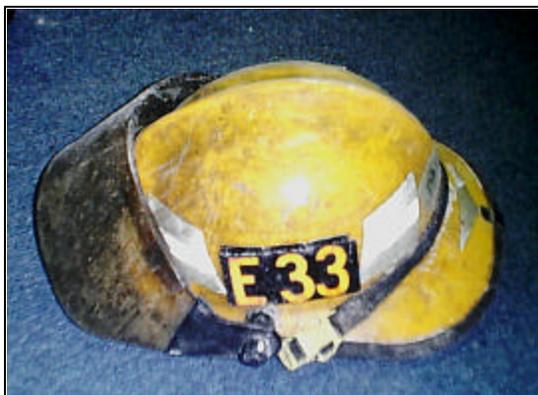
Davis' helmet was scratched and dirty, and when examined, was found with the chinstrap in the stowed position, wrapped around the back of the helmet. **(Figure 14)** Although not a factor in this incident, failure to wear the chinstrap may lead to loss of the helmet during firefighting operations, exposing the user to injury. There was no significant damage observed to the external shell or internal shock-absorbing cap assembly.

Figure 14. Fire helmet with stowed chin strap.

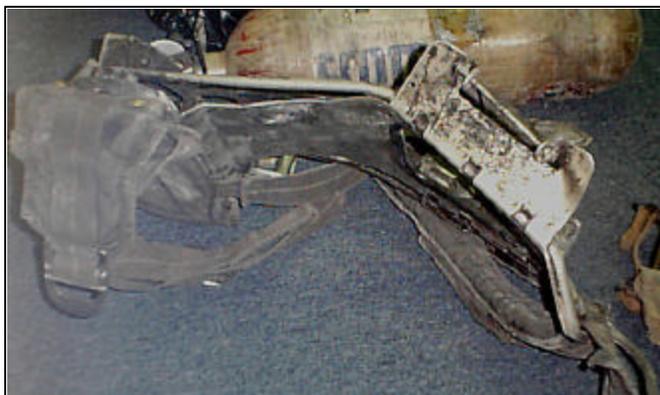
The SCBA backpack assembly was severely bent, probably by impact with falling bricks and structural members. **(Figure 15)** Firefighters that found Davis noted he was in a sitting position with outstretched legs and was bent over under the weight of the debris.

Figure 15. Bent SCBA backpack assembly.
