Firefighter Fatality Investigation

Investigation Number 05-127-12

Firefighter Nito R. Guajardo

December 20, 2004

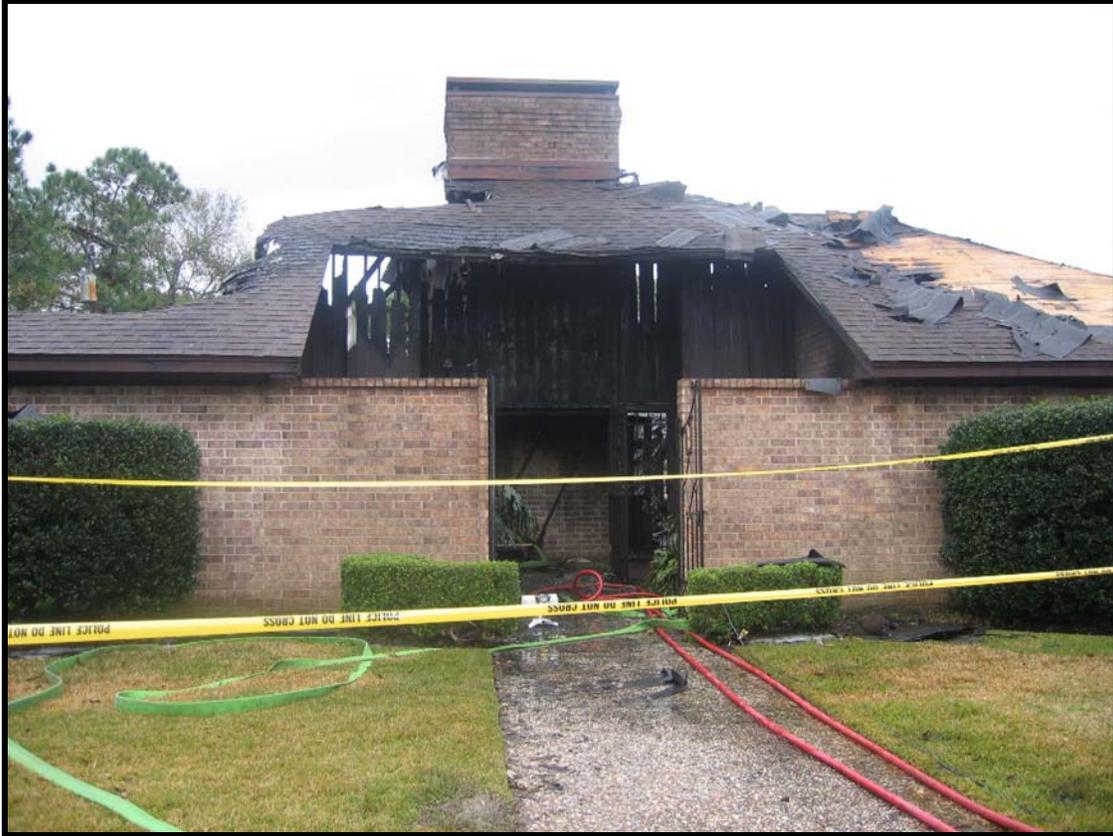
North (main entrance) side of the building

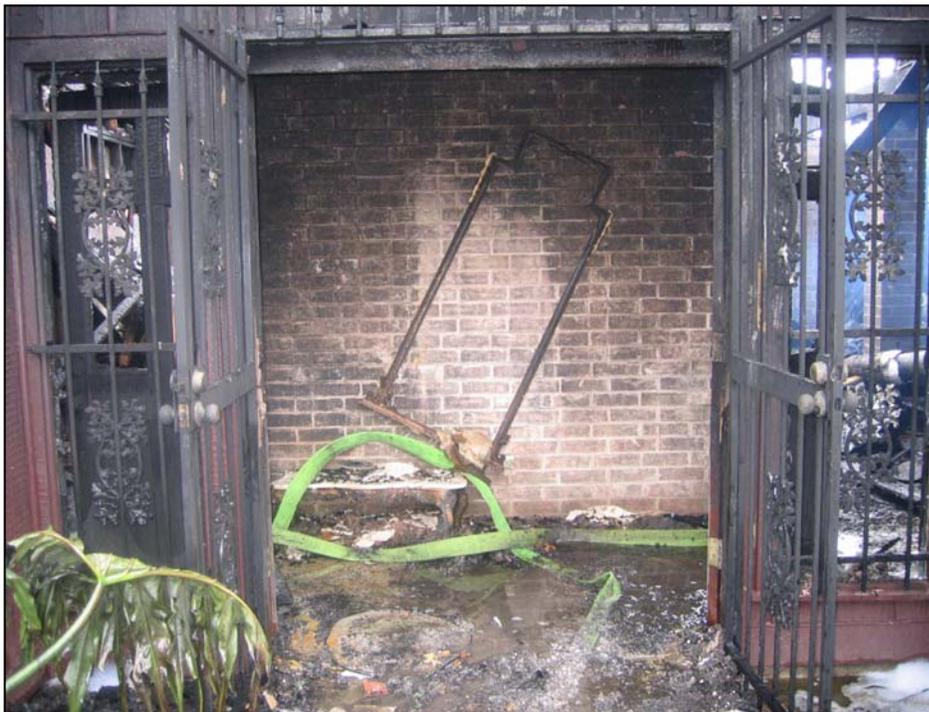
FF Lopez pulled a green 1 3/4" X 150' preconnect CAFS hose from EL1 and handed it to FF Guajardo. LT Lopez told FF Lopez to check the front door to see if it was locked. FF Lopez observed the wood front doors were locked as were the burglar bar gates covering the doors.

Window broken out before doors were forced.
Front Entrance after doors were forced.

Recommendation: Fire departments should ensure that, whenever a building is known to be on fire and is occupied by firefighters, all exits are forced and blocked open. When fire fighters are in a building, all exits should be available, even if the doors or security gates must be torn down. The doorways should be clear and free of any debris, so fire fighters and any other occupants can exit if needed. Fire fighters should be aware of the building's exits and be trained how to force open different doors or security measures they may encounter in a building.

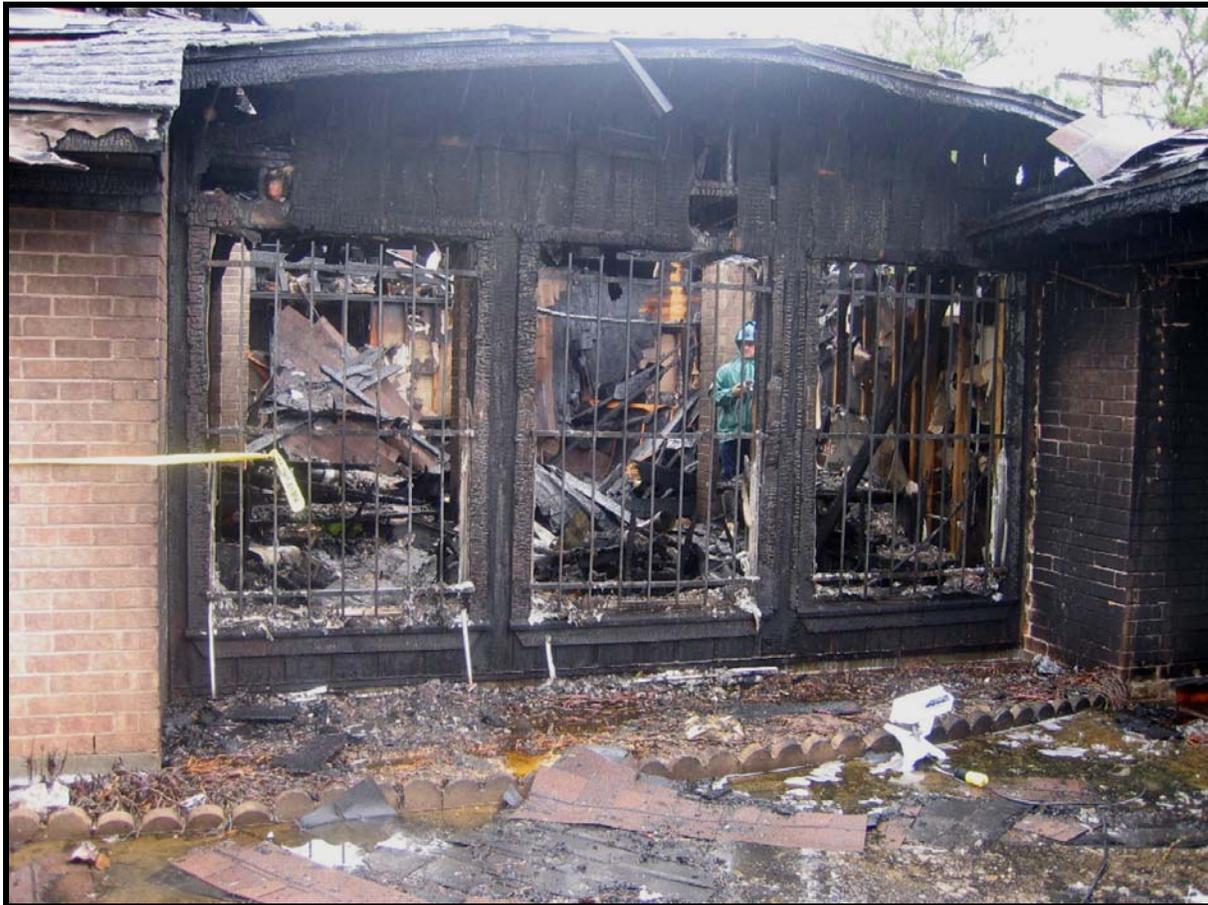
West windows looking into dining room
