TEXAS STATE FIRE MARSHAL'S OFFICE

Firefighter Fatality Investigation

Investigation Number FY 11-07

Lt. Todd Krodle

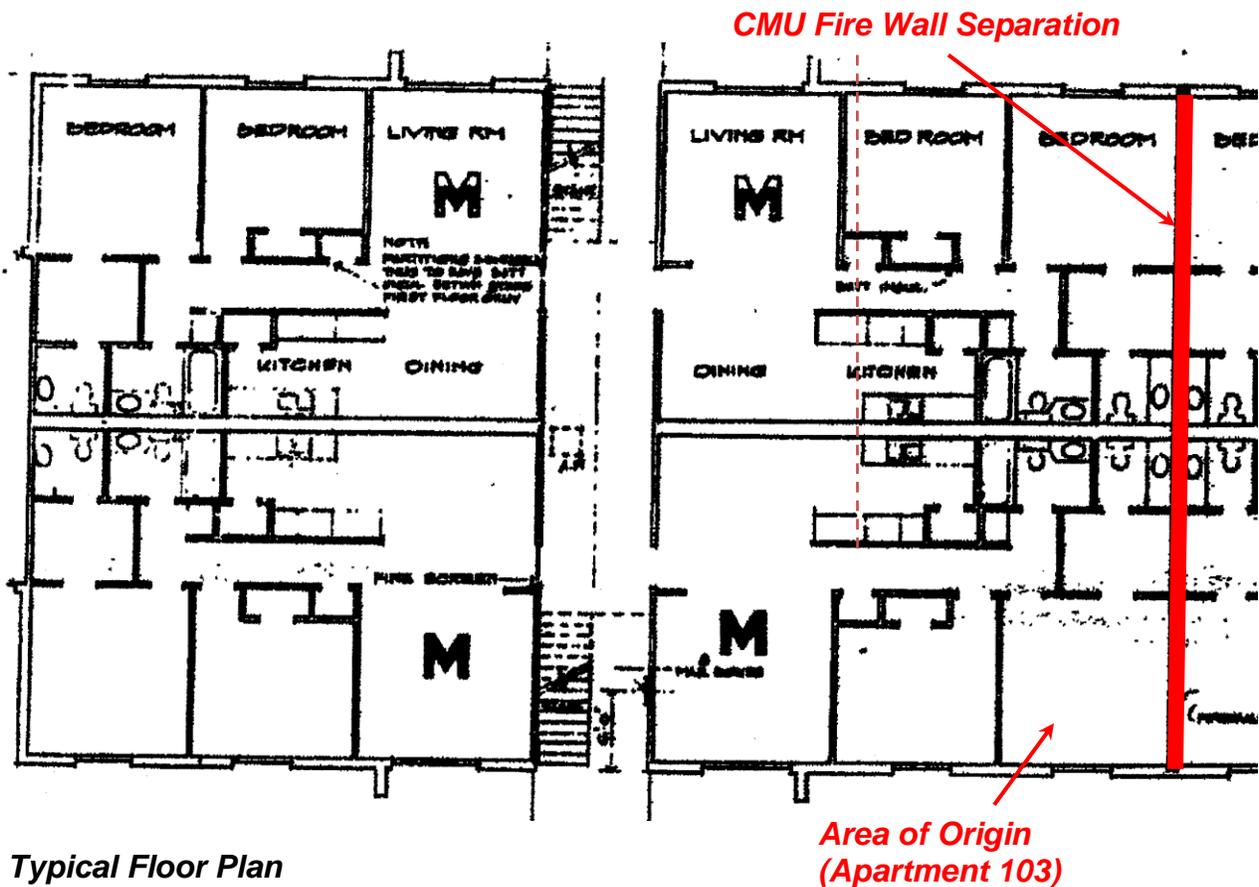
Figure 1

Apartment 103, where the fire originated, was not occupied at the time of fire discovery. The apartment is approximately 850 square feet, containing two bedrooms, two bathrooms, a living area and kitchen. Interior finish consists of ½ inch gypsum wall board applied to 2x4 wall studs placed 16 inches on center, with a textured and painted finish. Fuel loading was typical of a residence, containing furnishings, clothing and other ordinary combustibles.

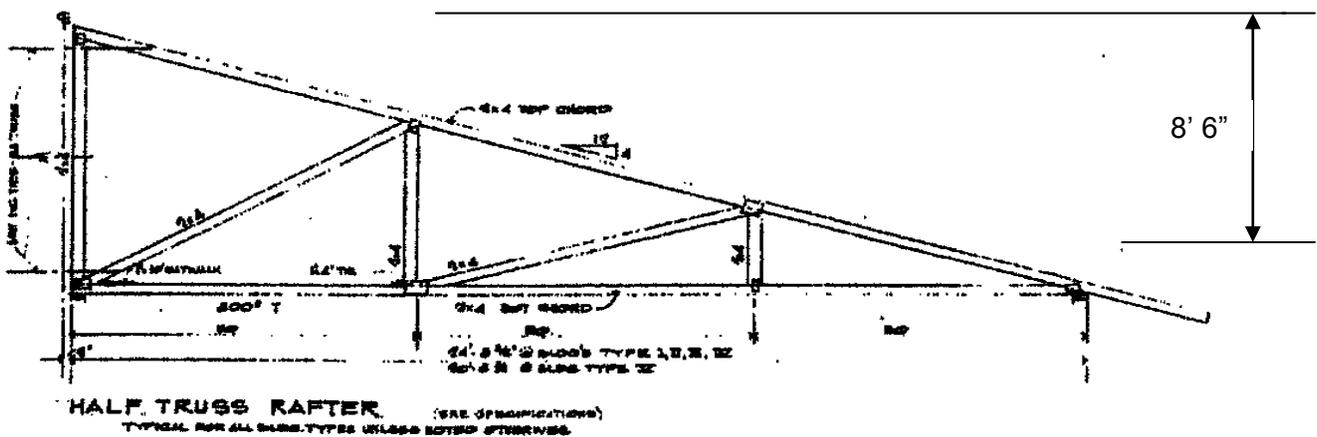
Exhibit A- As-Built Truss Diagram – Fire Building

Perforated metal truss plates connect the top and bottom chords and internal web structure of the trusses. The vertical height of the king post member, measured from the apex to the bottom chord of the truss at the ceiling line, was 8'-6" in the fire building (Exhibit A).

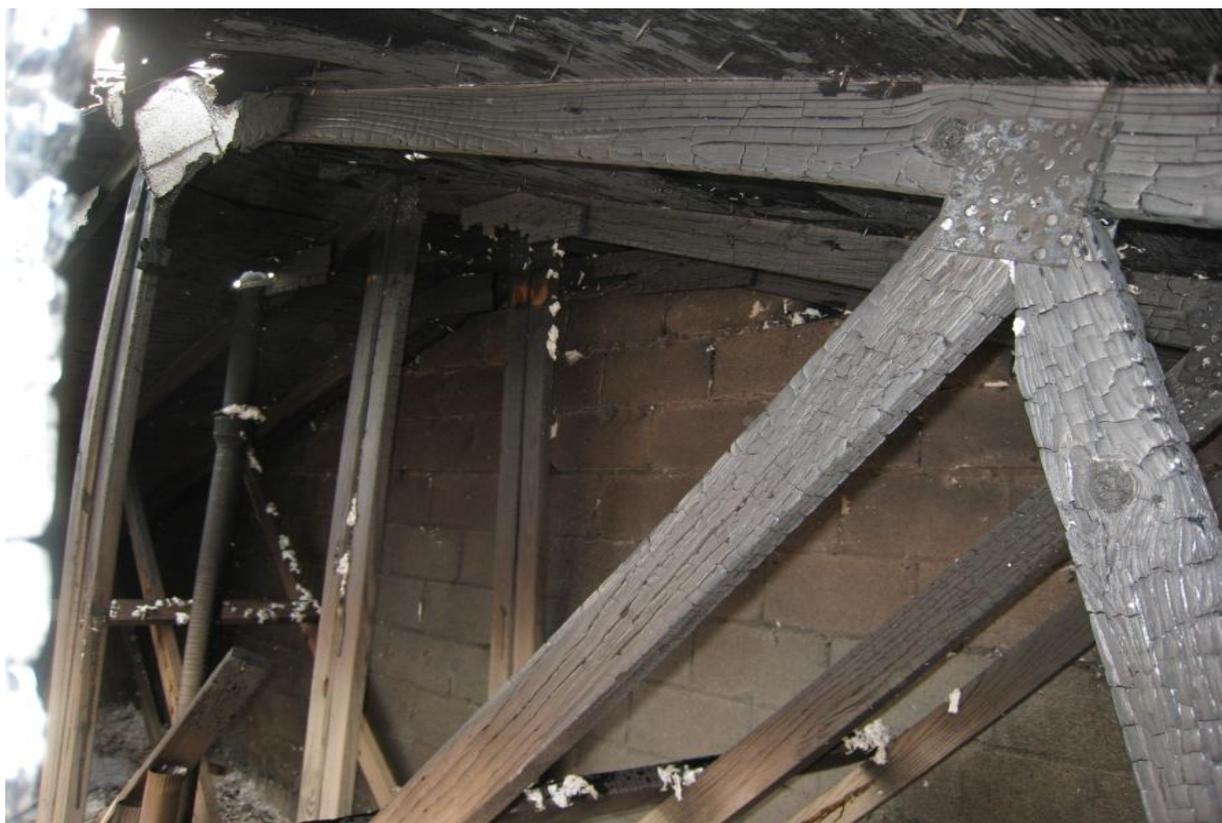
Photo 1 - Truss Assembly-Fire Building

Examination of the roof assembly within the attic space revealed deep charring of truss members. The plywood roof decking near the ridge line was burned through in some areas and exposed the felt paper underlayment, leaving only the shingle layer above intact (Exhibits B and C).

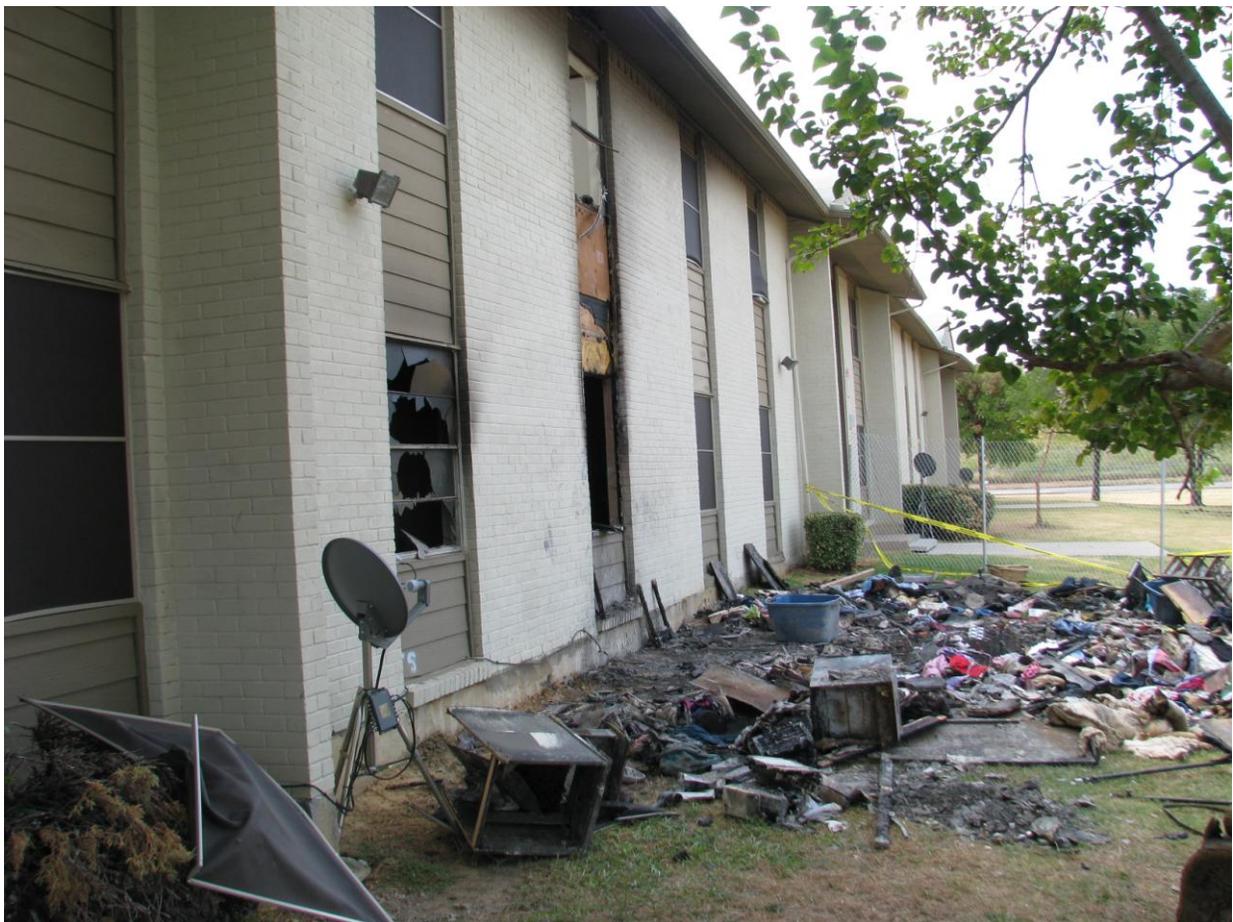
Photo 3 (photo taken August 16, 2011)

On August 15, 2011, Investigator Williams travelled to the scene to assess what resources were needed to conduct a scene examination. Williams found a two-story apartment complex with minimal damage to the East, South, and North sides of the building and fire damage to one lower and one upper apartment unit on the West side. These units were identified as unit #103 and unit #203. Heavily damaged furnishings and debris removed by fire department responders were outside on the west side of the building (Photo 3).

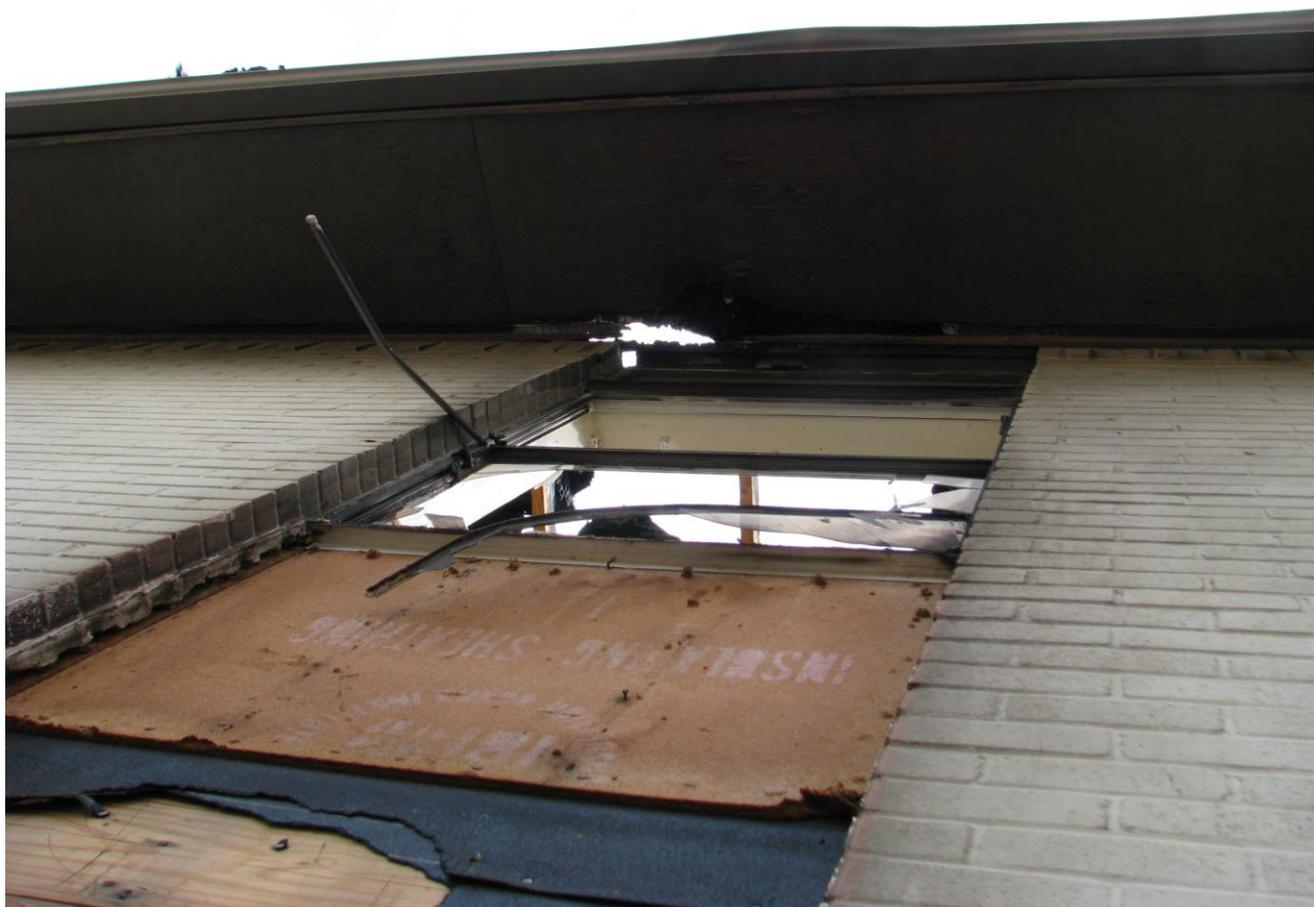
Photo 4

The State Fire Marshal's Office firefighter fatality investigation continued the following day, August 16, 2011, which included the scene examination to determine the origin and cause of the fire. Investigators found indications of the fire travel from the bedroom window of the originating apartment that continued upward in the brick and wood veneer exterior to the eave of the roof and through the vented metal soffit into the attic space (Photo 4).

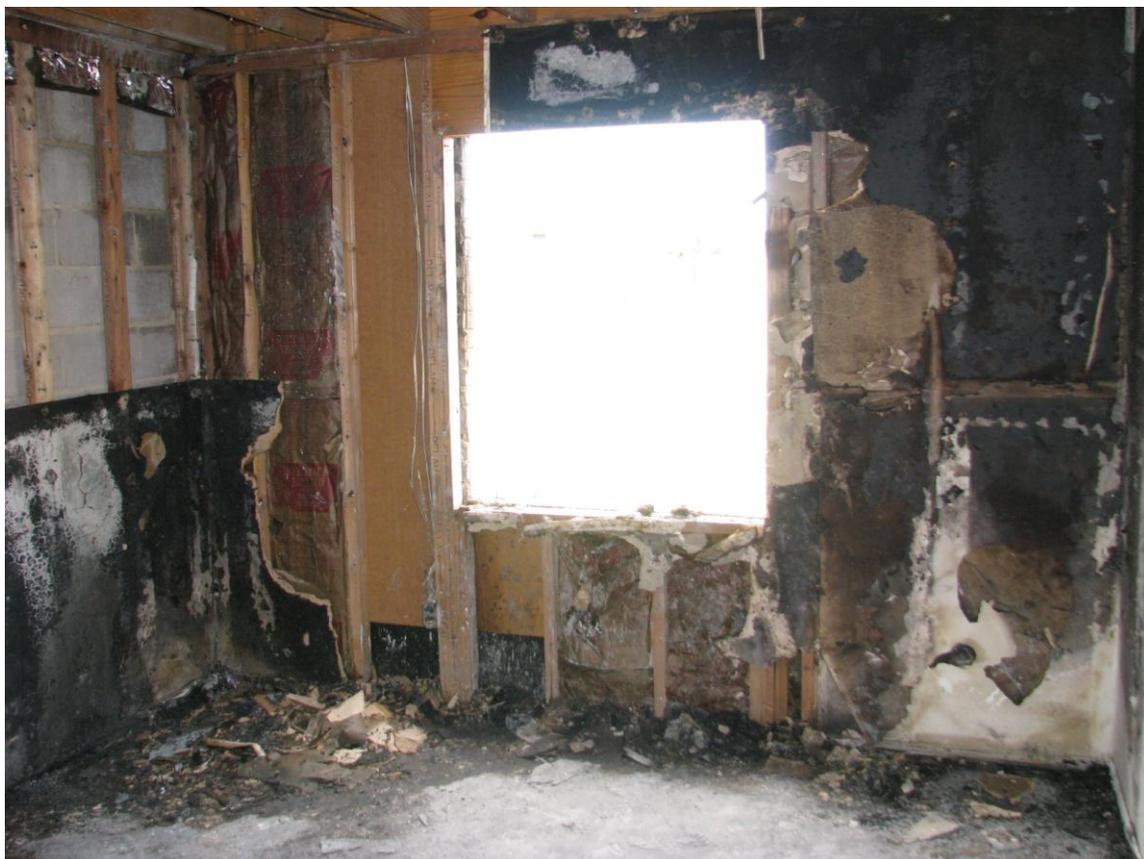
Photo 5

carpet padding. The gypsum ceiling and areas of the interior gypsum walls had been removed, exposing undamaged areas of wood ceiling joists, wall framing, the concrete masonry unit fire wall, and the exterior wood sheathing. Minimally damaged electrical conductors were exposed next to the single window opening (Photo 5).

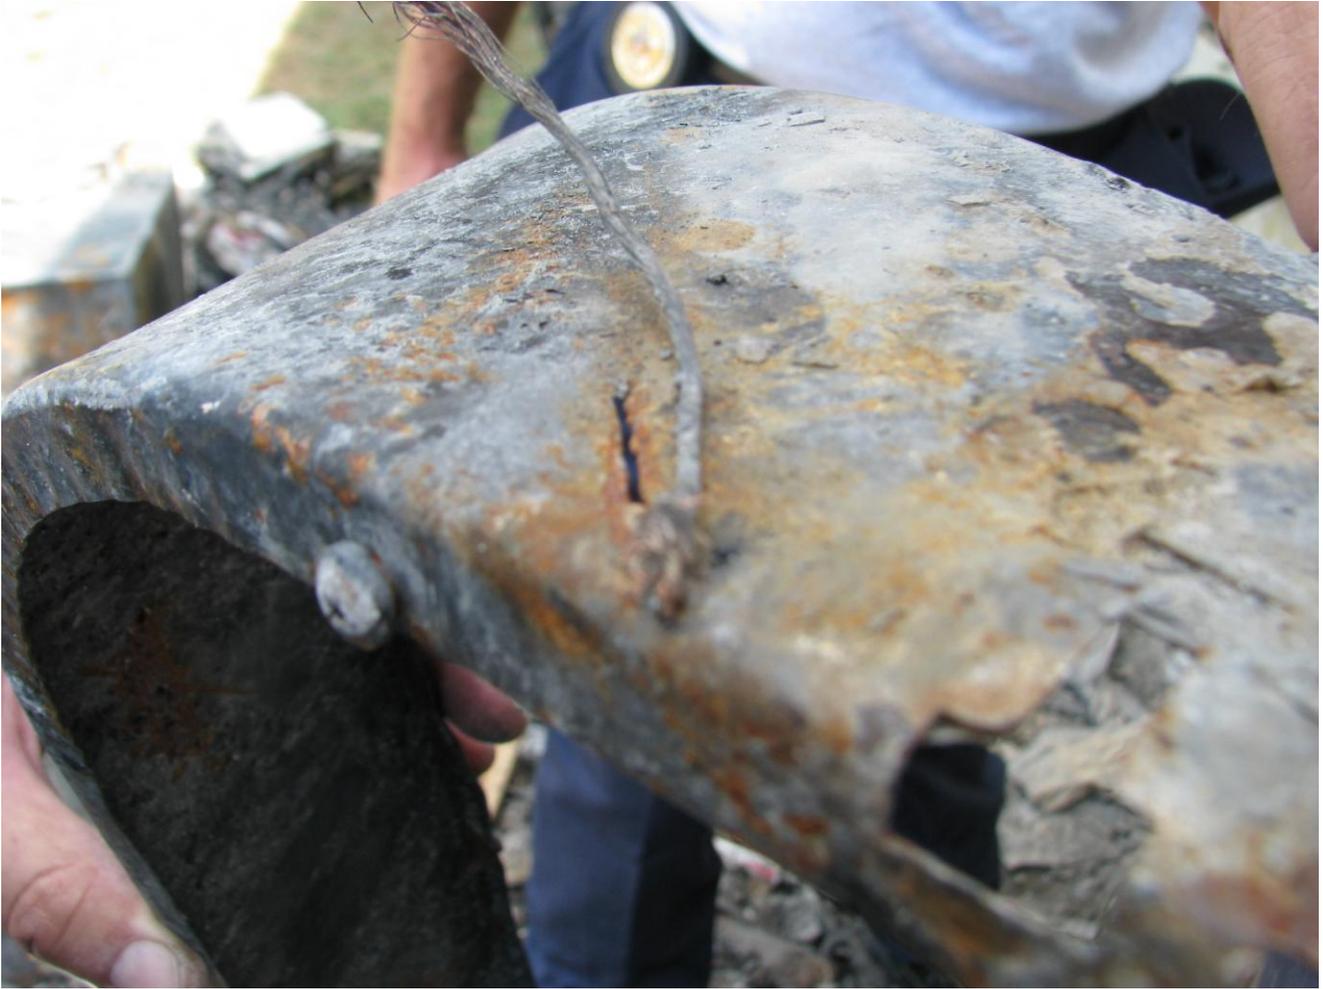
Photo 6

The examination of the furnishings outside included severely fire damaged king size mattresses, the remains of a nightstand or table, a wood shelf/television unit, and wood corner desk. The remains of a metal box fan and fan motor were located outside. Examination of the metal box fan shroud revealed a hole on the bottom where the stranded electrical cord touched the shroud (Photo 6).

Information from the occupant indicated that the box fan was normally running on a night stand in the SW corner of the room. The box fan was plugged into a receptacle behind the bed approximately four feet from the night stand. The information from the occupant indicated that the power cord for the fan would just reach the outlet and that the bed would help hold the plug in place. Clothing was routinely piled on the floor between the bed and the nightstand at the area of the fan. The area of origin was determined to be the SW corner of the bedroom.

The cause of the fire remains undetermined.

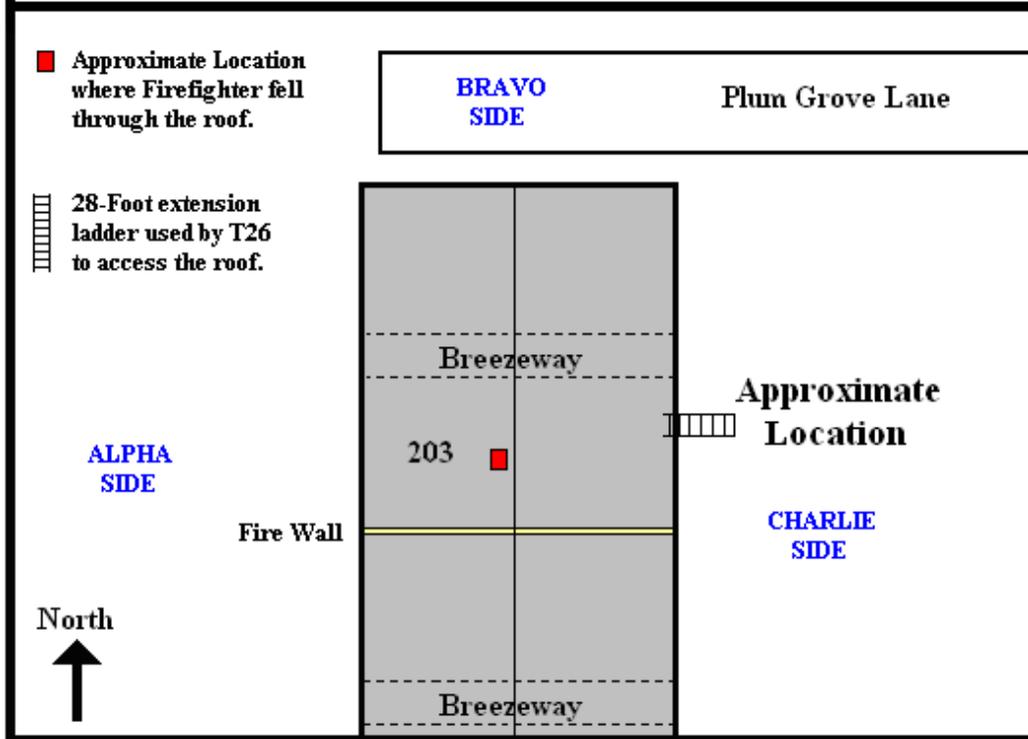
Figure 3 - Approximate Locations of Ground Ladder and Fall Area

While the crews were operating in the second-floor apartment, L26 Lt. Todd Krodle and the L26 EO laddered the Charlie (east) side of the building and began making their way to the roof. Lt. Krodle started and carried a chainsaw and was first on the roof with and the L26 EO following with an axe. Neither man had their gloves, hoods or SCBA masks in place at this time. The L26 EO stated that when he stepped on the roof, he dropped the axe. As he picked up the axe he looked toward the spot where Lt. Krodle had been standing and he saw a lot of smoke and a hole in the roof. The chainsaw was still on the roof near the hole. L26 EO stated that he heard Lt. Krodle yell for help and immediately broadcast over the radio that the Lieutenant was down and through the roof. Firefighters operating on the second floor heard the radio transmissions from the L26 EO and were unsure of the status of the personnel on the roof. E16 Lieutenant broadcast a "May Day" over the radio. The E16 Lieutenant walked into a small bathroom adjacent to the bedroom and saw the reflective tape of Lt. Krodle's bunker pants.

L26 EO approached the hole and reached in, attempting to grab his officer. He was not wearing gloves and he quickly withdrew his hands to don gloves. He reached in again but could not find Lt. Krodle. The L26 EO came down from the roof and quickly went to the second-floor apartment where he found other firefighters trying to free Lt. Krodle from the ceiling area.

Recommendation: Use tools and tactics that help reduce the dangers of roof operations. Become familiar with those indicators that are a precursor to collapse.
