## Firefighter Fatality Investigation

### **Volunteer Firefighter James McMorries**

Howardwick Volunteer Fire Department

Date of Incident: March 12, 2006

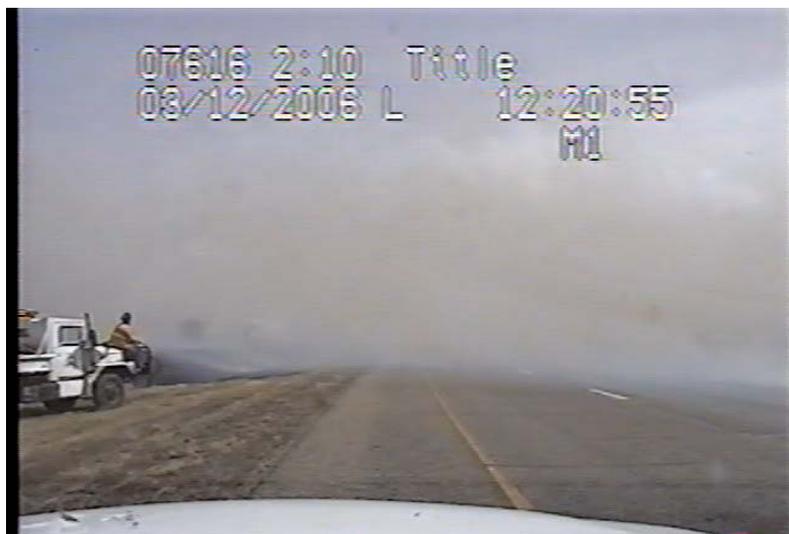
**View of smoke obscuring visibility on IH 40 from DPS dash camera**

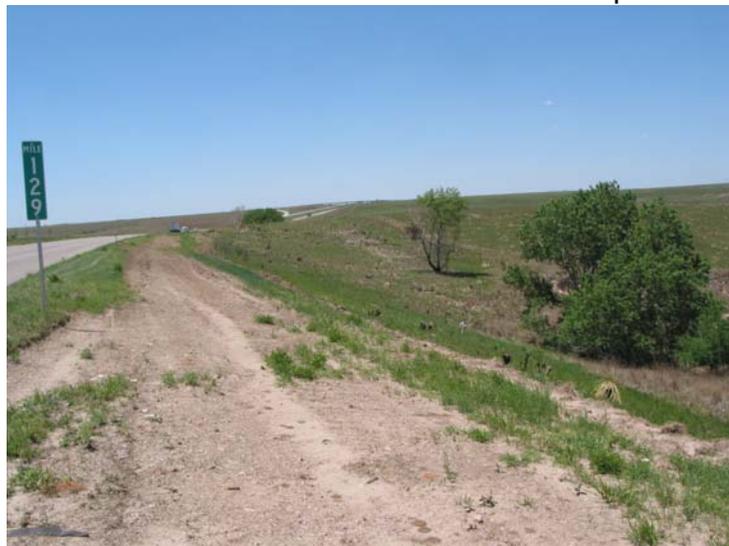
At approximately 1900 hours, after refilling at the rest area, Unit #417 was creeping east along the westbound shoulder in the soft sand between the paved shoulder and the drop-off into a ravine. The wind shifted and fire began approaching the truck. Garcia, riding the front bumper, motioned to McMorries to back up. As the truck reversed, the driver's side rear wheels lost traction in the sand and the truck loaded with water turned over and rolled down the side of the ravine.

**View of the location of the roll over**

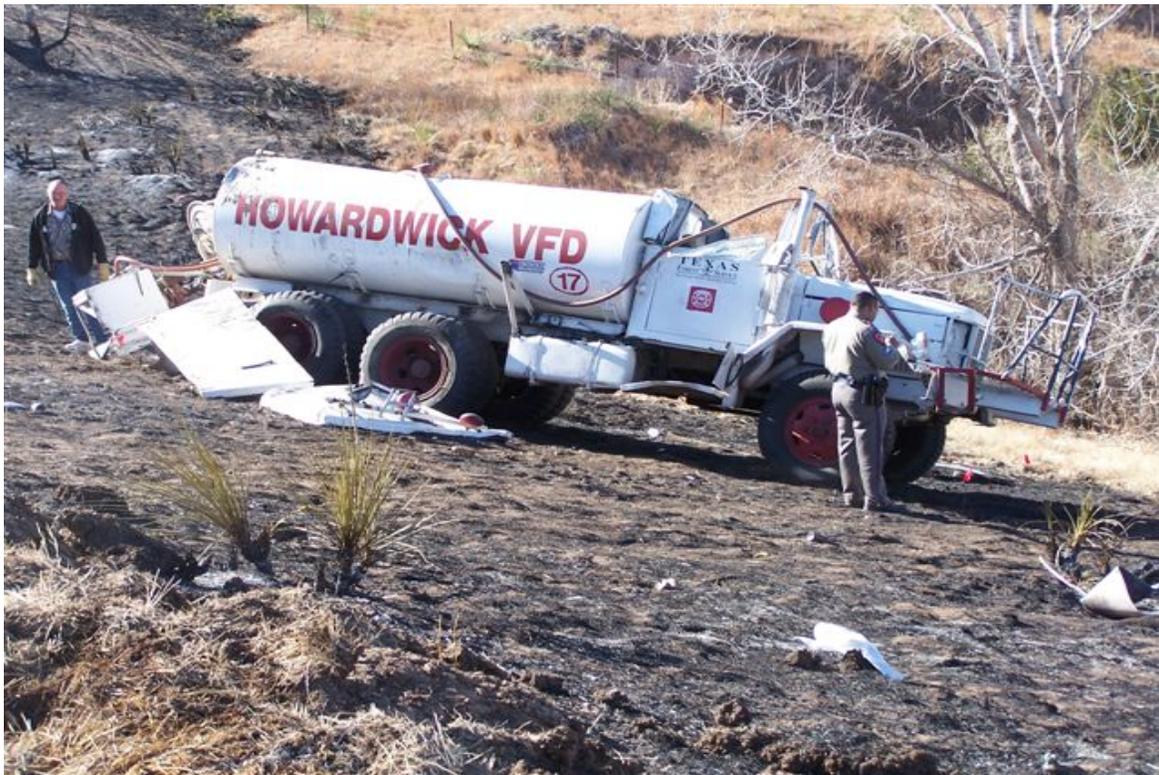
**Location of Unit #417 after roll over**

As Unit #417 was moving east, the wind shifted and fire moved up the side of the ravine and was approaching the truck. Garcia, riding the front bumper, motioned to McMorries and he began to back up. As the truck was shifted to reverse the driver's side rear wheels slid toward the edge of the ravine. Passenger Cook stated that he felt the tires slide and then drop off the edge of the improved shoulder. The rear of the truck continued to drop off the edge causing the weight to shift and the truck to overturn. The truck rolled over one time before coming to rest on its wheels.

- The fully loaded cargo tank trailer exceeded the maximum gross weight listed on the data plate by at least 3500 pounds.
- The ground next to the roadway was newly graded and did not provide a stable base for a truck of this size and weight.
- There were no baffles in the water tank to control water movement and subsequent weight shifts.

The overloaded vehicle with inadequate water tank baffles presented an extreme challenge to the driver to maintain control.

**Recommendation:** Any fire department acquiring a vehicle, chassis, or trailer not originally designed as firefighting apparatus should proceed with caution when converting equipment for use in firefighting. Fire departments should take into account factors such as the weight of tank water and equipment, center of gravity, load distribution, capacity of the drivetrain, tires, steering, and braking systems during fire apparatus construction.

**Recommendation:** All fire departments acquiring vehicles, chassis, or trailers should refer to all available manuals or documentation prior to commencing conversion or modification operations. Water tanks should be clearly marked with the tank capacity and full gross weight. Fire departments should install positive physical safeguards, such as overflow vents, to prevent vehicles from exceeding maximum permissible gross weight when fully loaded.
