STATE FIRE MARSHAL'S OFFICE

Firefighter Fatality Investigation

Investigation Number 06-139-11

Firefighter Clint Dewayne Rice

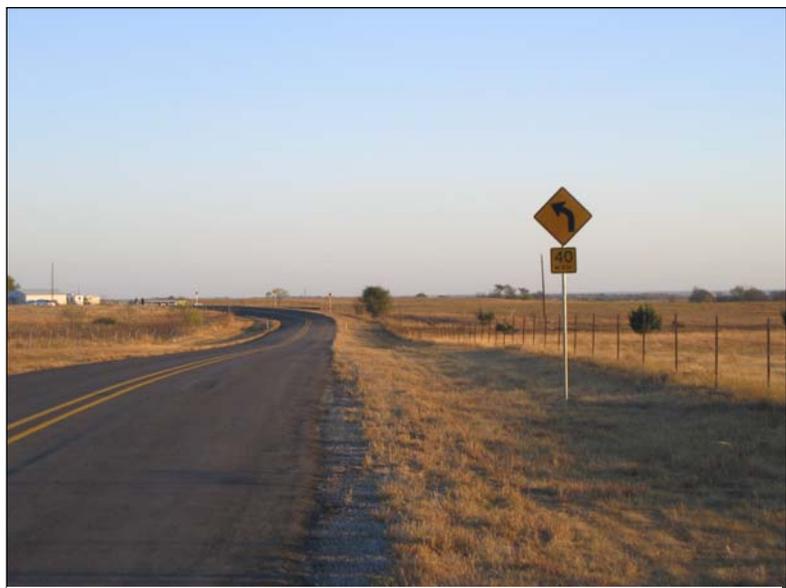
FM 219 approaching the incident scene in the direction of travel of Unit 610.

Warning chevrons delineated the curve. The asphalt roadway was dry, in good condition, and had a slight downhill grade continuing into a banked left curve. The incident occurred during daylight hours.

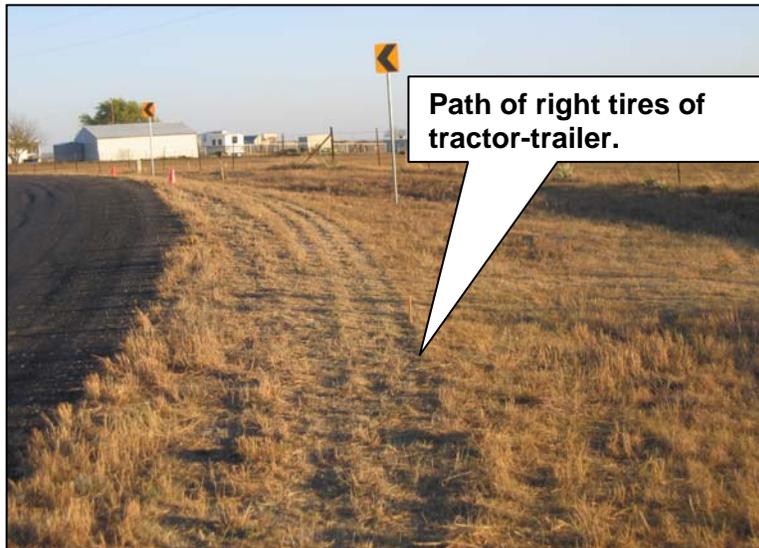
The right side tires of Unit 610 left the roadway at the transition of the straight road into the curve, .17 miles after passing the curve warning sign. Tire marks indicated that Firefighter Rice attempted to steer Unit 610 around the curve.

As Unit 610 approached the apex of the curve, the slope of the shoulder, combined with lateral movement of water in the cargo tank, began to lift the left side tires of the cargo tank off the pavement.

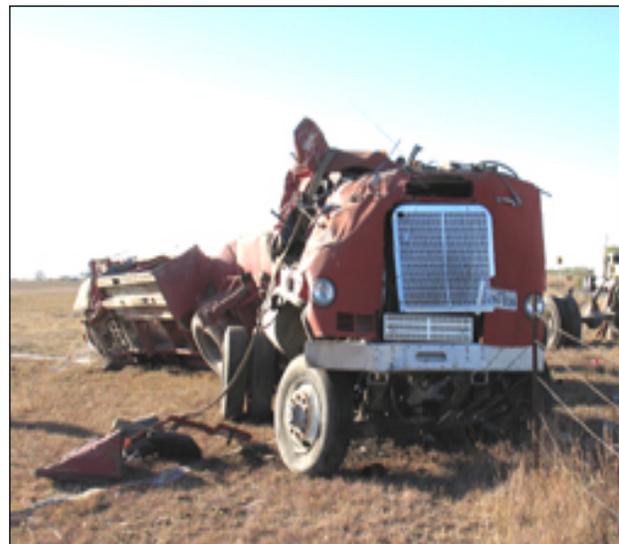
**Final resting position of tractor-trailer.
Photo by Hamilton County JP Lively .**

As the tractor-trailer combination came to rest in a field, the truck tractor rolled back upright onto its wheels. The cargo tank

came to rest on its left side. The force of the rollover separated several tire/axle assemblies from the tractor-trailer water tender. The vehicle traveled approximately 330 feet from the point the first tire left the roadway.

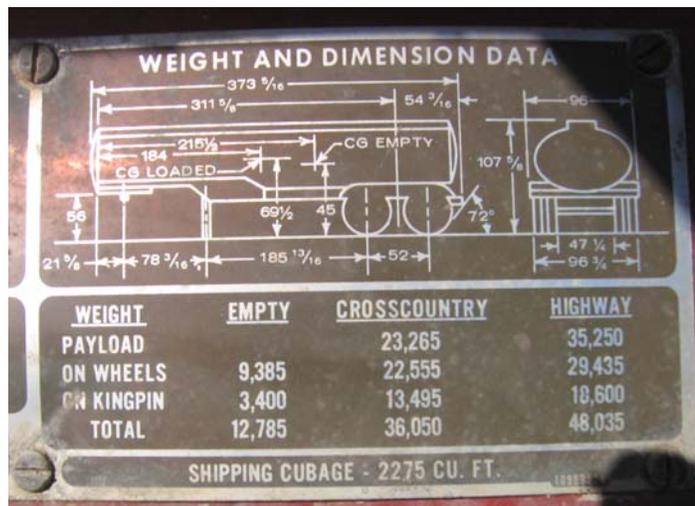
This is 6,450 pounds over the maximum 48,035-pound gross weight listed on the information placard on the trailer frame. This does not take into account the weight of the water pump and any additional equipment installed by CVFD.

Exceeding the gross trailer weight may have an adverse effect on vehicle handling, braking, and performance and may violate state motor vehicle laws.

Military data plate on frame of tank trailer

Recommendation: Any fire department acquiring a vehicle, chassis, or trailer not originally designed as firefighting apparatus should proceed with caution when converting equipment for use in firefighting. Fire departments should take into account factors such as the weight of tank water and equipment, center of gravity, load distribution, capacity of the drivetrain, tires, steering, and braking systems during fire apparatus construction.

Recommendation: All fire departments acquiring vehicles, chassis, or trailers should refer to all available manuals or documentation prior to commencing conversion or modification operations. Water tanks should be clearly marked with the tank capacity and full gross weight. Fire departments should install positive physical safeguards, such as overflow vents, to prevent vehicles from exceeding maximum permissible gross weight when fully loaded.

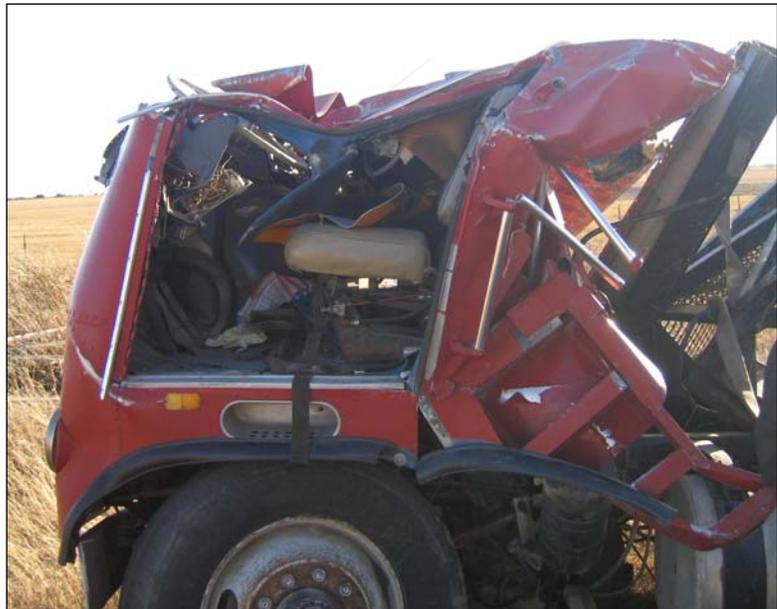
The driver's seat of the 1979 Freightliner cabover truck-tractor-owned by Carlton VFD is equipped with a lap type safety belt, but Firefighter Rice was not wearing it at the time of the motor vehicle incident. Due to the forces involved in this crash, it is not possible to determine if safety belt use would have prevented fatal injuries to Firefighter Rice.

Left side view of truck cab of Unit 610
