# STATE FIRE MARSHAL'S OFFICE

## Line of Duty Death Investigation

**Investigation Number 03-193-01**

**Firefighter Gary L. Staley**

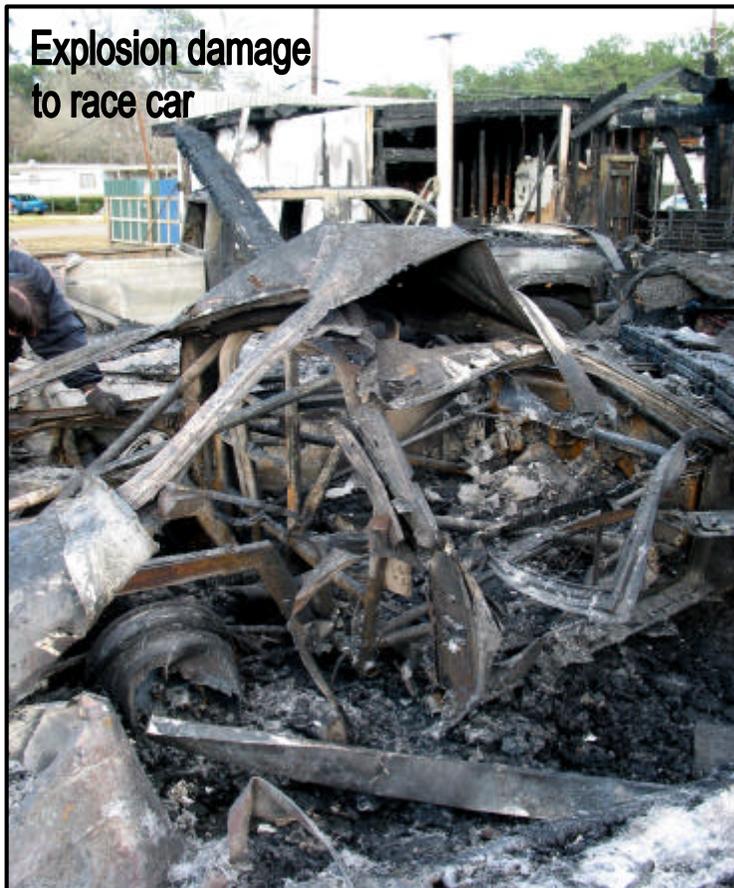
During the fire a nitrous oxide cylinder exploded and fragmented causing extensive damage to a Chevrolet Monza race car. The deceased firefighter sustained some trauma from the explosion, but at this time it is not known if this was the primary cause of the firefighter's death.

The hose line nozzle was found in the area next to the blast-damaged race car. The force of the explosion was sufficient to propel a fire extinguisher through the side of the car and wrap it around a metal support post.

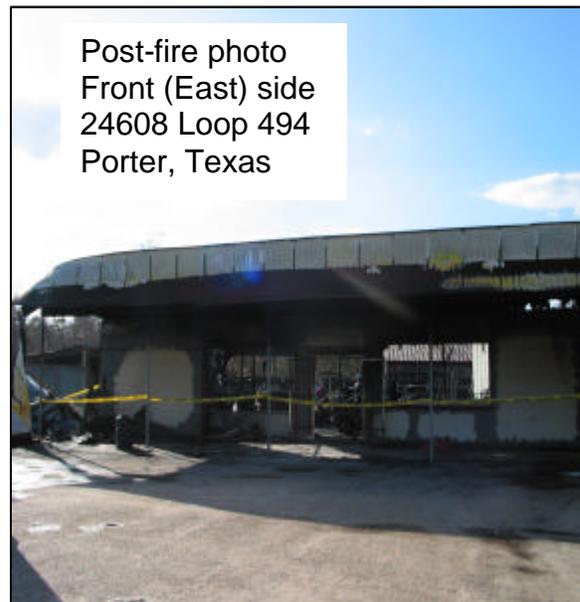
The business faces east and fronts onto Loop 494. The single-story building is of wood frame construction. Metal siding covers all areas except the concrete block façade on the front part of the building. The floor is a concrete slab. The roof in the front part of the building is a tar built-up roof with an overhanging canopy. The roof in the remainder of the building is corrugated metal installed over wood joists supported on metal columns. There is a rear overhanging roof protecting an open storage area enclosed with chain link fencing. There are several additions to the original building.

Post-fire photo  
Front (East) side  
24608 Loop 494  
Porter, Texas

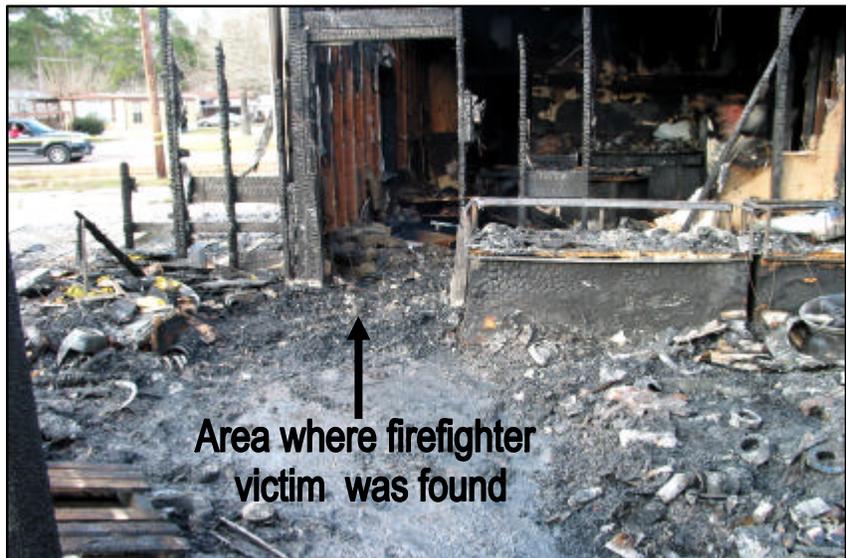
As the fire progressed, the metal roofing and wood rafters collapsed in the showroom area. None of the metal support posts failed. The area where the deceased firefighter was found had no significant structural failures.

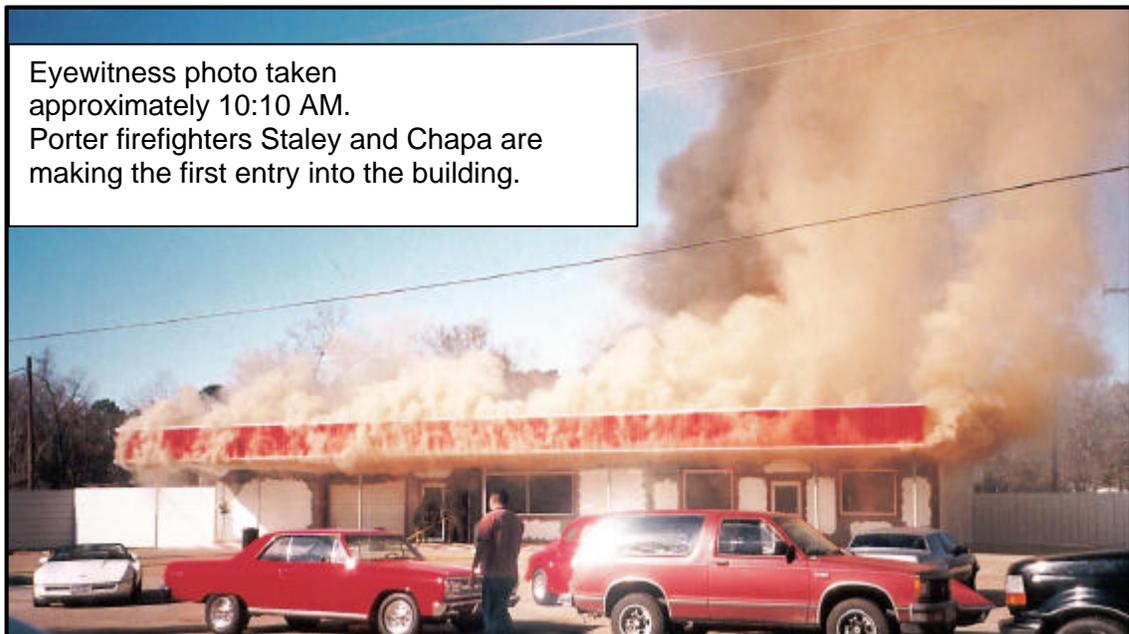
Eyewitness photo taken approximately 10:10 AM. Porter firefighters Staley and Chapa are making the first entry into the building.

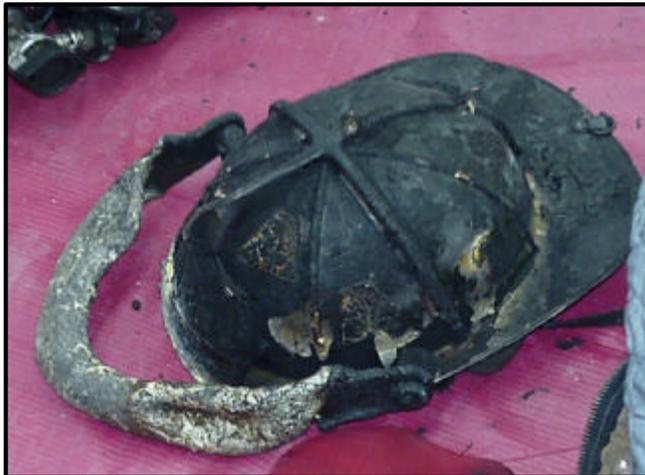
The protective visor on Staley's helmet was burned and melted but the helmet, although burned on the exterior, was intact.

Staley's protective clothing sustained extensive heat damage, burning completely away in the lower back, buttocks, and thigh areas. Damage to the bunker coat included a burned-through area on the upper right arm. Damage to the rest of the coat was limited to some moderate charring in the right hip area and melting/burning of reflective trim.

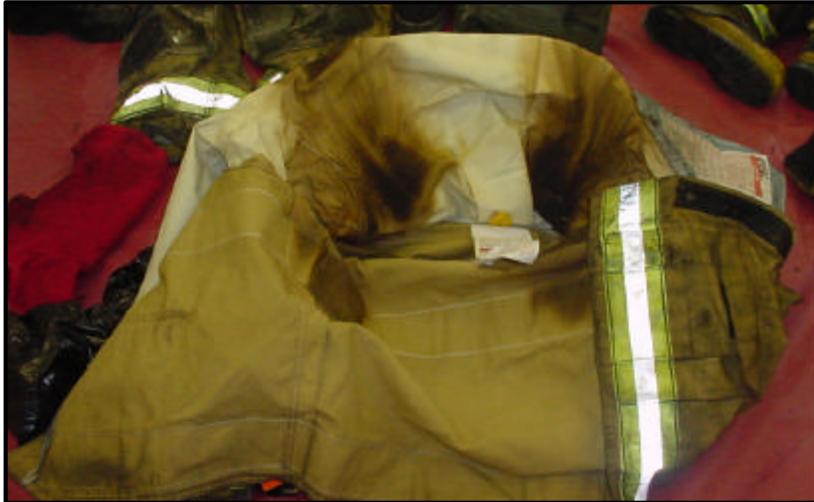
The fabric shells of Chapa's and Haynes' bunker gear showed extensive melting to reflective trim. Inner liner vapor barriers were scorched even though the fabric shells of the coats appeared undamaged other than damage to the reflective trim.

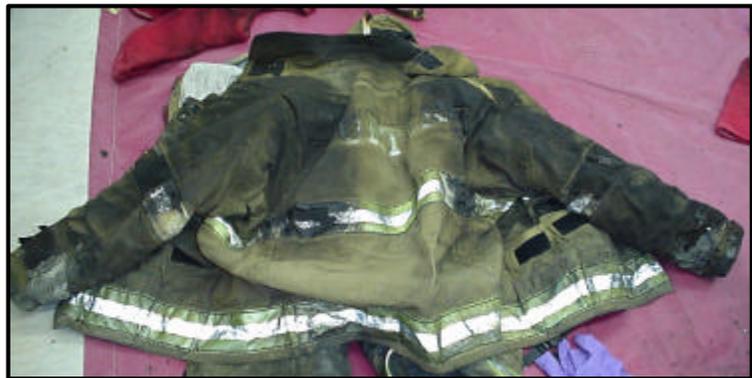
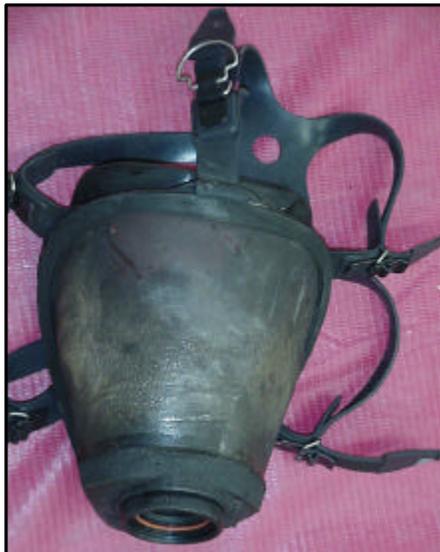
All SCBA masks were melted and opaque in some areas due to flame exposure. Some areas of the face pieces were undamaged because they were covered with portions of the firefighter

protective hood. Haynes sustained serious facial burns when he removed his face piece inside the building because he could not see. Haynes was the only injured firefighter that was wearing a "Reed Hood," a protective hood made of material similar to that used in bunker clothing and designed to be worn over a standard knit fabric fire resistant hood.
