Firefighter Fatality Investigation

**Firefighter William Scott Tanksley
Dallas Fire-Rescue Department**

Investigation FFF FY 14-02

Dallas, Texas
February 10, 2014

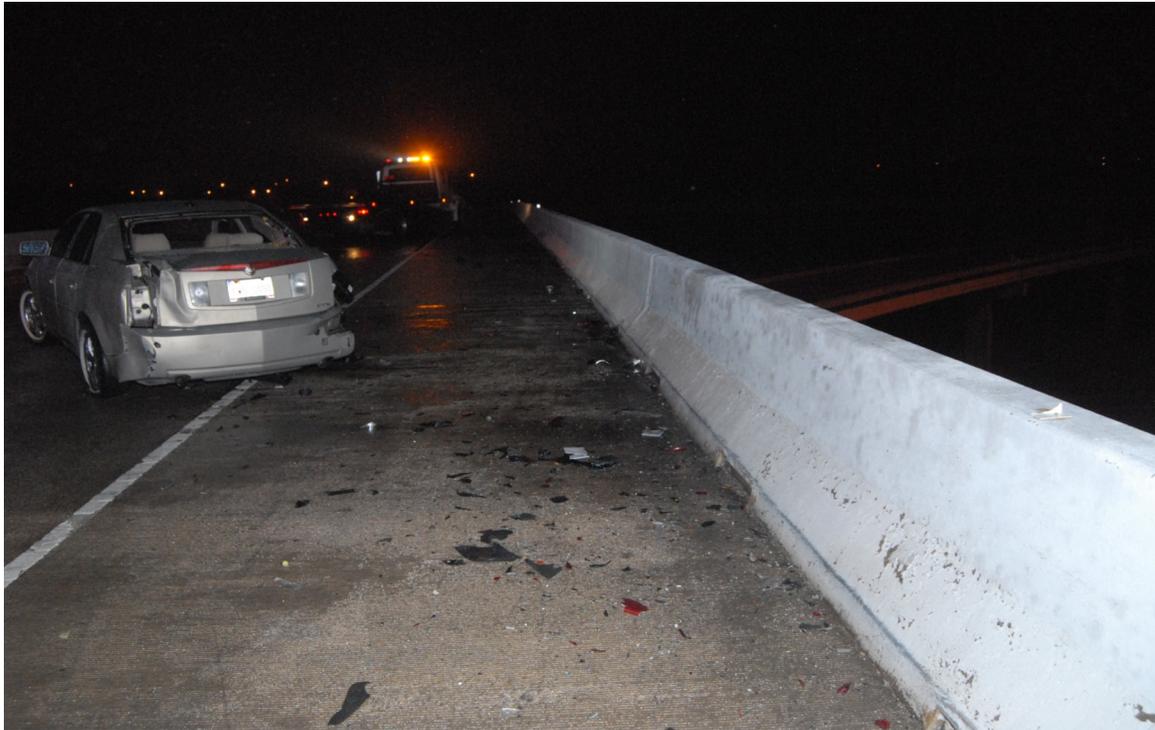
The investigation conducted by the Dallas Police Department indicated a 2009 maroon Dodge Charger (Unit 2) struck the right concrete wall on the bridge and spun around, where it was facing north on the southbound outside shoulder. Tanksley crossed the center wall and told the driver to remain in the vehicle. A 2007 gold Cadillac CTS (Unit 1) was traveling south on the bridge and saw Unit 2 and hit the brakes. Unit 1 then lost control and spun, striking Tanksley. Unit 1 then continued moving, carrying Tanksley on the back of the vehicle until impacting the west side of the bridge. The momentum sent Tanksley over the side. Tanksley landed on the eastbound IH-20 on ramp, 56 feet below.

Unit 2 and location Firefighter Tanksley was struck.

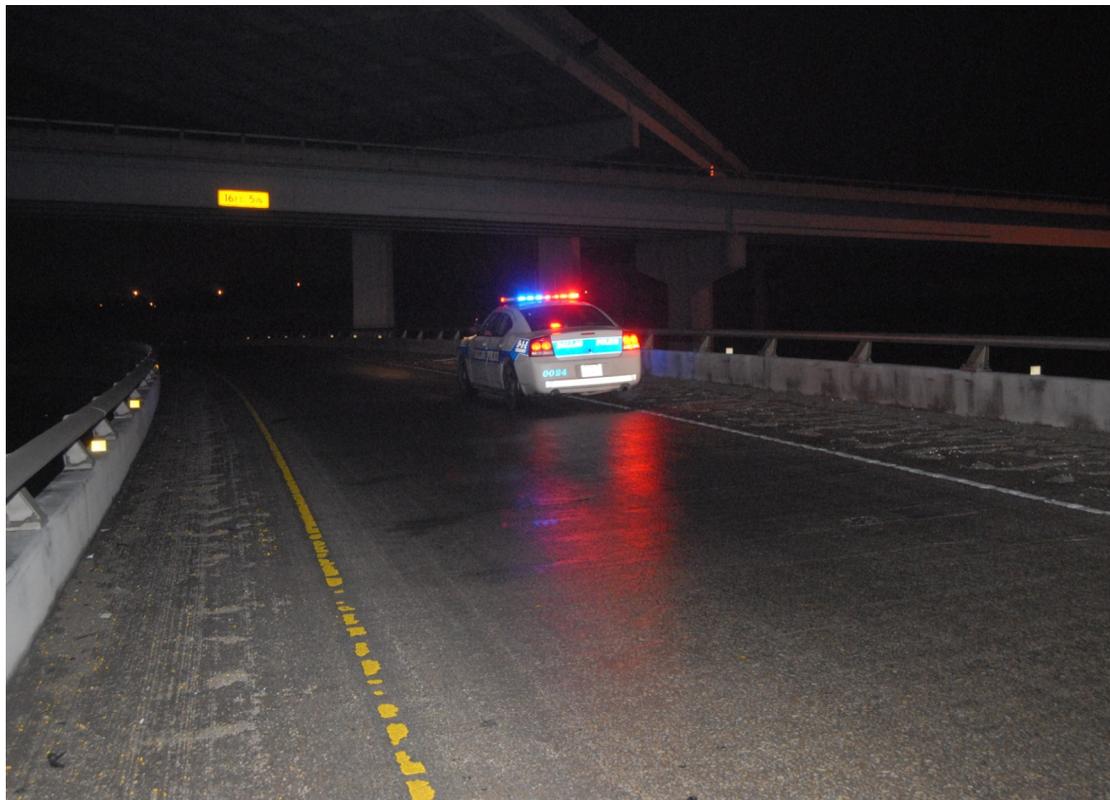
View of area where Firefighter Tanksley was located.

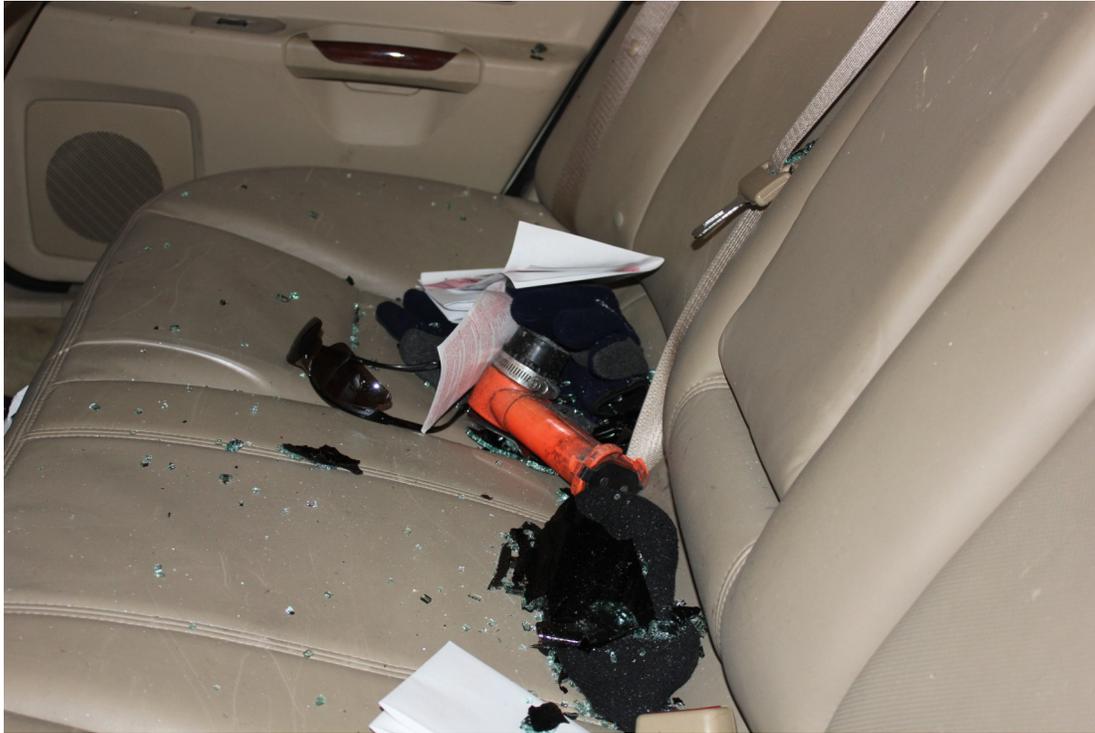
Firefighter Tanksley's flashlight was found in rear seat.

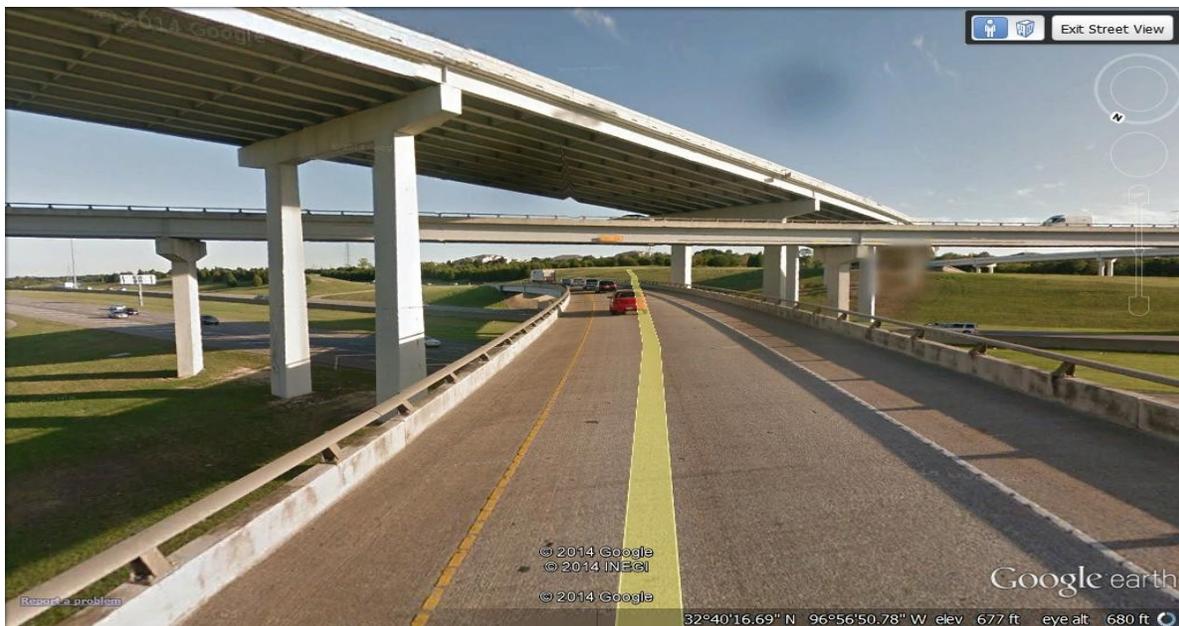
Photograph of southbound Spur 408 to eastbound IH-20. Location Tanksley found. (Courtesy of Google Earth).
