STATE FIRE MARSHAL'S OFFICE

Firefighter Fatality Investigation

Investigation Number FY 07-01

Firefighter Phillip Townsend

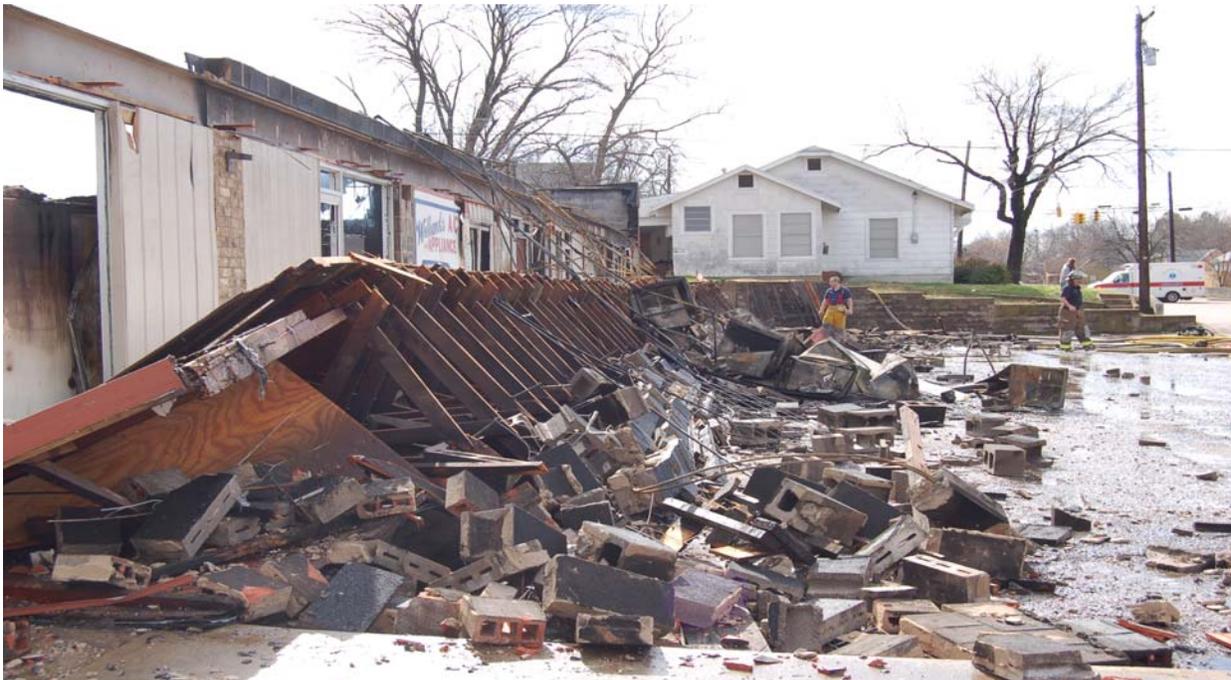
The front of the structure faced west toward South Crocket Avenue. The front wall was a combination steel I-beam, supported by steel pipe columns, masonry block, wood siding, aluminum frame windows, and glass doors. An awning over the sidewalk along the length of the front extended from the wall approximately 6 feet, 8 inches wide and 6 feet, 8 inches high, forming an open, triangular space. It was constructed of two-inch by six-inch (2 x 6) wood joists and two-inch by four-inch (2 x 4) wood framing. It was nailed to a 2 x 4 wood ledge that was bolted to the lower edge of the I-beam. The back of the awning assembly was attached to the concrete block wall above the I-beam with one-half inch diameter by 13 inch long steel bolts ($\frac{1}{2}$ " x 13"). The roof of the awning was curved with one-inch-thick plywood under composition shingle roofing and measured nine feet from the top to the front fascia. **(Figures 1 and 2)**

Figure 1. Collapsed awning (Photo by Denison FD)

Finding 8: The failure of the truss roof assembly in the building led to a partial building collapse, detaching the awning, which collapsed on firefighter Phillip Townsend and the Fire Chief.

Recommendation 8: Identify Fire Ground Hazards Associated with Roof and Floor Truss Systems

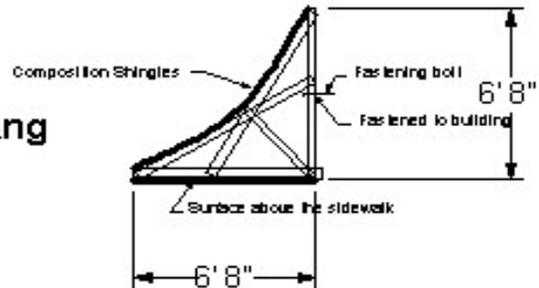
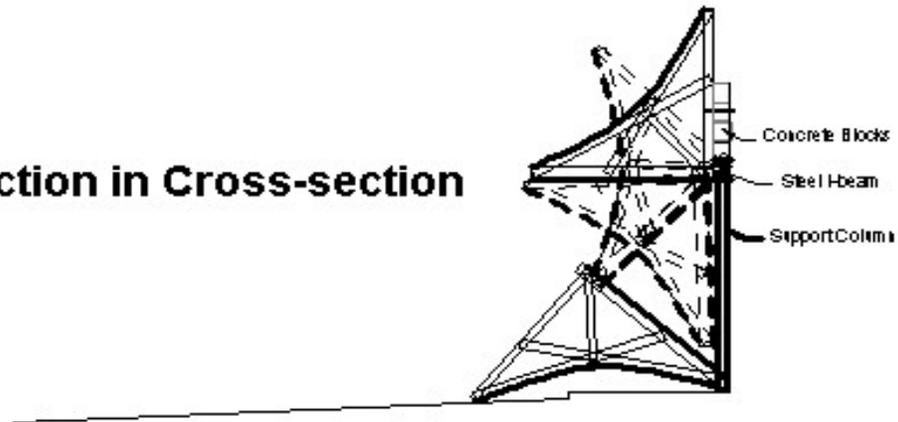
Figure 2. Awning construction (By DSFM E. Cheever)

The examination of the scene revealed that the roof structure collapsed and was consumed, leaving the tubular webbing of the truss system unsupported by the wood chords. This loss of the truss system allowed for the lateral movement of the front wall supporting the awning.

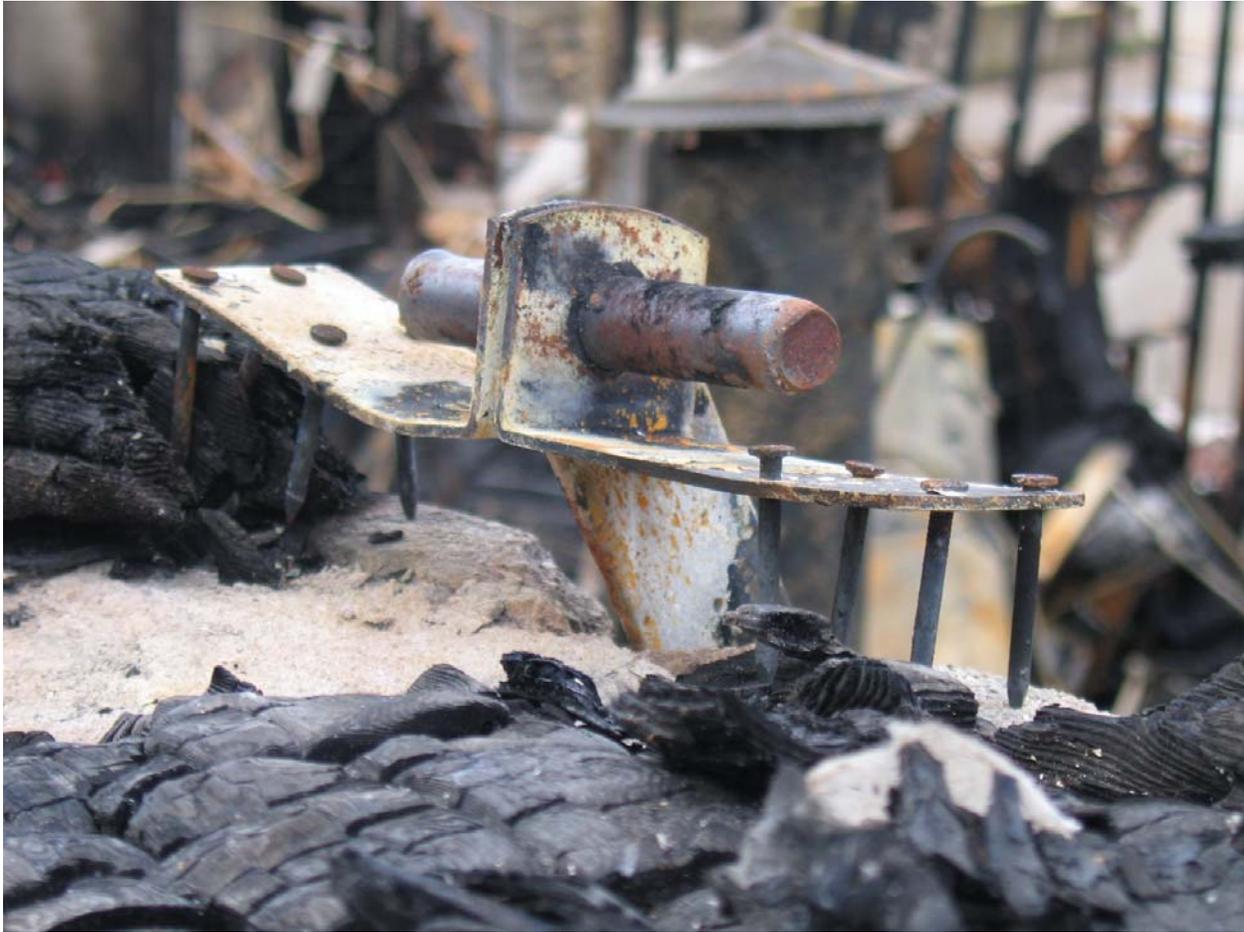
The truss system was attached to the masonry block at the east (rear) side by eight, two-inch nails per anchor assembly. Fire and collapse damage prevented inspection and determination of the method for attachment of the truss system to the west (front) side. The truss system extended from west to east in the attic space. **(Figure 3)**

Figure 3. Roof truss attachment to east wall (Photo by SFMO)

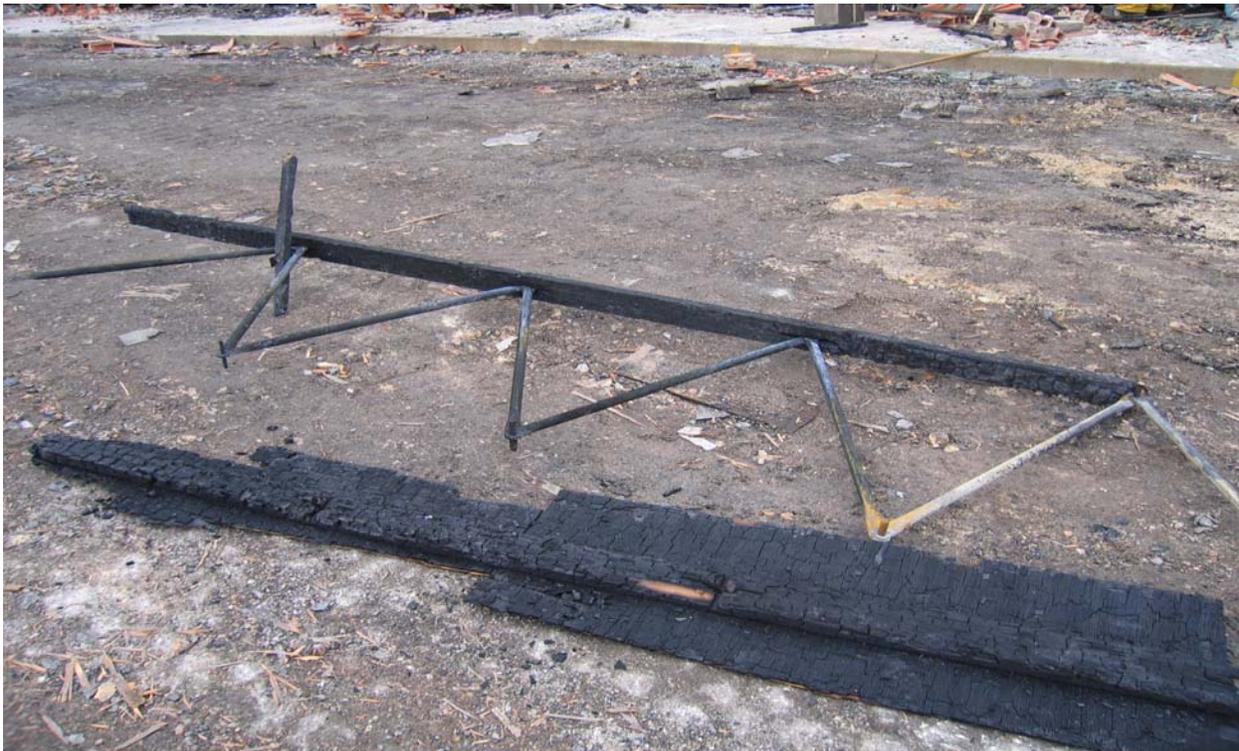
The building had a dropped ceiling, without fire separation between compartments to prevent heat and smoke spread. The exposed roof system was a pin-connected open web truss of tubular webbing and solid steel pins secured in unprotected two-inch by four-inch (2 x 4) wood chords. There were no indications that fire retardant or insulation was used on any of the exposed wood surfaces of the truss system or the roof decking. **(See Figure 4.)**

Figure 4. Remains of truss (Photo by SFMO)

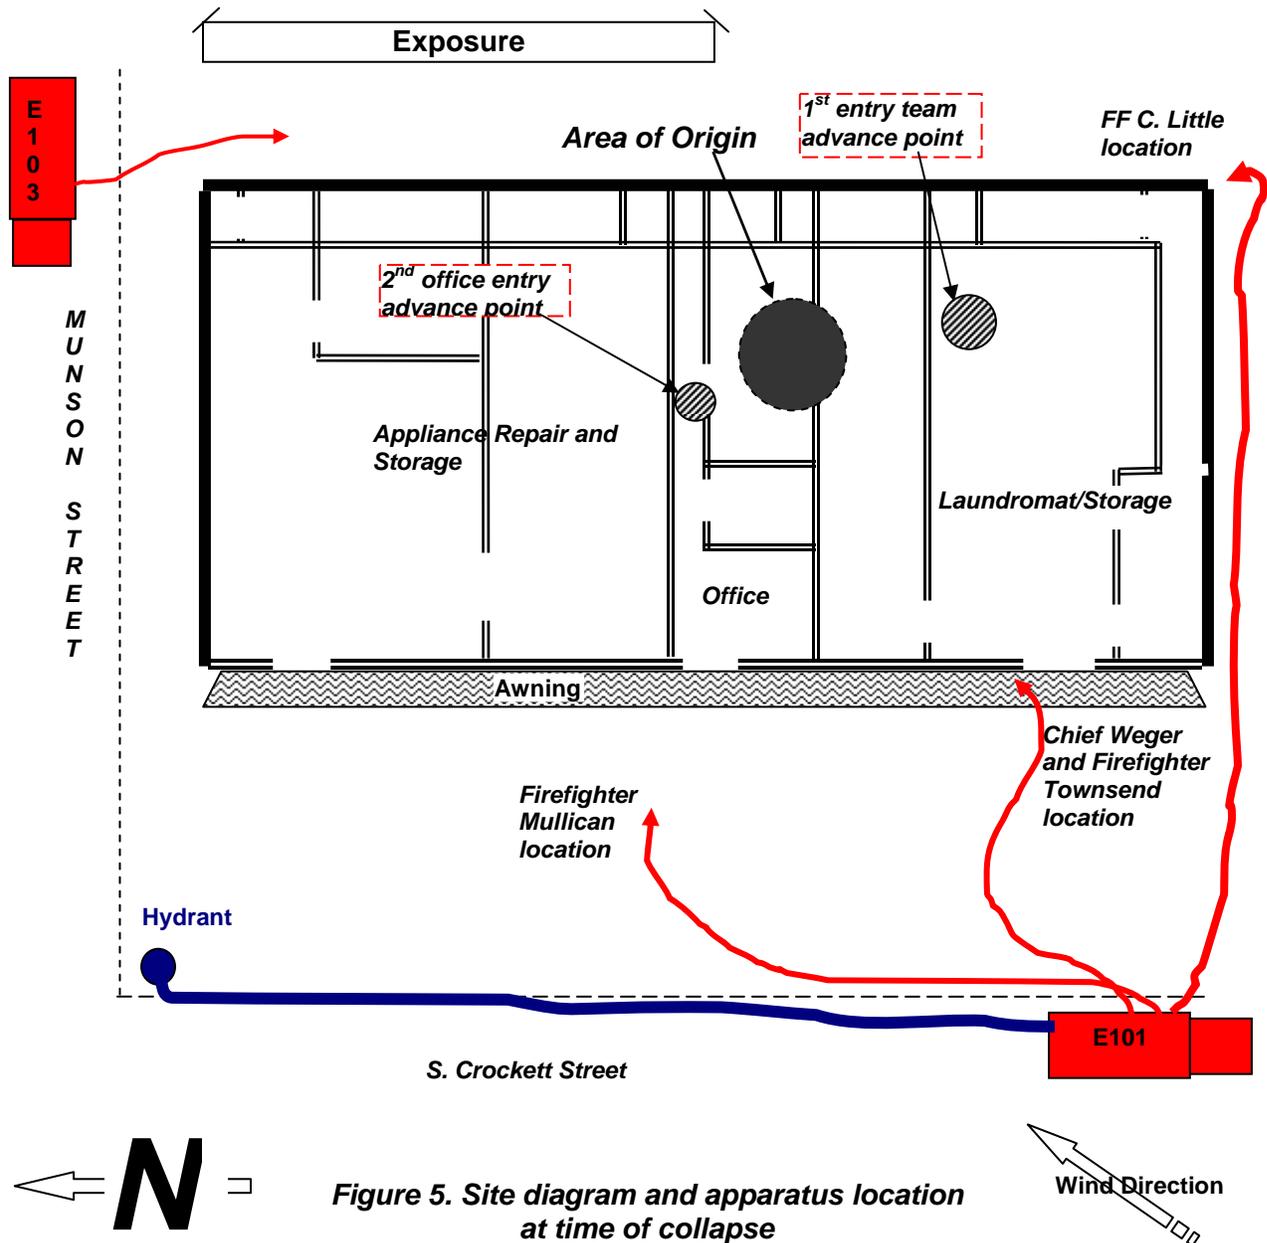
The fire investigation revealed that the fire originated above the concealed space of the owner's office and storage room near the center of the building. The undivided area of the roof system allowed for the development and spread of the fire, while remaining hidden. Forcible entry into the laundry at the south end of the building by the initial response team and the opening of the door into the center office area allowed the southwest wind of approximately seven mph to add air to the ventilation-starved fire, which aided rapid fire spread across the concealed area of the roof system. (See Figure 5.)

Figure 5. Site diagram and apparatus location at time of collapse

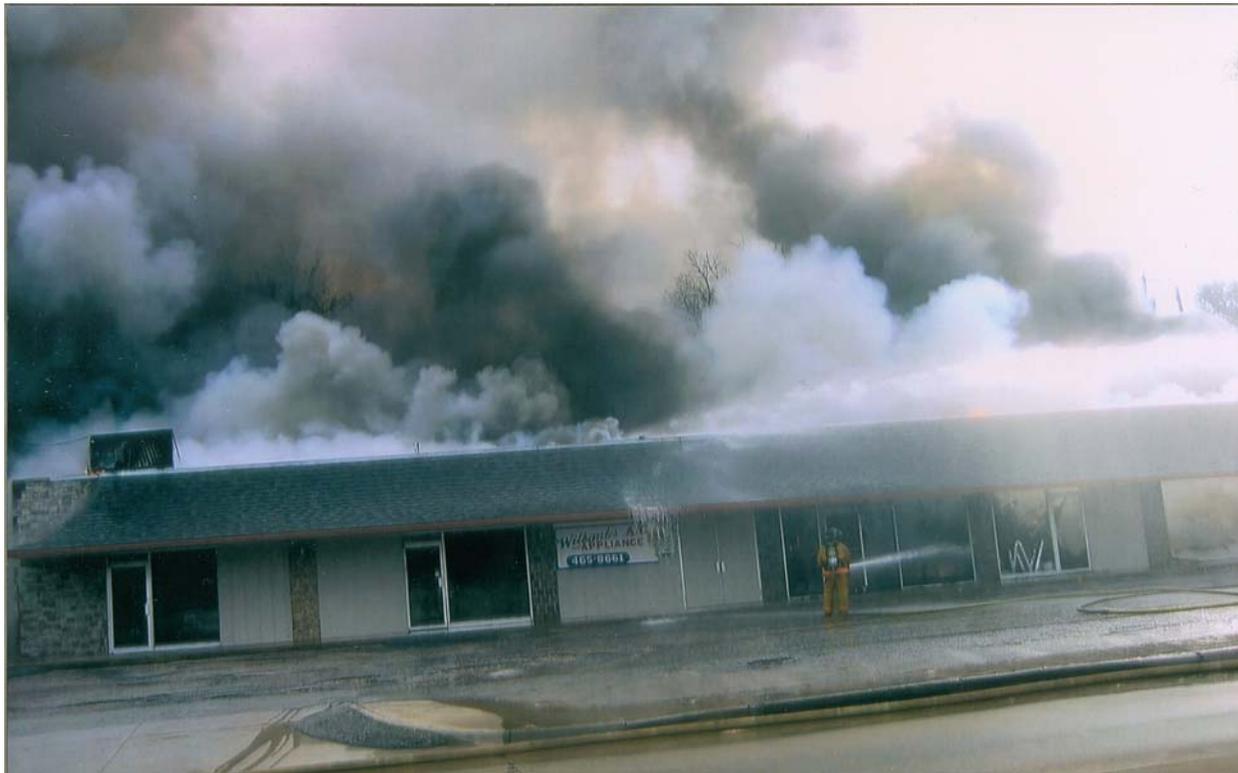
**Figure 6. Firefighter Mullican's position during defensive mode
(Photo from Denison FD)**

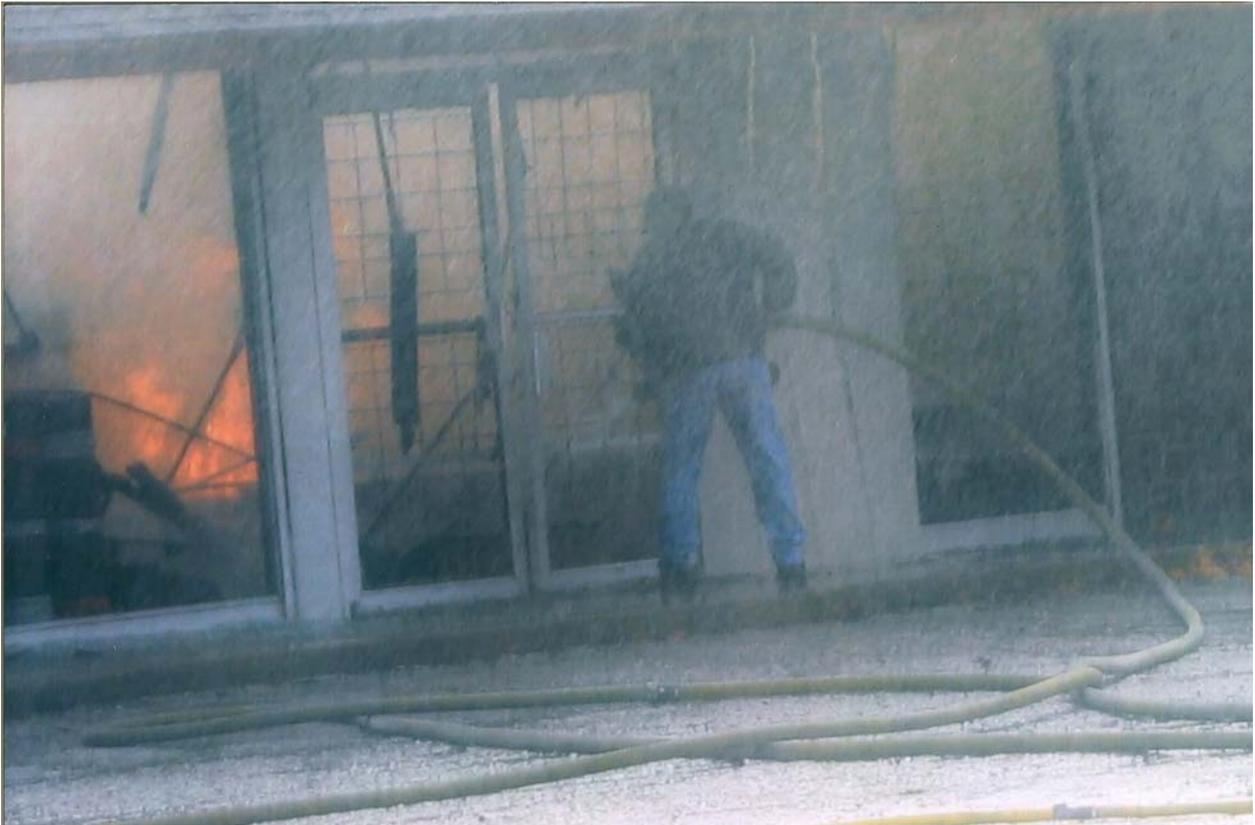
Figure 7. Chief Weger performing firefighting operations prior to the collapse. (Photo from Denison FD)

FINDING 2: The Fire Chief and firefighter Phillip Townsend operated inside a collapse danger zone after firefighters withdrew from the building interior and a defensive attack was initiated.

Recommendation 2: Establishment of Safety Zones

- Fire Departments should establish safety zones whenever defensive mode of attack has been declared to protect firefighter safety during operations. The designated Safety Officer should monitor the collapse zone to ensure that no firefighting operations take place within this area as part of the defensive operations.

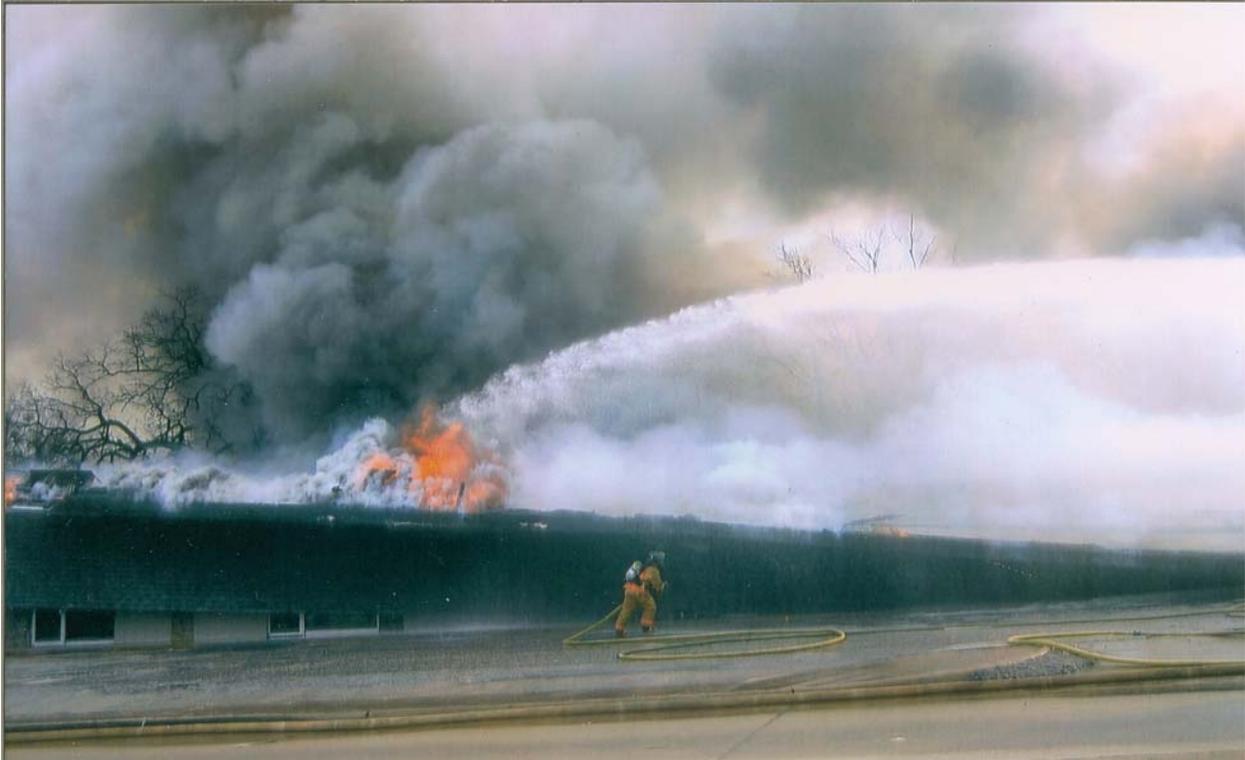
Figure 8. At the moment of collapse Firefighter Mullican starts toward Weger and Townsend's position. (Photo from Denison FD)

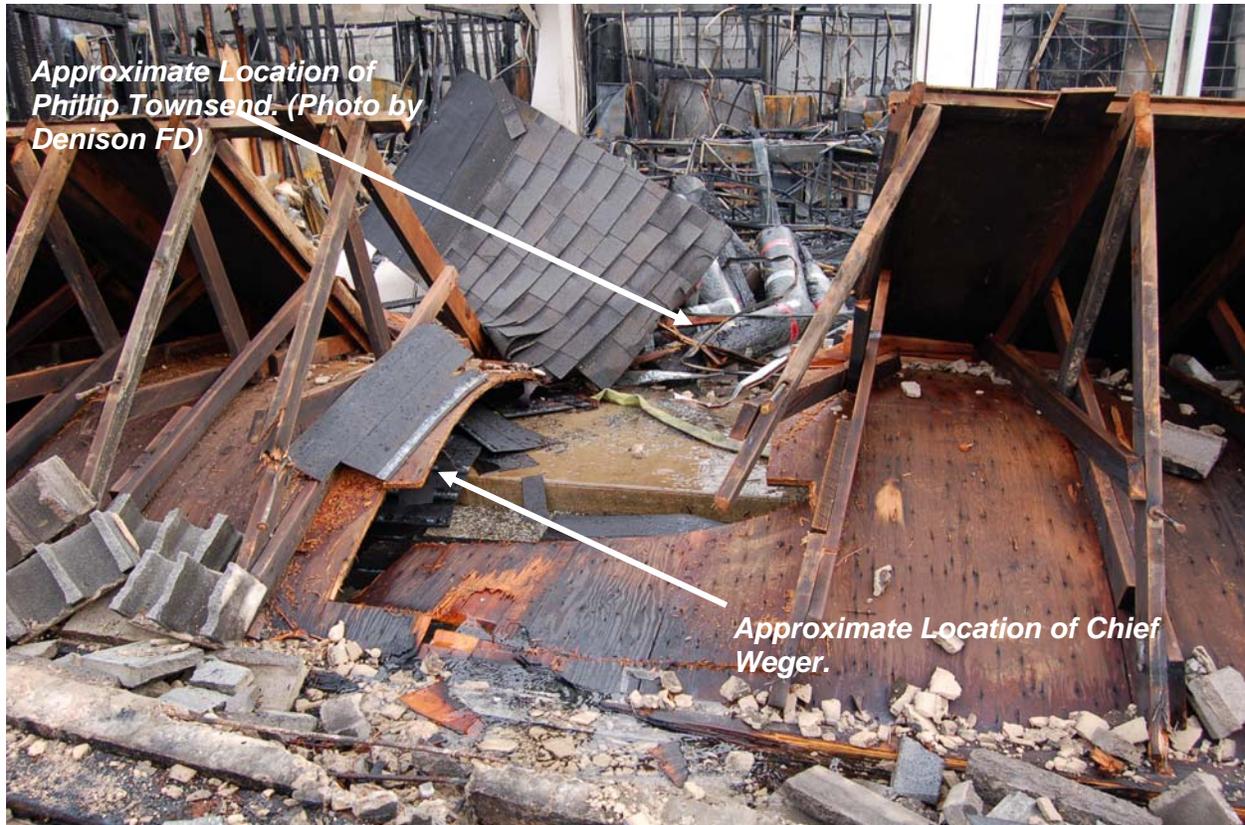
**Figure 9. Locations of Chief Weger and Phillip Townsend after collapse
(Photo by Denison FD)**

Firefighter Townsend was located near the wall of the building in a sitting position, pinned between the collapsed overhang and the masonry wall. Firefighters attempted to provide first air from his SCBA and later oxygen to him. He was unresponsive from the first time firefighters reached him. Firefighters Little, Mullican, Kuykendall, Flippo, Oates, Floyd, and Denison Police Officer Murrin all report hearing firefighter Townsend's PASS sounding when reaching him.

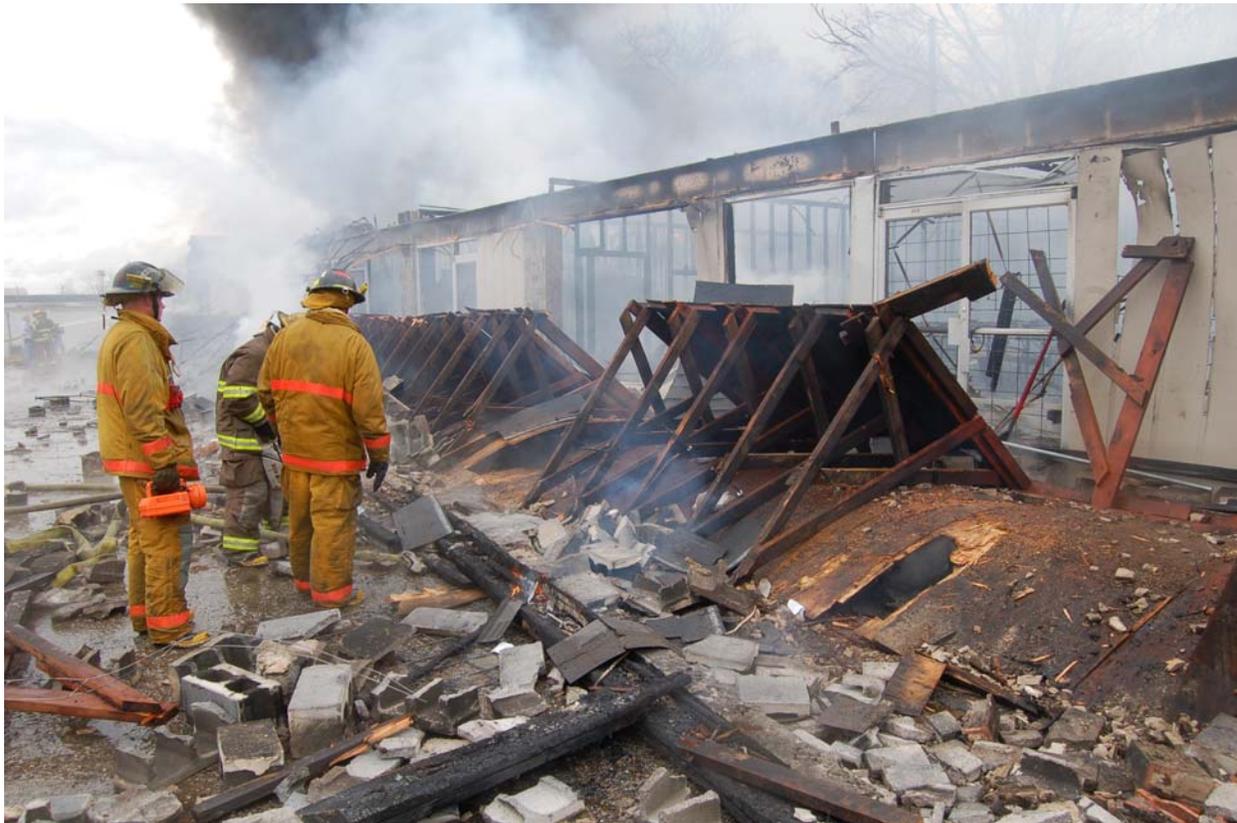
Figure 10. South view of collapse (Photo by Denison FD)

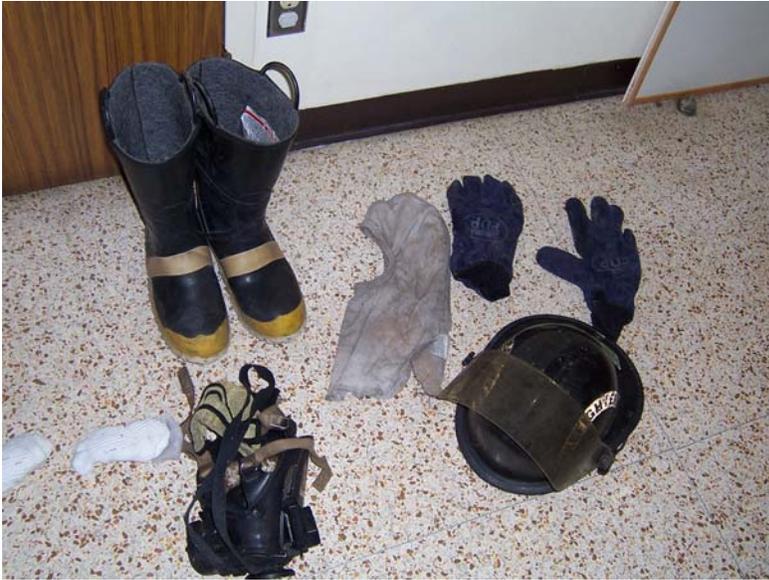
- Helmet – No apparent damage.
- Hood – No apparent damage.
- Self-Contained Breathing Apparatus – SCBA frame was damaged due to apparent impact of falling structural overhang.
- SCBA Mask – No apparent damage.
- Boots – No apparent damage.
- Structural Coat – The outer shell and liner of the coat were damaged due to removal by medical personnel. No apparent damage from fire or the collapse.
- Structural Pants – No apparent damage.
- Boots – No apparent damage.
- Gloves – No apparent damage.

Figure 11. Firefighter Townsend's PPE (Photo by TCFP)

It was determined that firefighter Townsend donned his personal protective clothing properly and that it was not a contributing factor in his death.

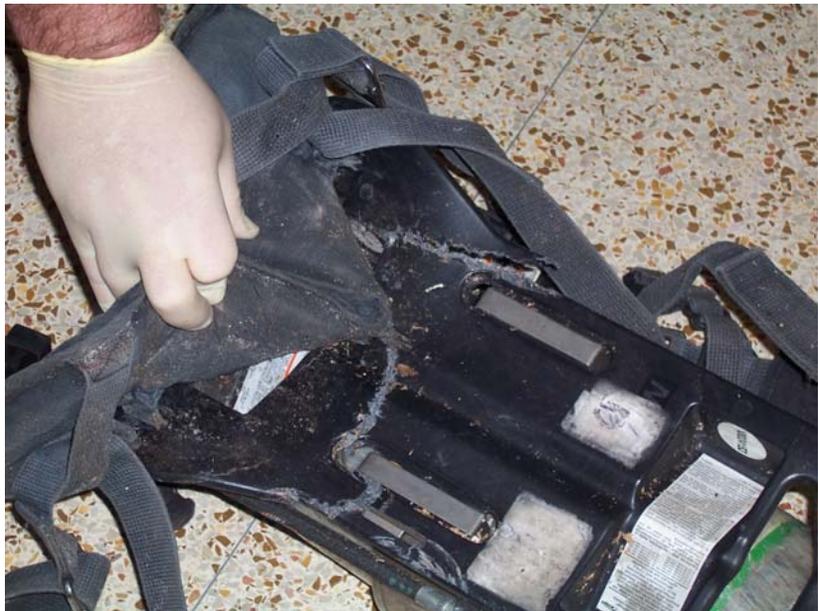
Figure 12. Photograph of the SCBA frame damage illustrating the cracked bracket (Photo by TCFP)
