Firefighter Fatality Investigation

Investigation Number 06-166-12

Firefighter Chad Ernest Wessels

Briggs Volunteer Fire Department
December 11, 2005

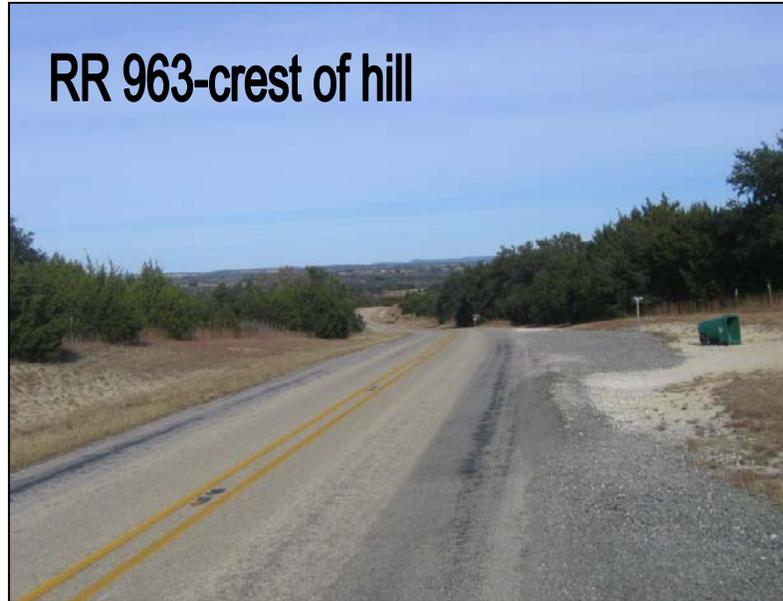
Approximately 5 miles from the Wessels residence eastbound on Ranch Road 963, Briggs Unit 4240 passed a diamond left curve sign. No speed advisory sign is attached. (See attached diagram)

No warning chevrons delineated the curve. The asphalt roadway was dry, in good condition, and had a slight downhill grade transitioning from a slight left curve into a straight section. The roadway was marked with a double yellow centerline. The edges of the roadway are not marked with a white line, and loose asphalt and rock material is present at the edges of the roadway. The terrain of the shoulders and adjacent land is rocky and uneven.

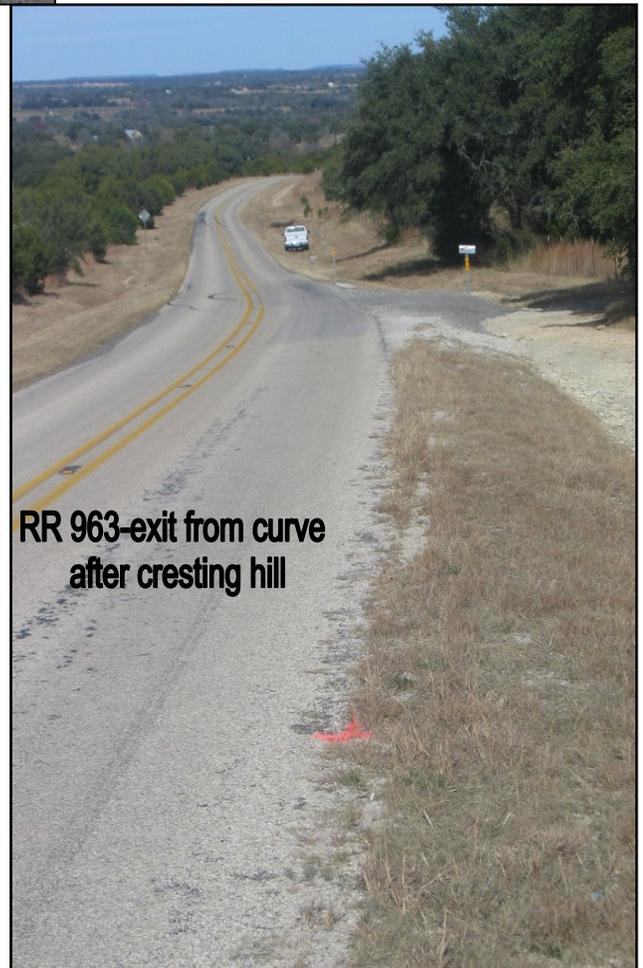
A post-crash fire ignited and consumed the front and cab interior of Unit 4240. The investigating DPS trooper surmised that the movement of the truck through fences and across rocky terrain disrupted the fuel system of the Unit 4240, leading to the fire. The DPS report stated that it was believed that Firefighter Wessels, who was not wearing a safety belt, was thrown about and possibly rendered unconscious during the off-road excursion of the truck and was not able to respond and escape the burning truck. There was collision damage to the front bumper area of the truck, but none to the cab area.

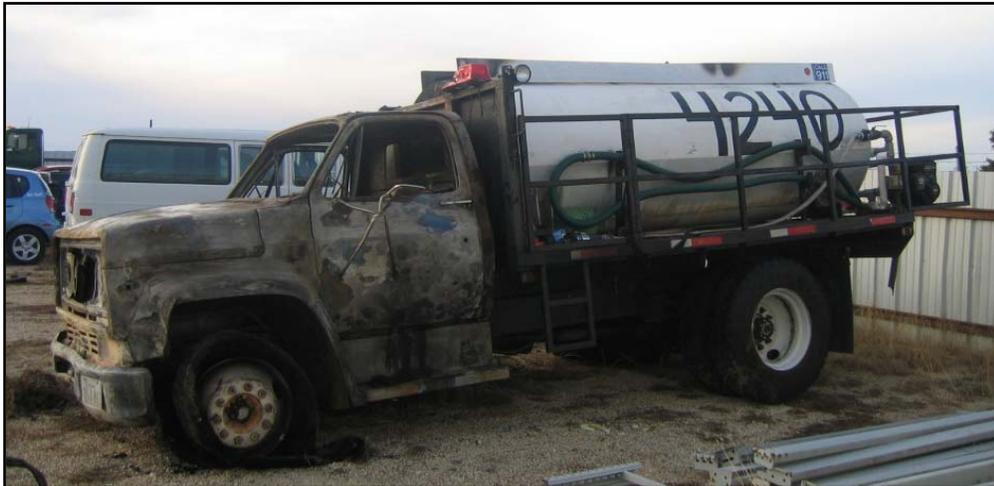
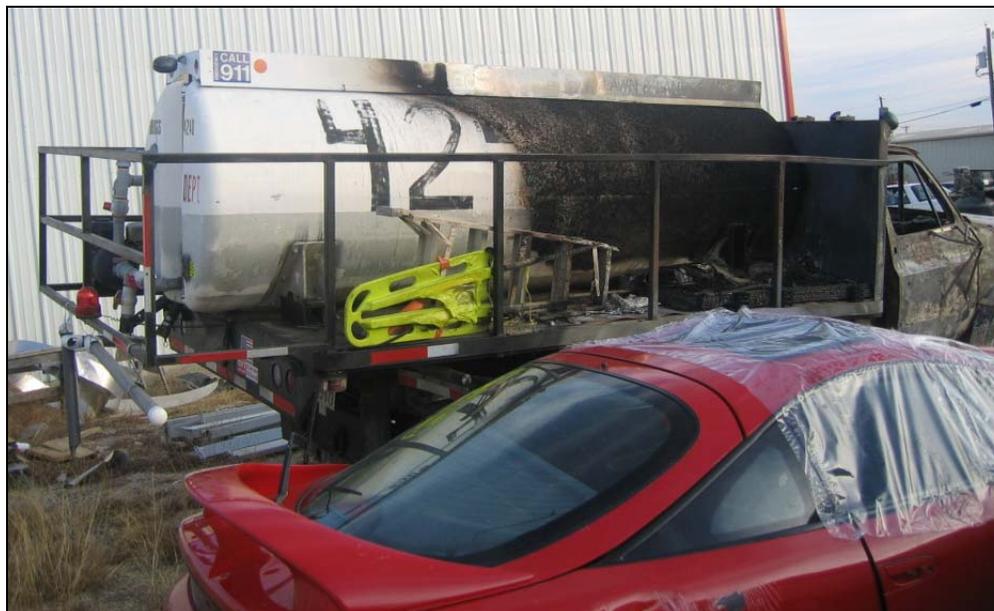
Texas Department of Transportation records show that the 1986 GMC chassis had an empty weight of 11,500 pounds and a maximum permissible weight of 16,500 pounds for a maximum payload of 5000 pounds. Filling the cargo tank on this truck with 1,200 gallons of water weighing 10,008 pounds, (8.34 pounds/gallon) produces a vehicle weight of 21,508 pounds.

This is 5,008 pounds over the maximum 16,500-pound gross weight listed on the vehicle title. This does not take into account the weight of the truck bed and the water tank, pump, hoses and additional equipment installed by BFD.

Exceeding the gross vehicle weight may have an adverse effect on vehicle handling, braking, and performance and may violate state motor vehicle laws.

The former fuel truck cargo tank originally had two compartments divided by a bulkhead. SFMO investigators found that BFD modified the bulkhead by cutting holes in them to facilitate the transfer and discharge of water. While the modified bulkhead may have served as a baffle to control the movement of water from front to back in the cargo tank, there were no baffles to control the lateral movement of water, which would tend to affect the handling characteristics of the vehicle as the weight of the water shifted from side-to-side.

Recommendation: Any fire department acquiring a vehicle, chassis, or trailer not originally designed as firefighting apparatus should proceed with caution when converting equipment for use in firefighting. Fire departments should take into account factors such as the weight of tank water and equipment, center of gravity, load distribution, capacity of the drivetrain, tires, steering, and braking systems during fire apparatus construction.

Recommendation: All fire departments acquiring vehicles, chassis, or trailers should refer to all available manuals or documentation prior to commencing conversion or modification operations. Water tanks should be clearly marked with the tank capacity and full gross weight. Fire departments should install positive physical safeguards, such as overflow vents, to prevent vehicles from exceeding maximum permissible gross weight when fully loaded.

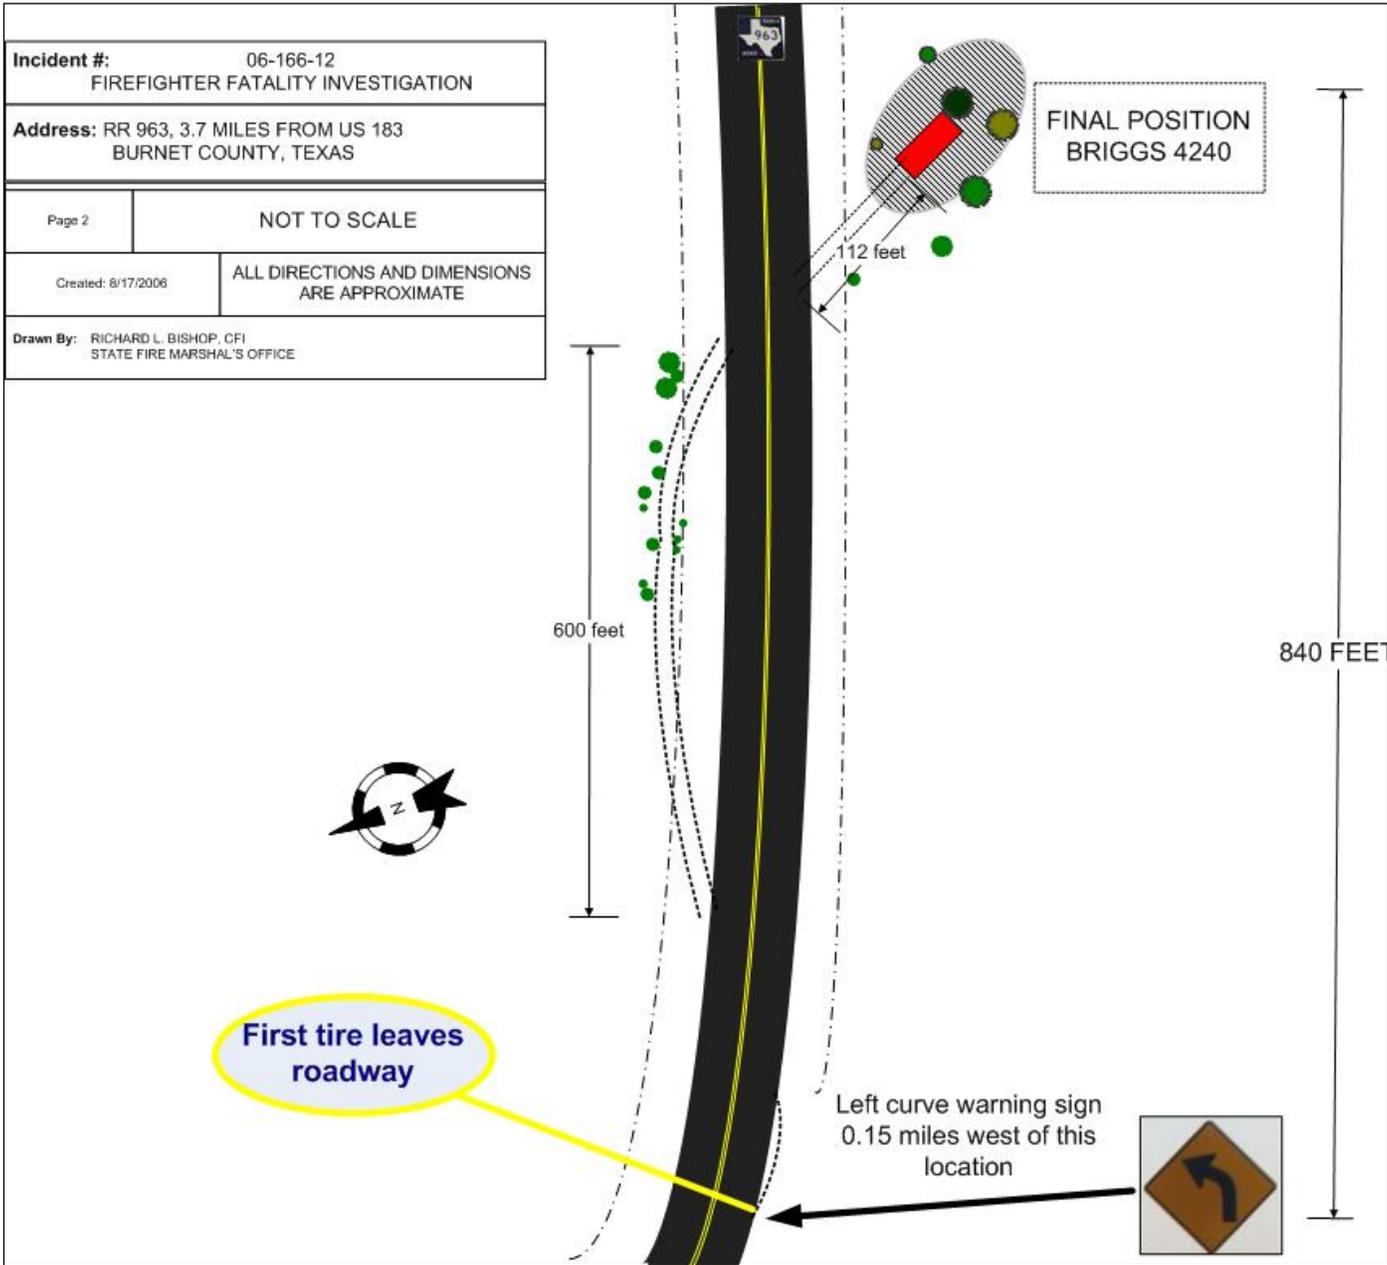
Incident #: 06-166-12 FIREFIGHTER FATALITY INVESTIGATION	
Address: RR 963, 3.7 MILES FROM US 183 BURNET COUNTY, TEXAS	
Page 2	NOT TO SCALE
Created: 8/17/2006	ALL DIRECTIONS AND DIMENSIONS ARE APPROXIMATE
Drawn By: RICHARD L. BISHOP, CFI STATE FIRE MARSHAL'S OFFICE

After cresting the hill, the right front tire of Unit 4240 left the right hand side of the roadway at the exit of the left curve to the downhill straight section, after passing the curve warning sign. The Texas Department of Public Safety (DPS) report stated no tire marks were present that would have indicated that Firefighter Wessels applied heavy braking action.

Unit 4240 reentered the highway and veered left across the roadway at an angle and left the roadway on the left side. The water tender passed through a barbed wire fence and traveled parallel to the roadway approximately 600 feet before reentering the roadway, crossing it an angle and crashing through a barbed wire fence on the right side of the road. After traveling approximately 112 feet off road, Unit 4240 came to rest in a grove of cedar trees and brush.
