Firefighter Fatality Investigation

Investigation FFF FY 13-06

West, Texas
April 17, 2013

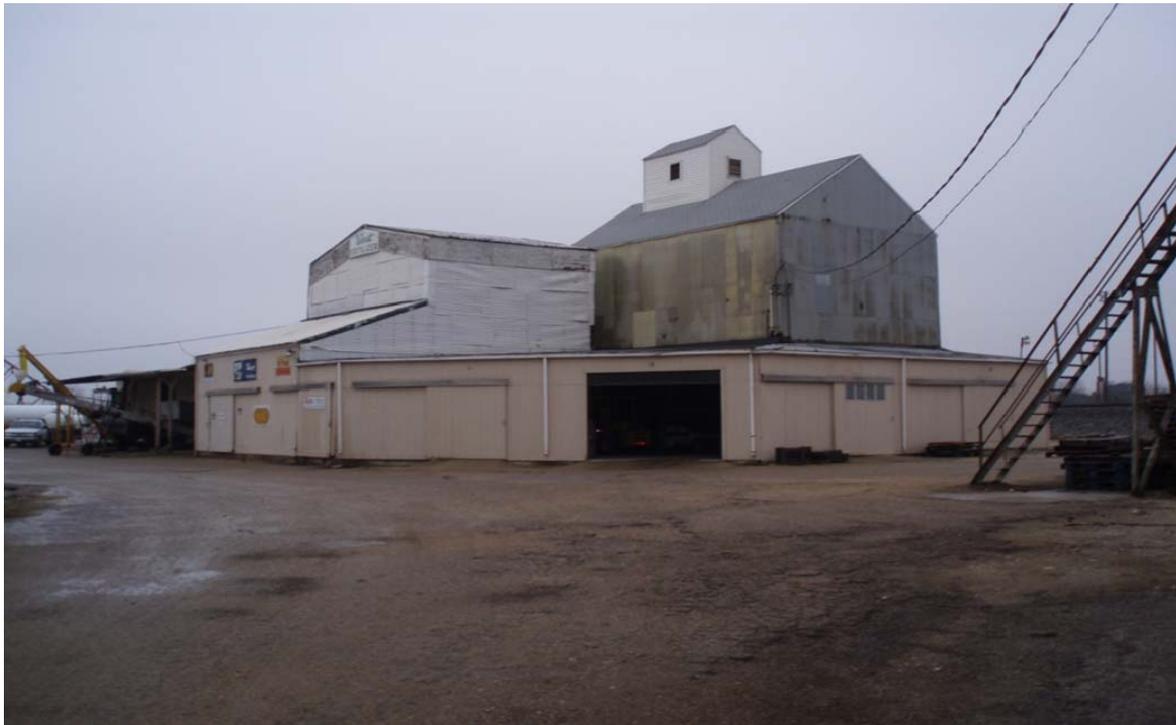
Ammonium nitrate with 34 percent total nitrogen content, also referred to as 34-0-0 (with 97 percent pure ammonium nitrate), was stored in bulk granular form in an open system consisting of a vertical bin constructed of wood walls approximately 24 feet high.

The bin contained an estimated 20-30 tons of ammonium nitrate. An air conditioner was installed to maintain low humidity levels and reduce “shrinkage loss” and caking of the ammonium nitrate product in the vertical bin. Investigators determined through interviews of the employees that the air conditioner was not in use the day of the incident.

View of the building from the northeast

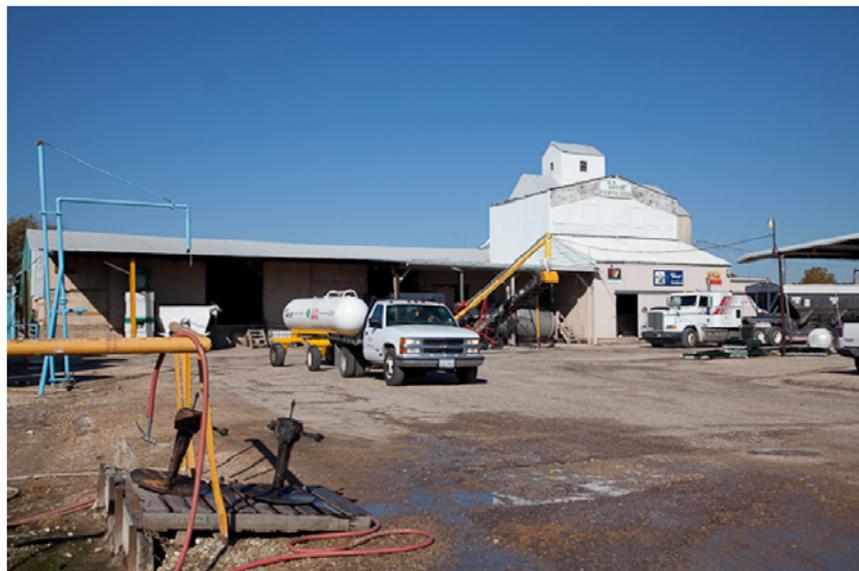
East side of the processing building where the mixing and delivery of chemicals occurred

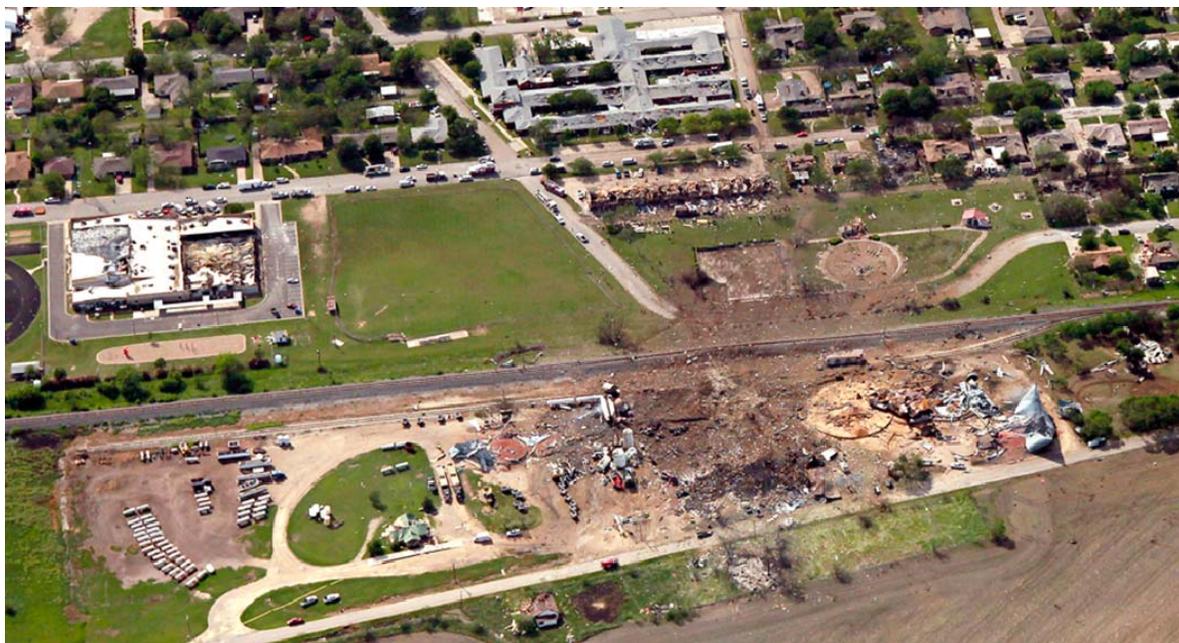
View of the site prior to scene excavation and examination

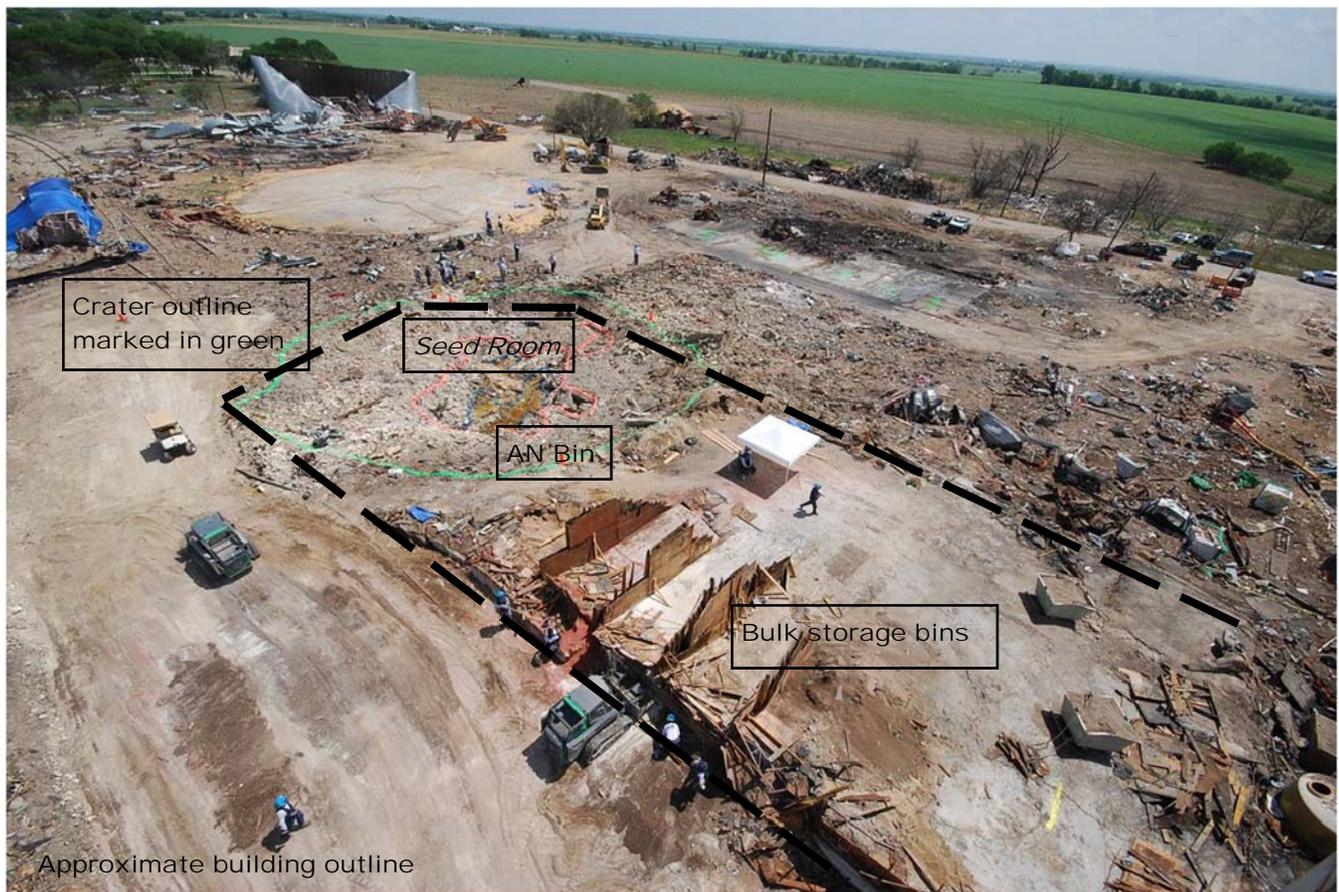
View of the scene during the examination and reconstruction

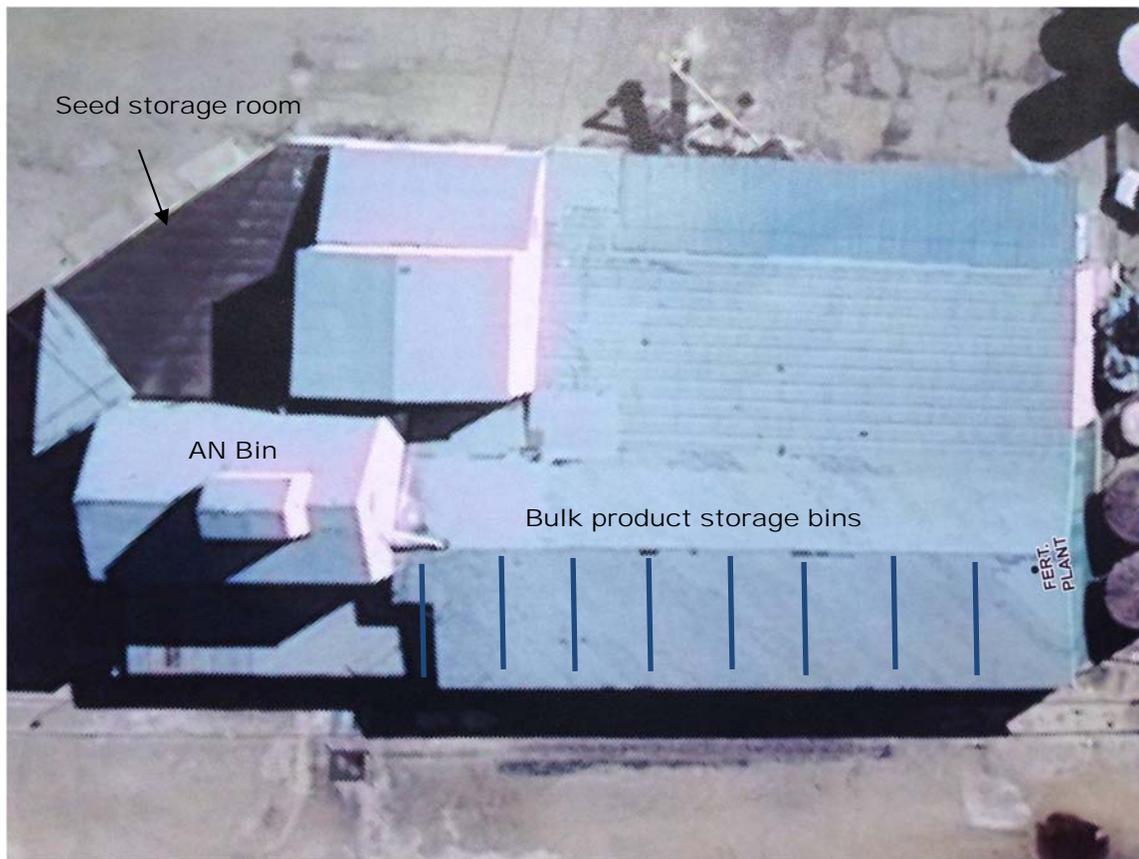
Comparison photos of the reconstruction and pre-blast photos of the processing building

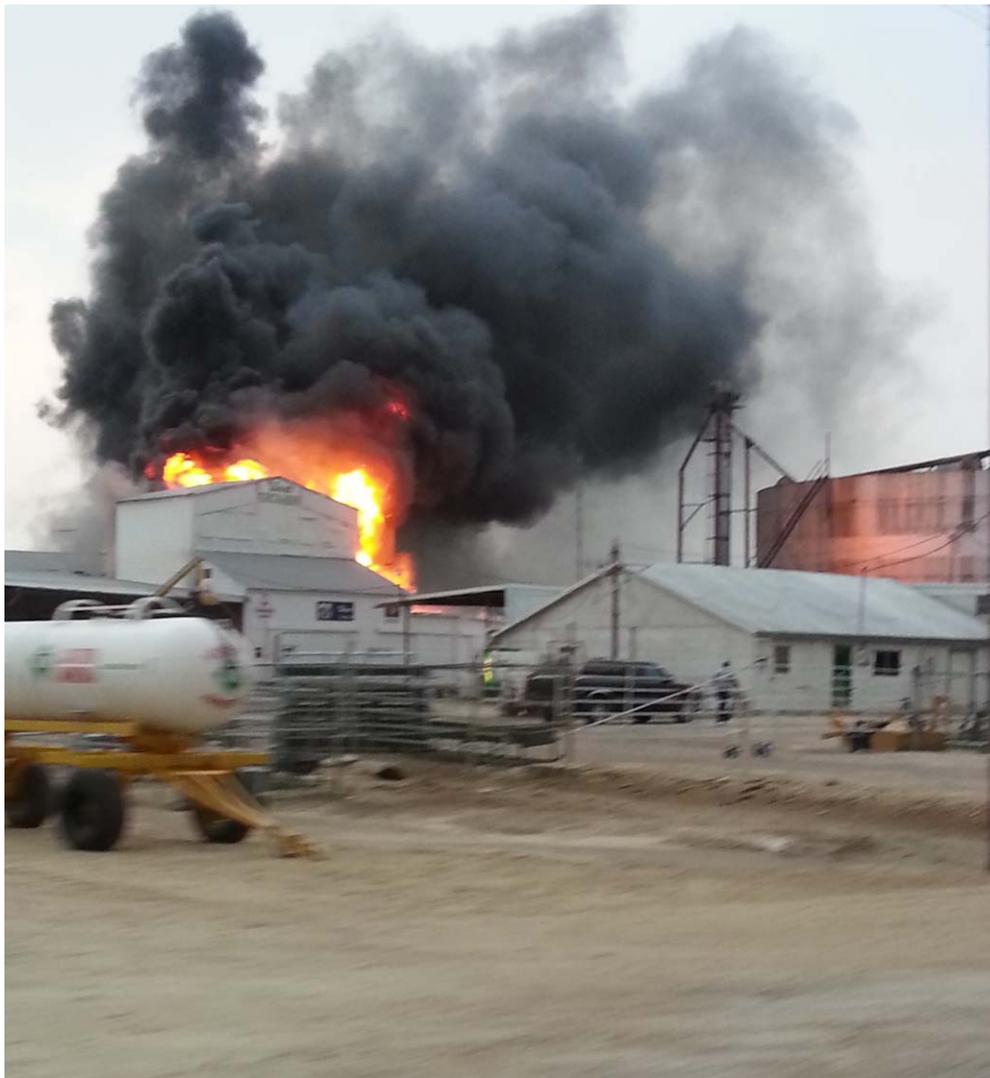
Passerby view of the east side of the building, approximate time 7:38 p.m. (Photo by Macik)

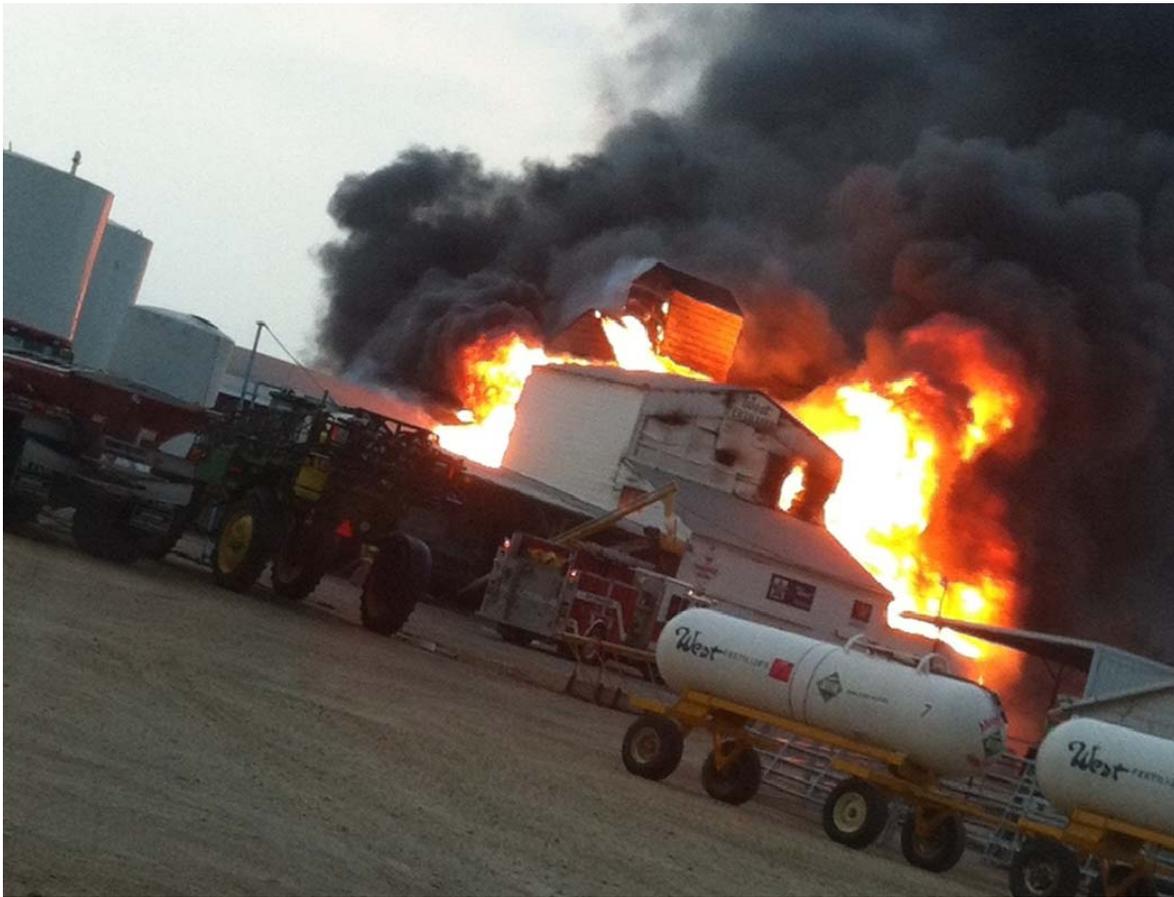
Passerby view of Engine 1 position at east side of building, approximate time 7:40 p.m. (Photo by Campbell)

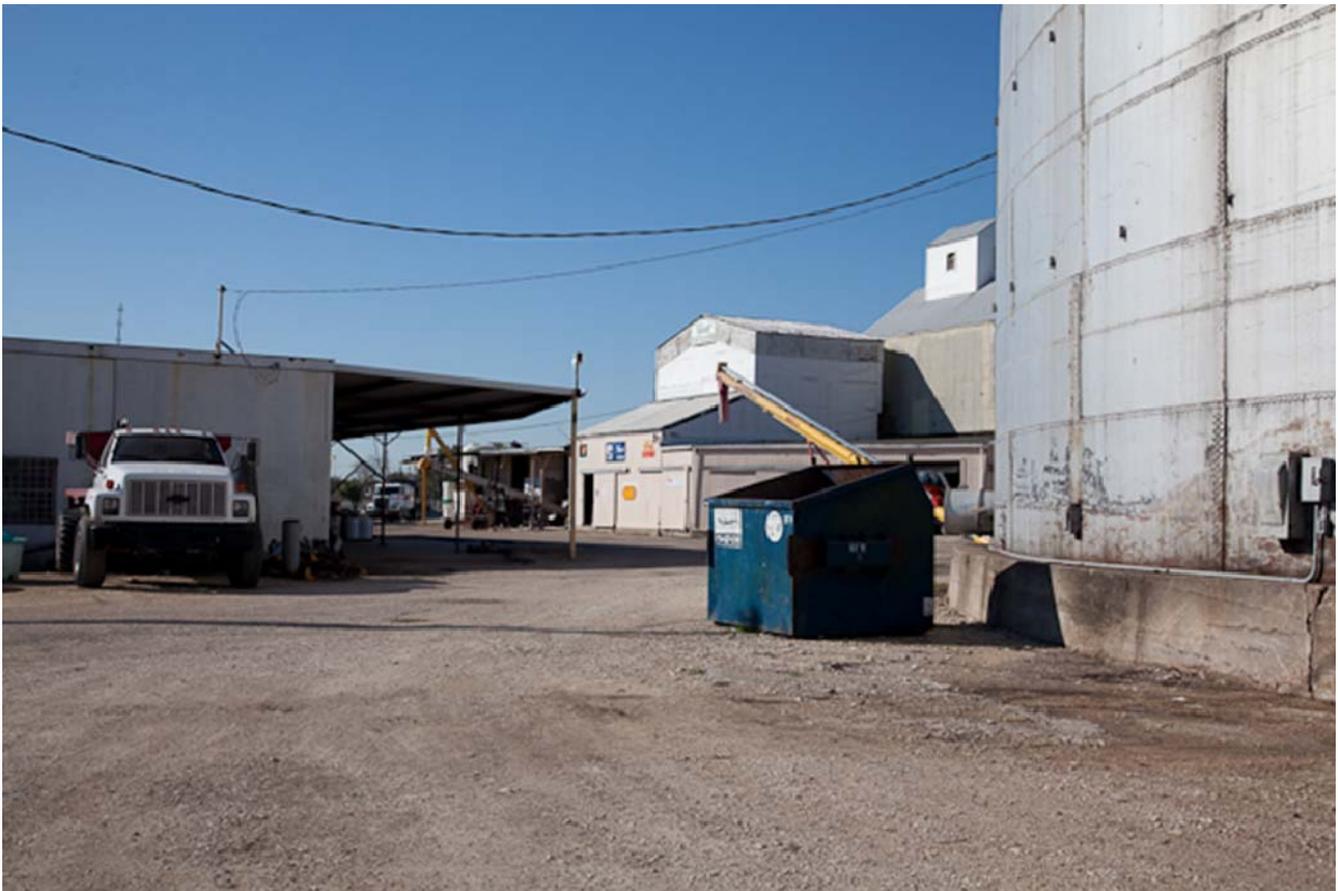
The white brush truck was positioned under the electric service lines in this area before moving back
(Insurer photo)

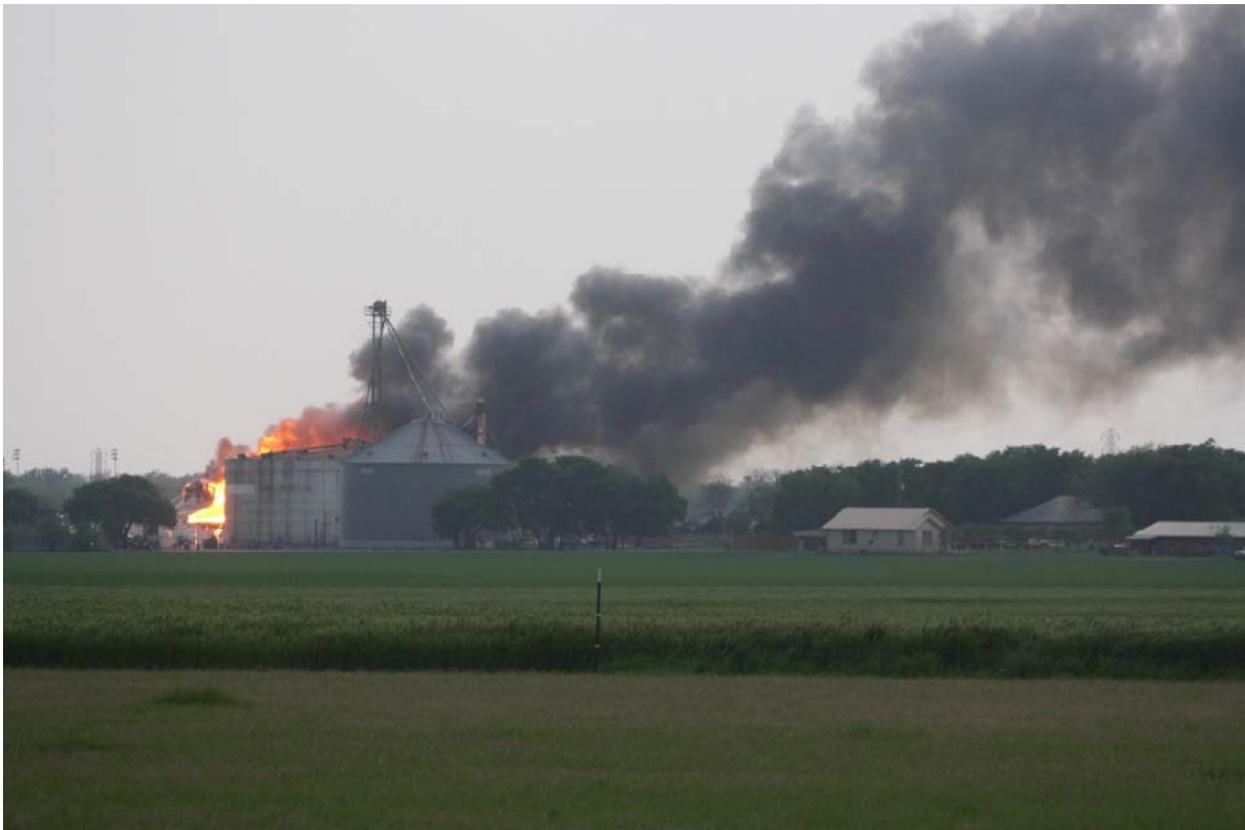
View of the site from the northeast (Photo by Wright)

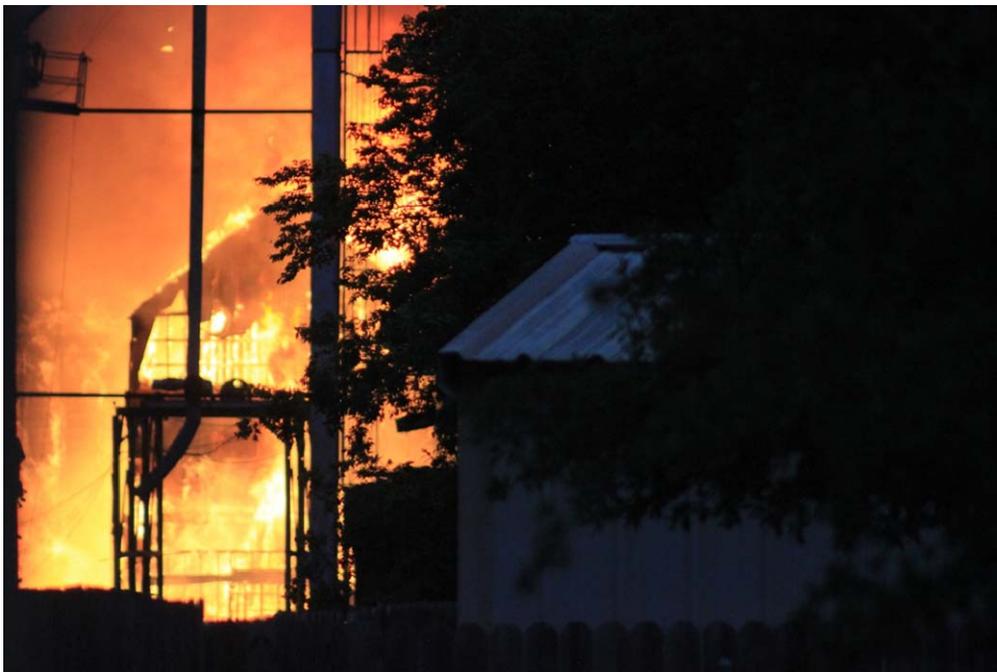
View from the north at approximate time 7:48 p.m. (Photo by Bajer)

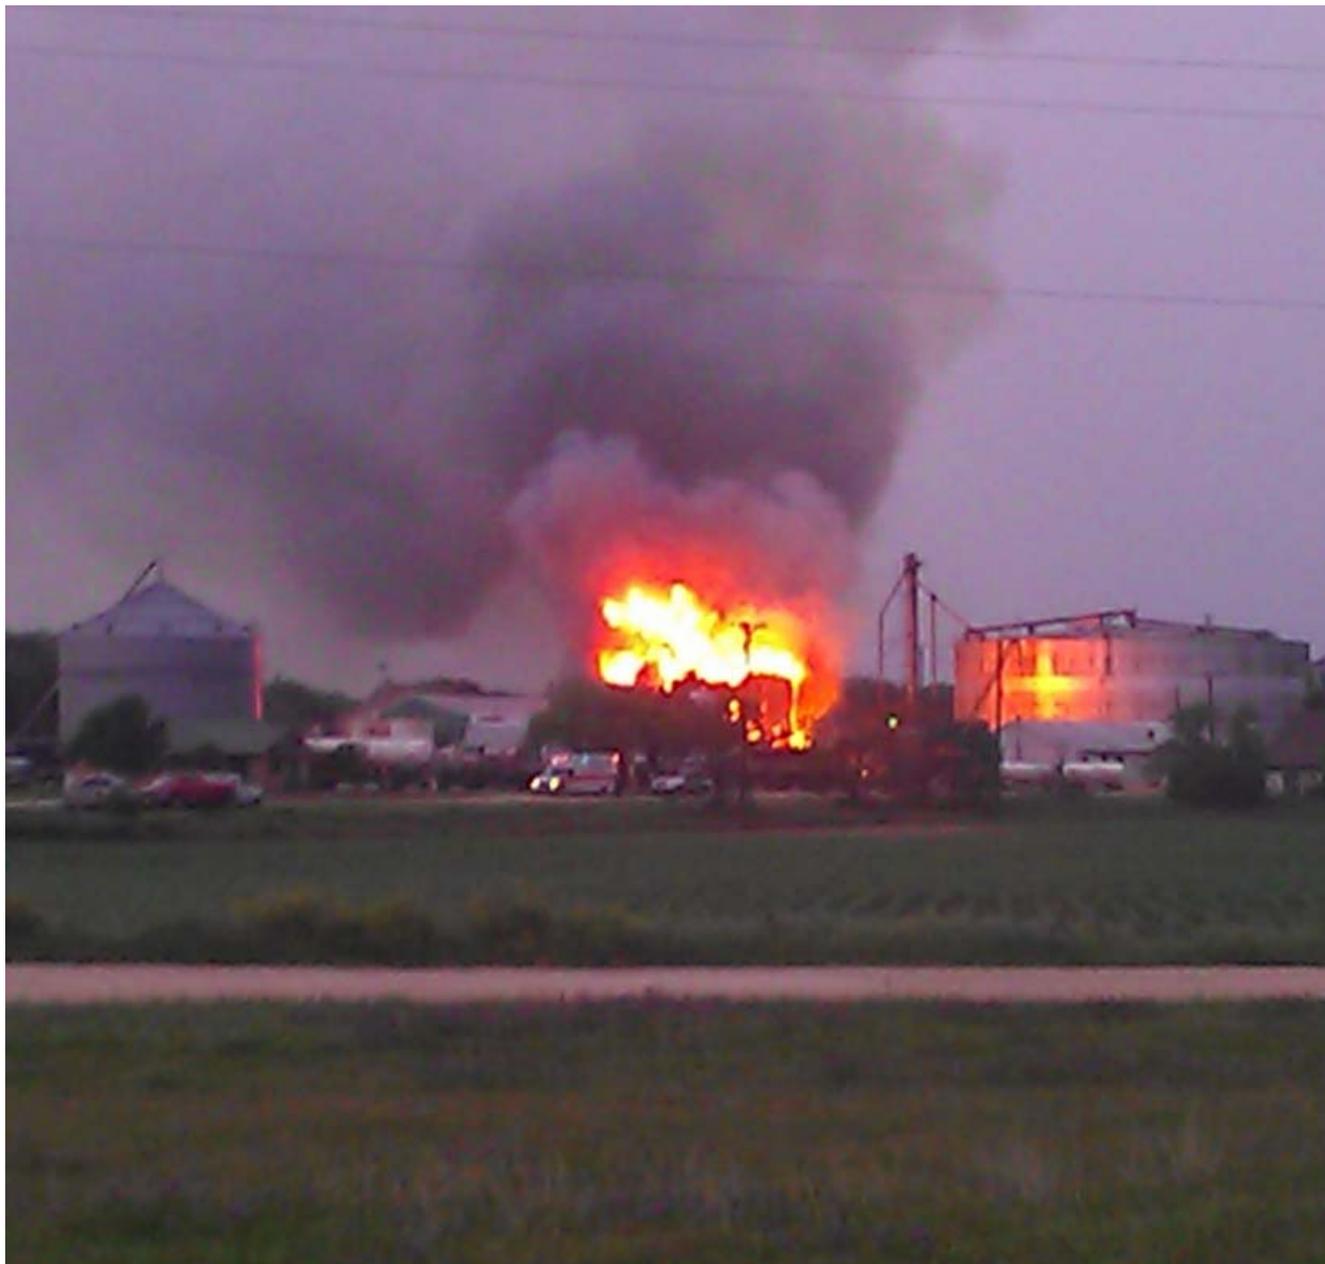
View from the southeast at approximate time 7:50 p.m. (Photo by Nathan Nors)

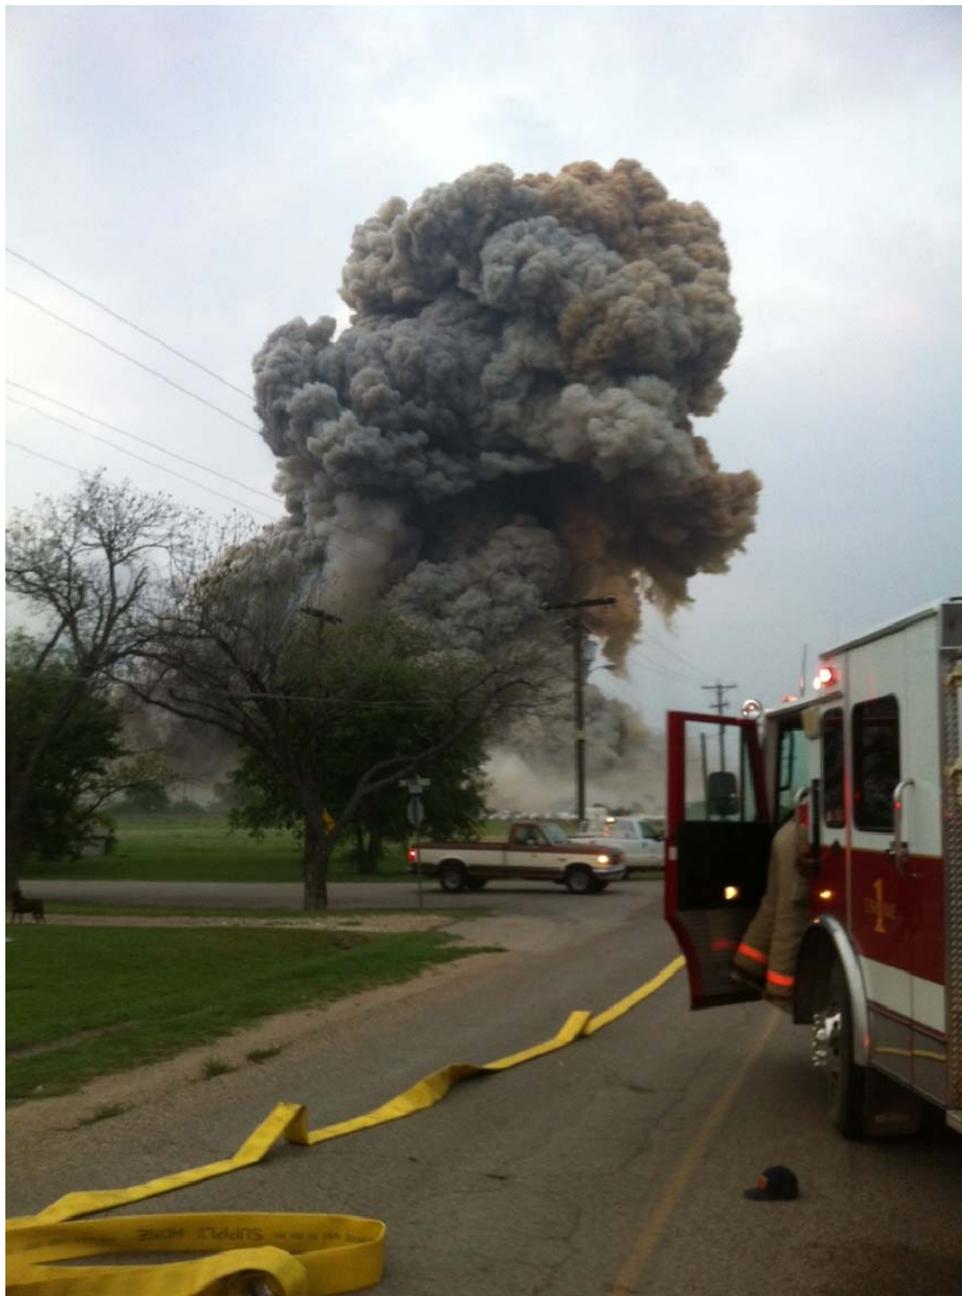
View of the plume of smoke after the explosion
(Photo by Kapavik)

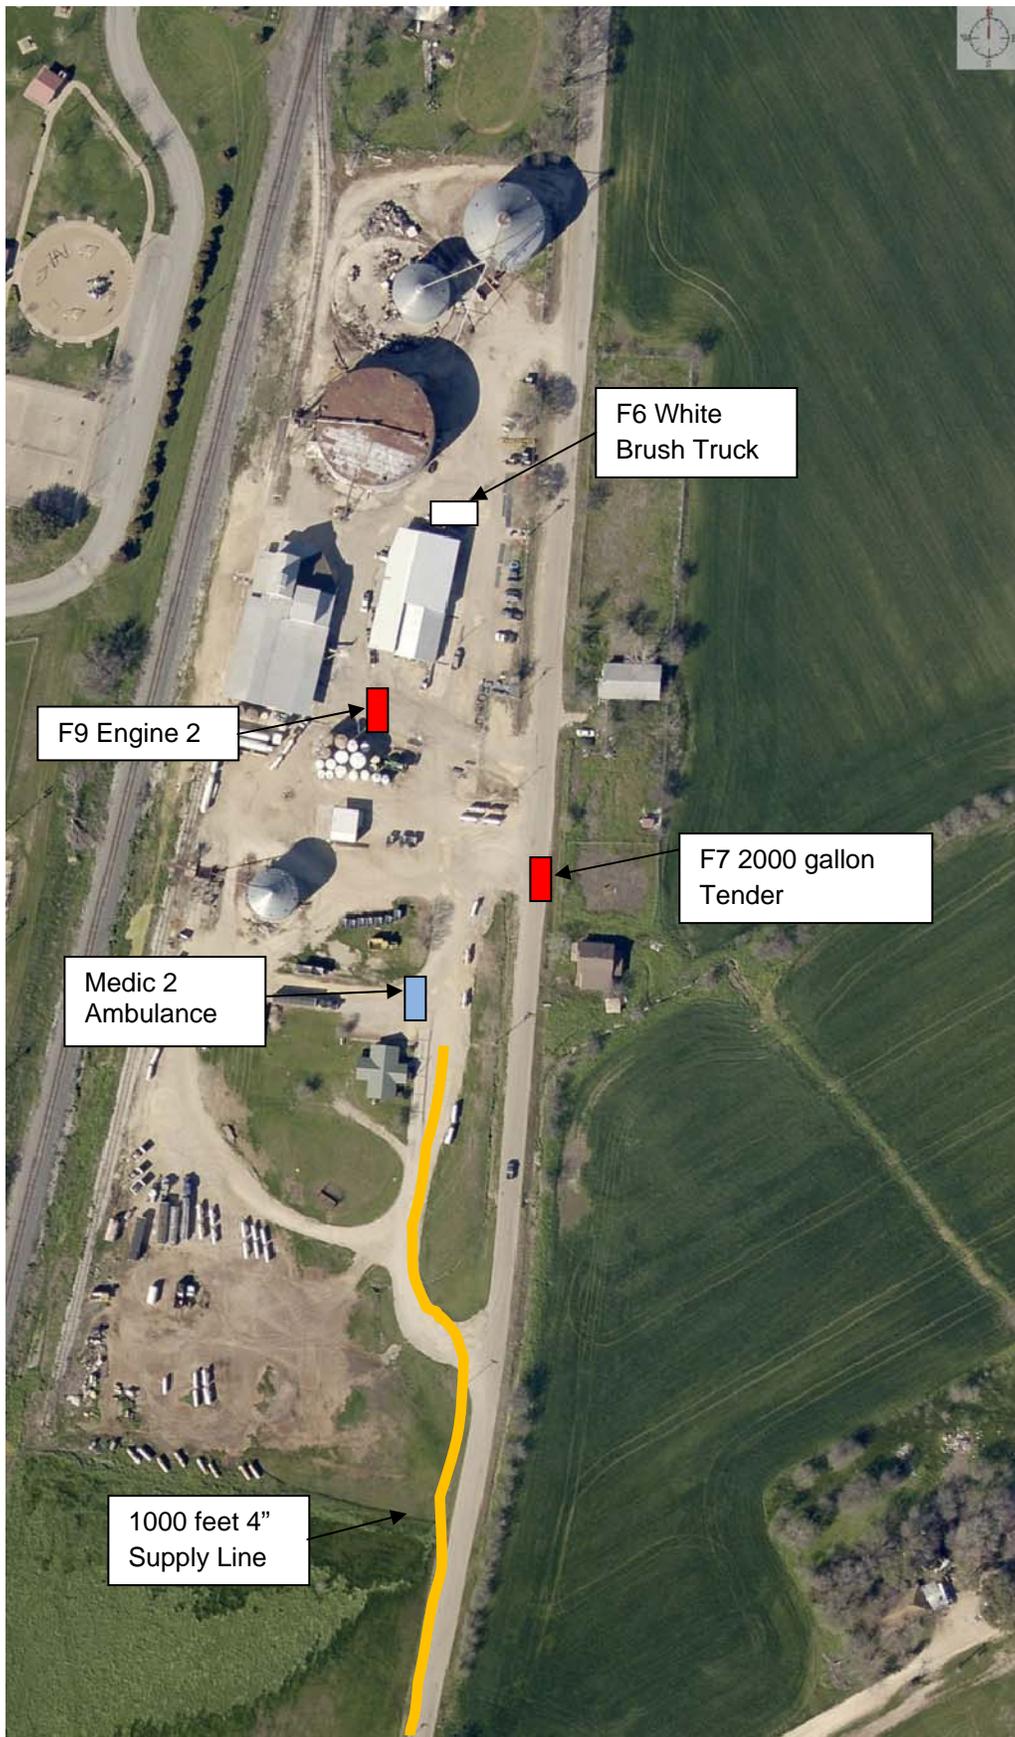
Approximate positions of apparatus at time of explosion
