# STATE FIRE MARSHAL'S OFFICE

## Firefighter Fatality Investigation

Investigation Number FY 07-02

Captain Kevin Williams  
Firefighter Austin Cheek

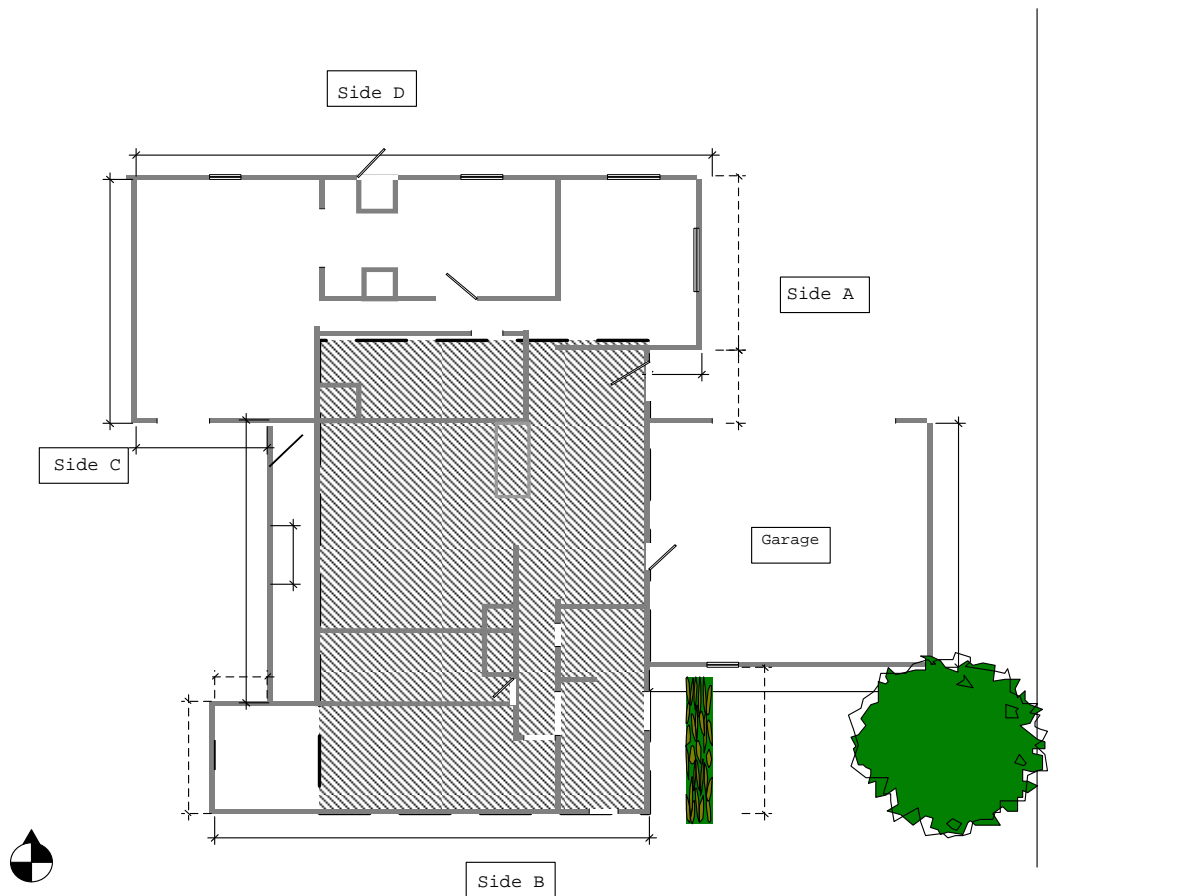
**Diagram 1**

The house was of wood frame construction, approximately 65 feet wide and 80 feet long from the front of the garage to the rear of the master bedroom. It was built on a concrete slab foundation with a composition roof. Electrical service was supplied through a meter located at the southwest corner area. The exterior walls were unprotected wood siding. The interior finish was wood paneling or gypsum board walls and ceilings. The house consisted of four bedrooms, two bathrooms, an attached garage, and an enclosed patio with approximately 2700 square feet of living space. The house had extensive additions since its construction in the 1970s. The original house was pre-fabricated and site constructed, with exterior walls and roof consisting of structural insulated panels (wood panels over polyurethane foam). The original construction included the living room, dining room, kitchen, one bathroom, and three bedrooms approximately 30 feet by 50 feet (See Diagram 1). The new construction included combining the two small bedrooms at the southeast corner by removing the separating wall. Additions to the original structure involved the removal of the roof overhang and construction of a new roof over the entire structure resulting in a double roof over the original structure. New construction included the addition of the garage and north end of the house consisting of the master bedroom, master bathroom, study/office, and bedroom. Three-quarter inch plywood sheets were added over the ceiling joists in the attic space of the new construction for a future second floor addition.

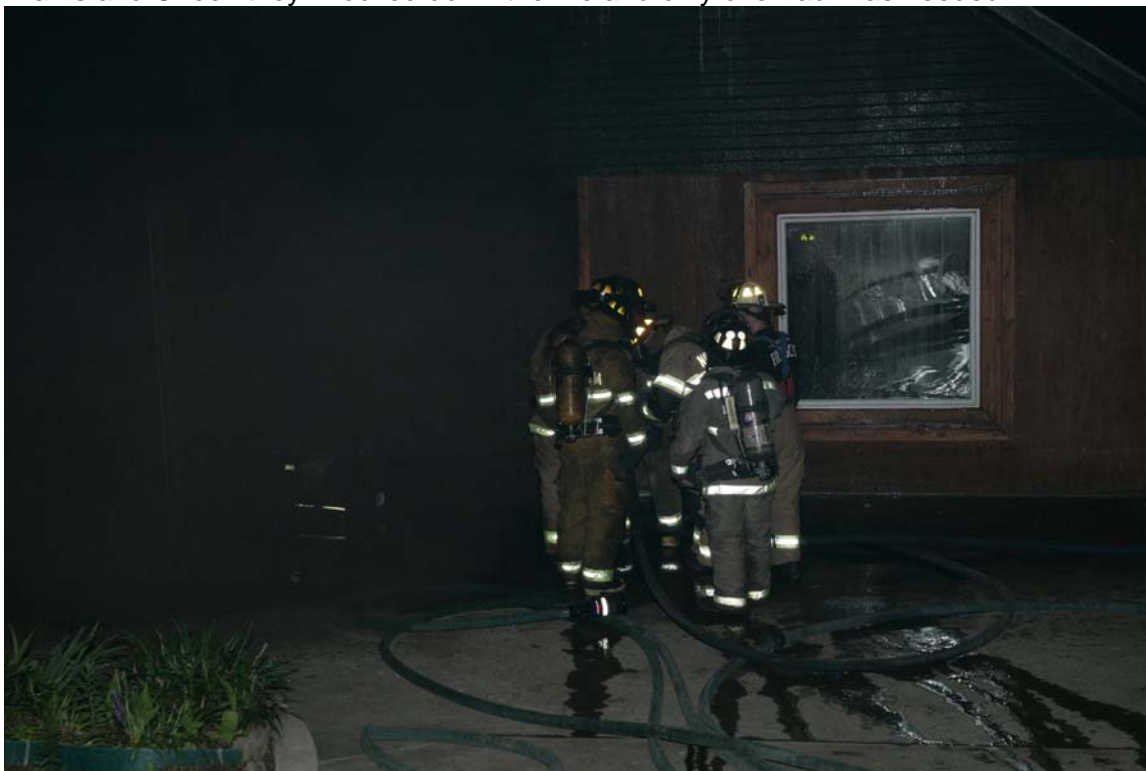
***At 02:10 Noonday FD Captain Williams and Firefighter Cheek are briefed before entering (Photo Courtesy of Bullard FD)***

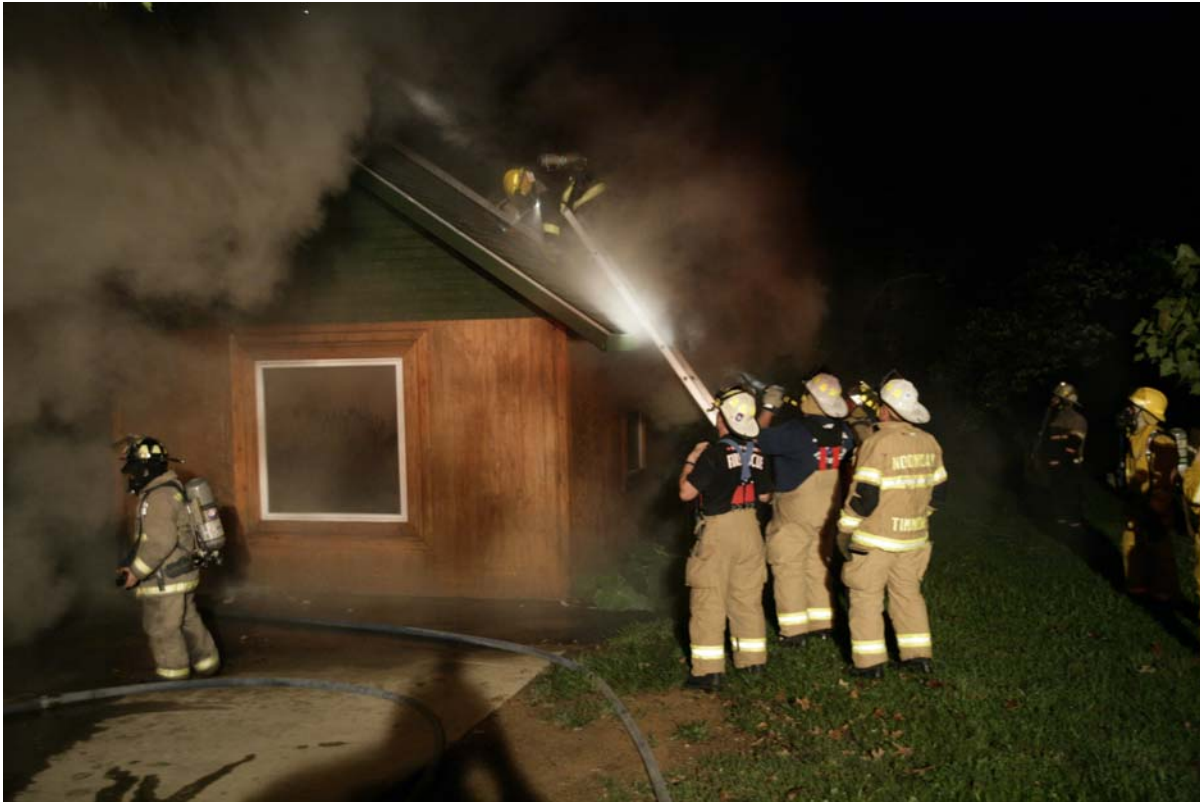
***At 02:19:41 the IC and other Chiefs are shown monitoring activities during roof ventilation, six minutes after entry by Williams and Cheek. (Photo courtesy of Bullard FD)***

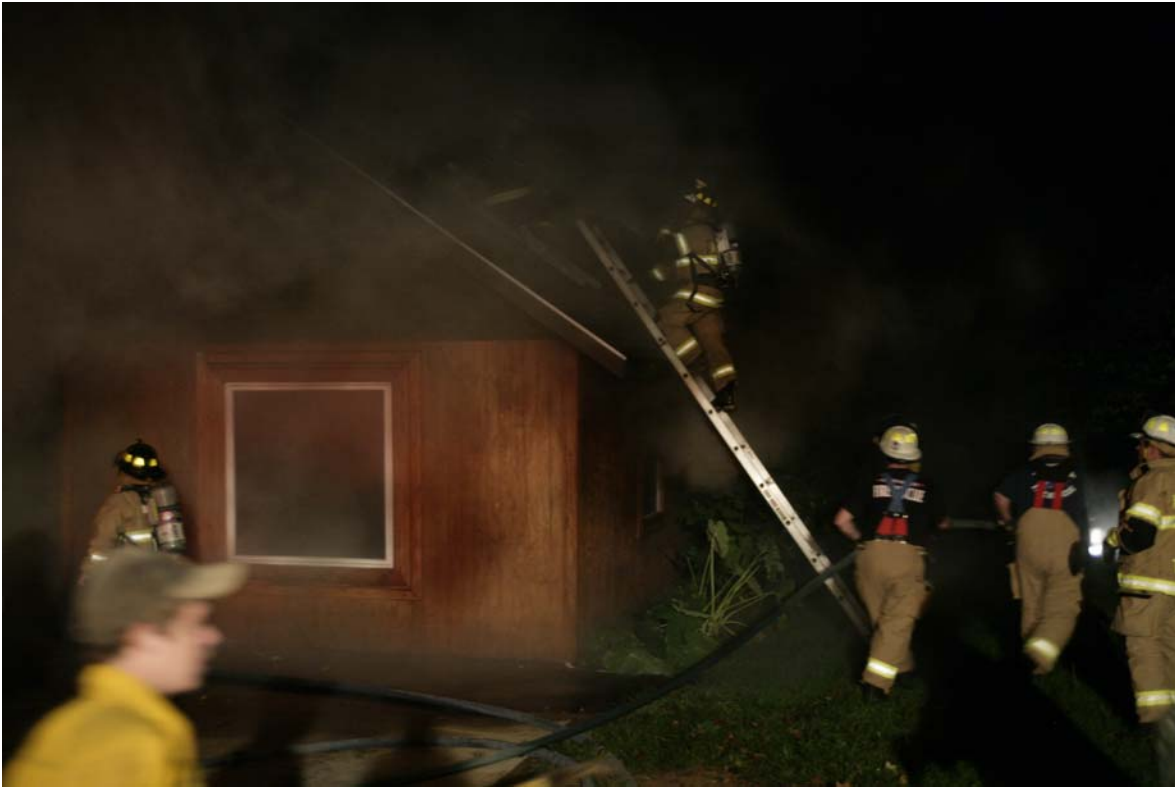
**At 02:20:31 Command and Asst. Chief Aarant pull the safety line to side “D” for the ventilation team. (Photo by Bullard FD)**

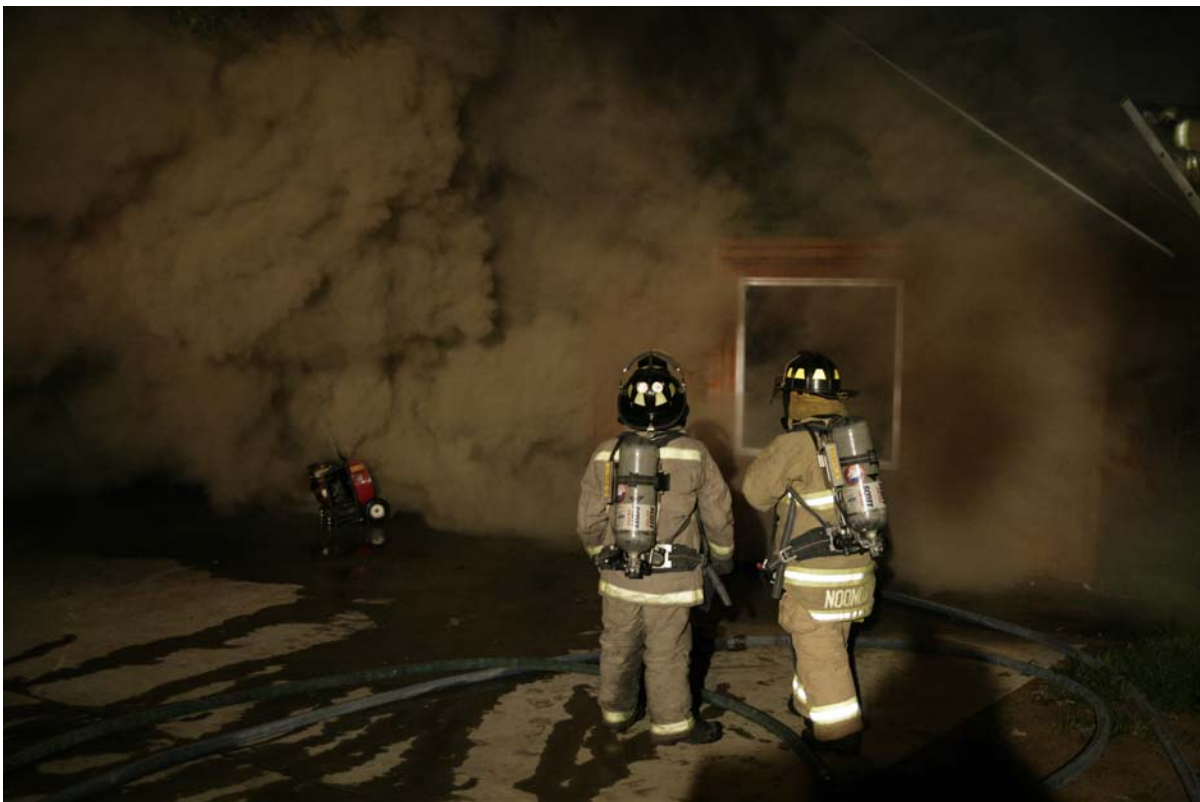
***This photo at 02:23 shows thick, black smoke exiting the front door under pressure. Williams and Cheek have been in for 11 minutes. (Photo courtesy of Bullard FD)***

| 02:23 | Smoke conditions change drastically, smoke now thick and black with sharp edges, PPV fan obscured |

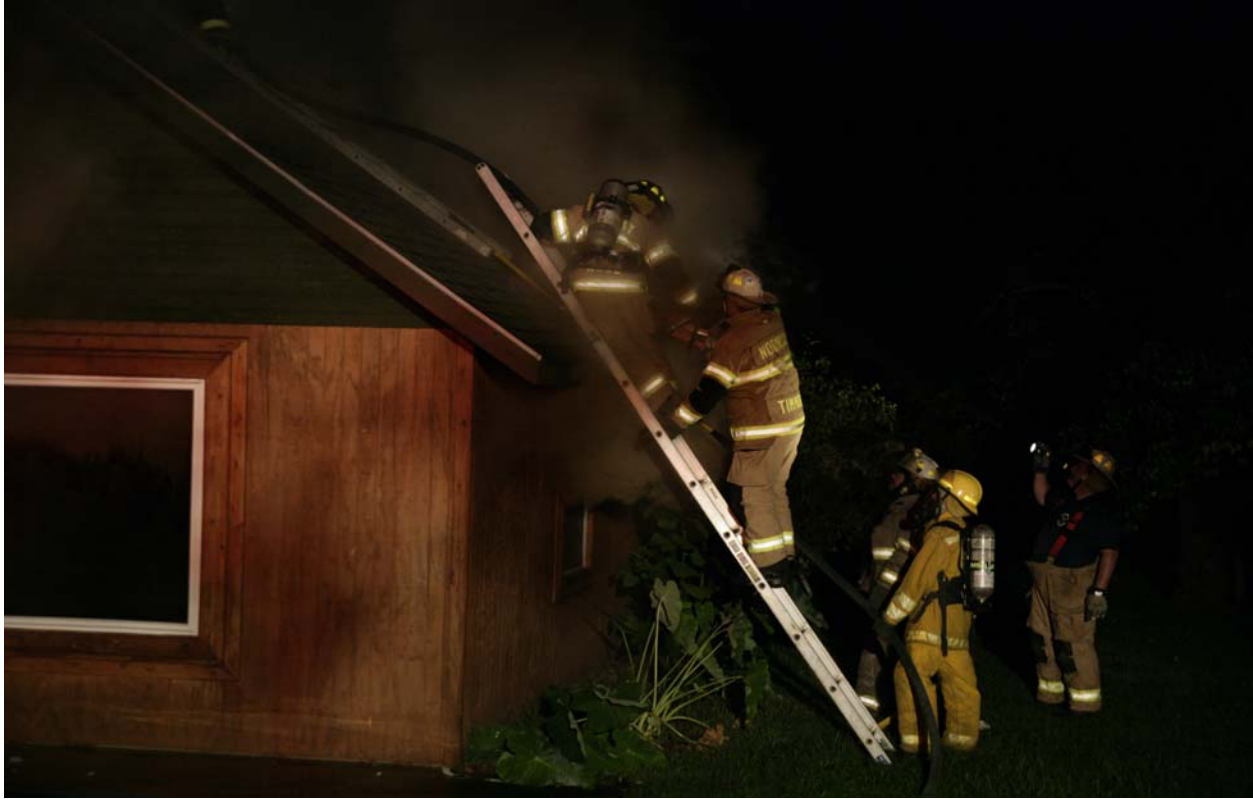
**At 02:26 the safety line is on the roof as a power saw is passed up the ladder.  
(Photo by Bullard FD)**

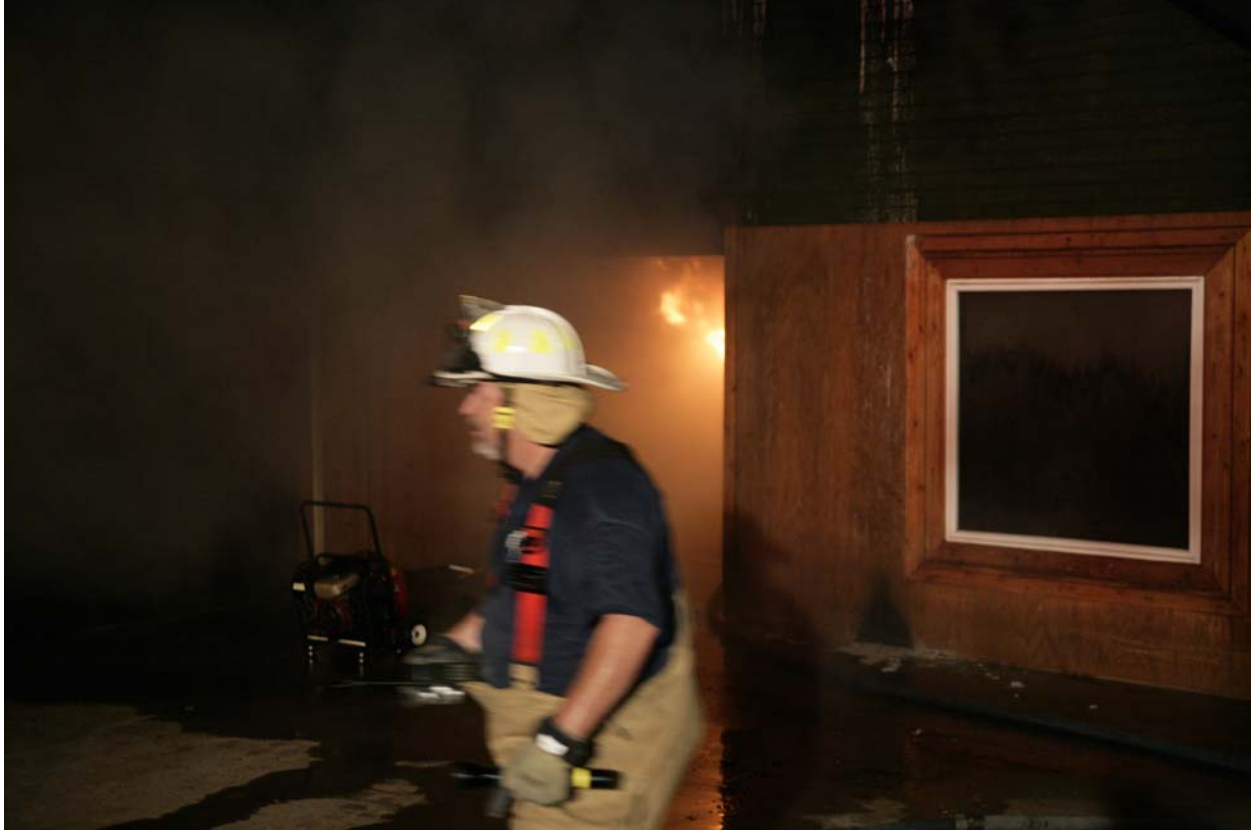
***At 02:30:10 flames are visible exiting front door just before operations went to rescue. Williams and Cheek have been in for 16 minutes. (Photo courtesy of Bullard FD)***

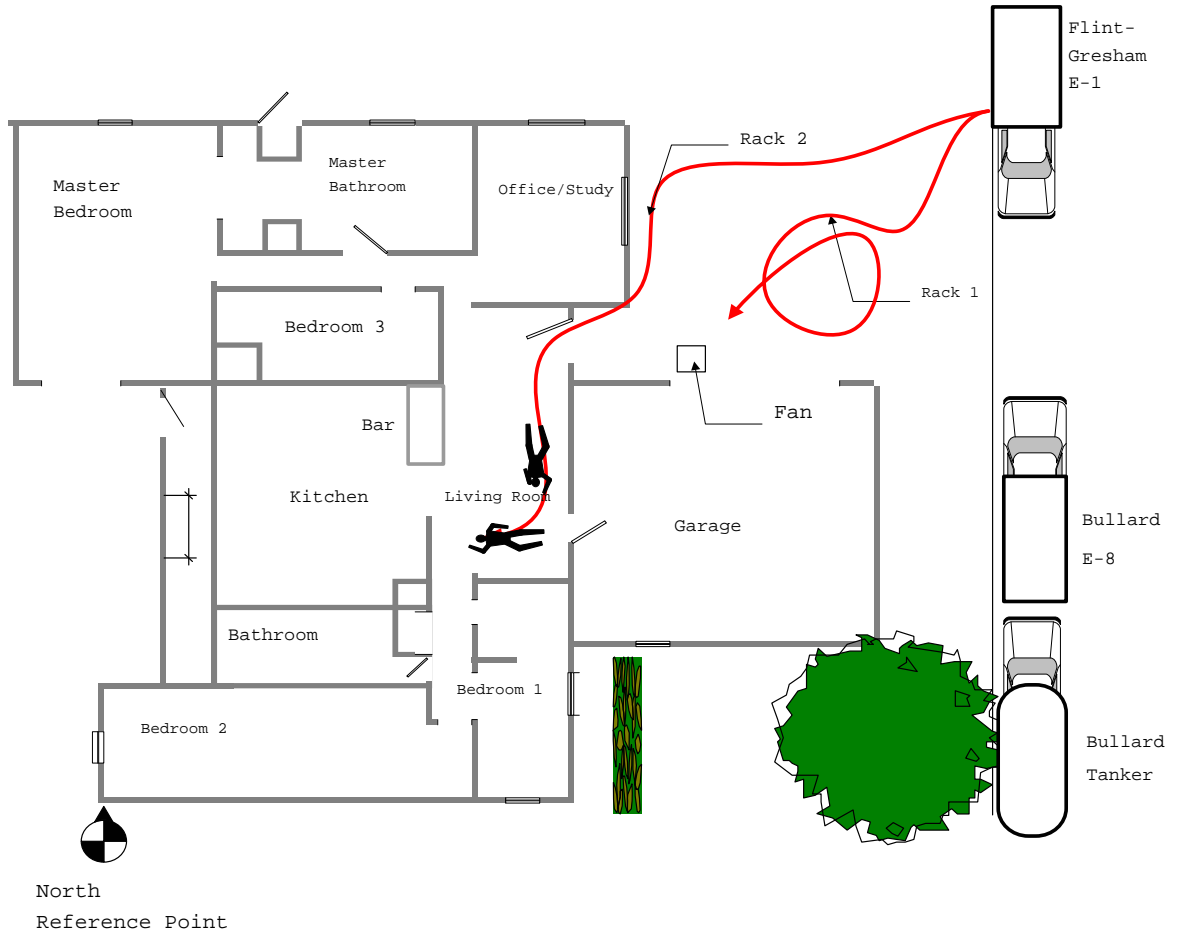
**Diagram 3**  
**Locations of Downed Firefighters**

After hearing the calls for assistance from Yates, Firefighter Stephens and Firefighter Thatcher found Cheek and removed him from the structure. Firefighter Cheek's gear was removed before he was taken to an ambulance and subsequently transported to East Texas Medical Center.

RIC 3, composed of Bullard Firefighter Justin Walker and Noonday Firefighter Travis Barnett, was formed and entered the structure. RIC 3 located Captain Williams and after several unsuccessful attempts to remove Captain Williams, the crew exited the structure and requested additional assistance. RIC 4, composed of Firefighters Victor Robles, Ben Bernard and Robert Koss was then assembled. Firefighters Robles and Koss entered the structure as Firefighter Barnard tried a secondary route through an interior garage passage door. Unable to open the door, Barnard returned to the front door and stood by. The removal of Captain Williams began when he was located by Firefighters Robles and Koss. At this time Incident Commander Baldauf and Firefighter Barnett breached the passage door in the garage and witnessed the removal of Captain Williams. CPR was performed by on-scene crews. Captain Williams was transferred to a second ambulance and subsequently transported to East Texas Medical Center.

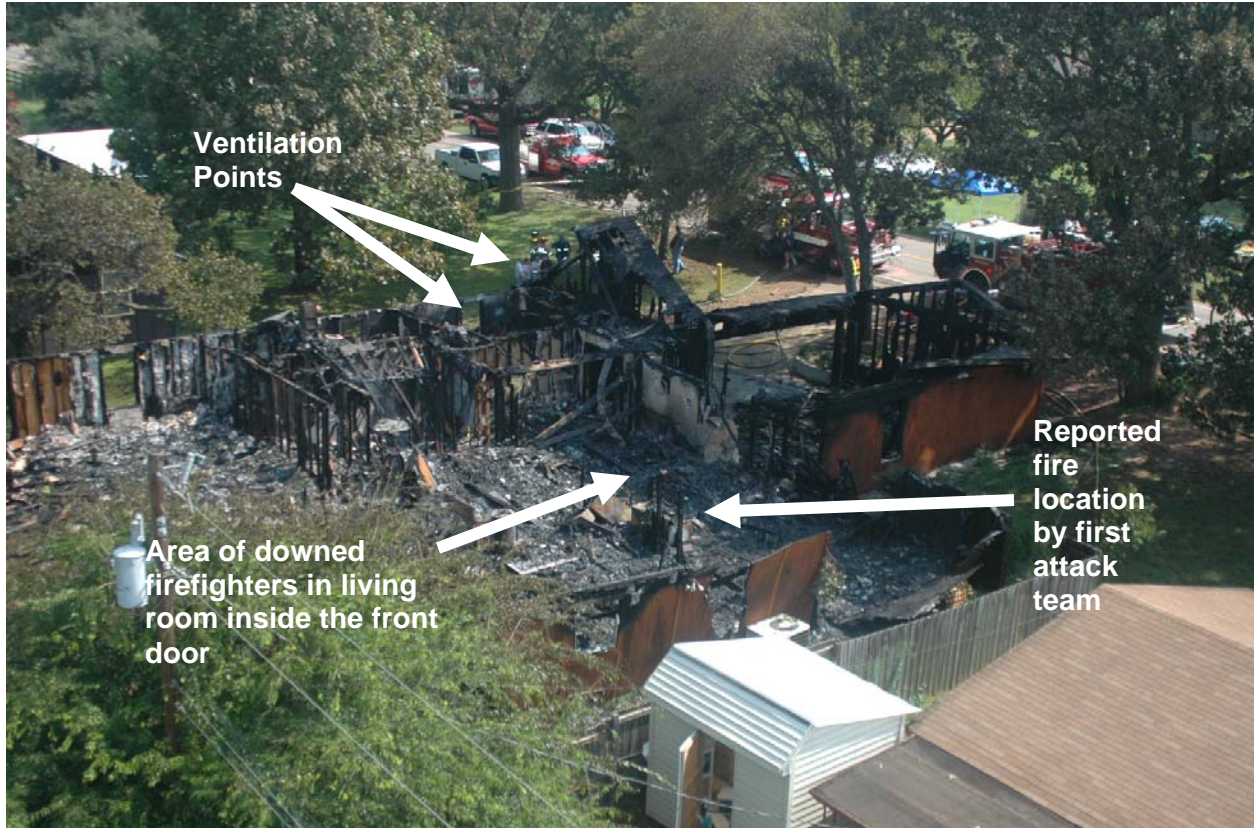
**View of the scene from the southwest  
(Photo by Smith County Fire Marshal)**

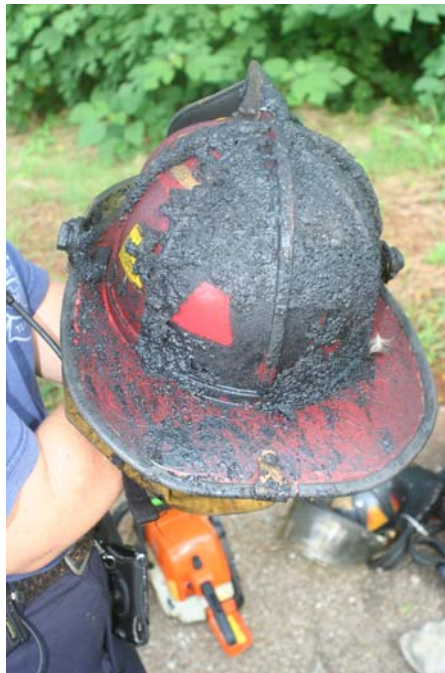
a) Captain Williams was wearing a Morning Pride brand helmet. His helmet had melted tar covering the rear half of the helmet, the crown, and the bill.

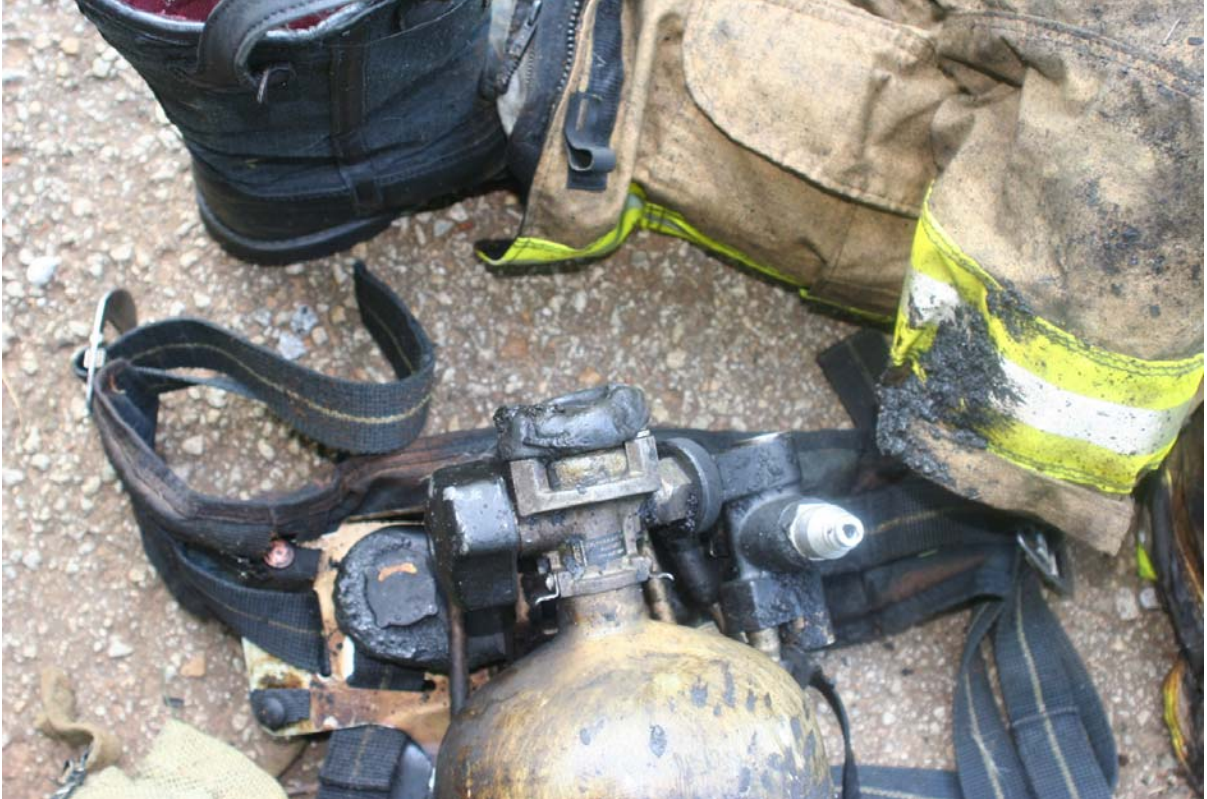
- a) The Luxor air cylinder serial number was unreadable due to the tar on its surface. The cylinder pressure gauge was too heat damaged to read.

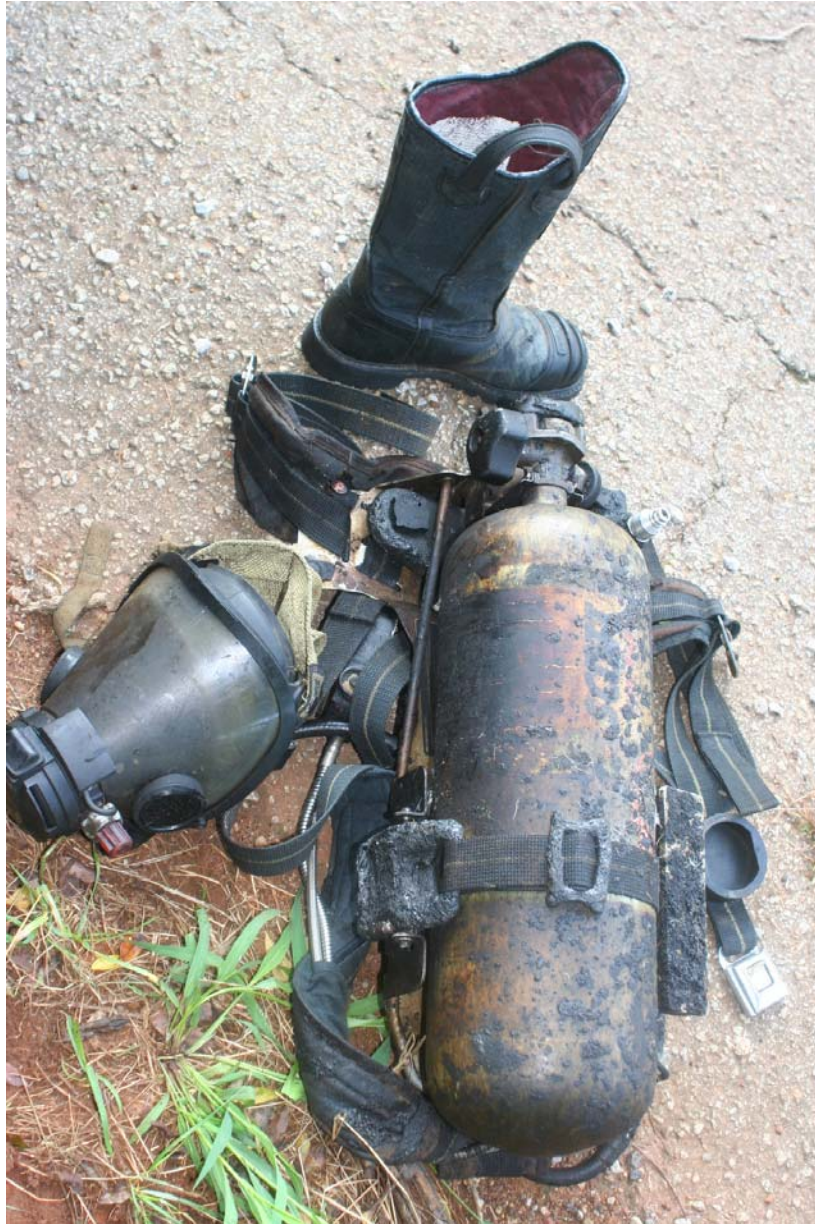
- b) The face piece was found to be intact and serviceable but had indications of heat and smoke exposure.
- c) All hoses and tubes had signs of heat and smoke exposure.
- d) The regulator had indications of heat and smoke exposure. The mainline valve position was reported as unknown, as was the bypass valve position. The regulator gauge was reading zero at the time of inspection.
- e) There were signs of heat and smoke exposure of the back frame and harness assembly, but not enough to affect performance.

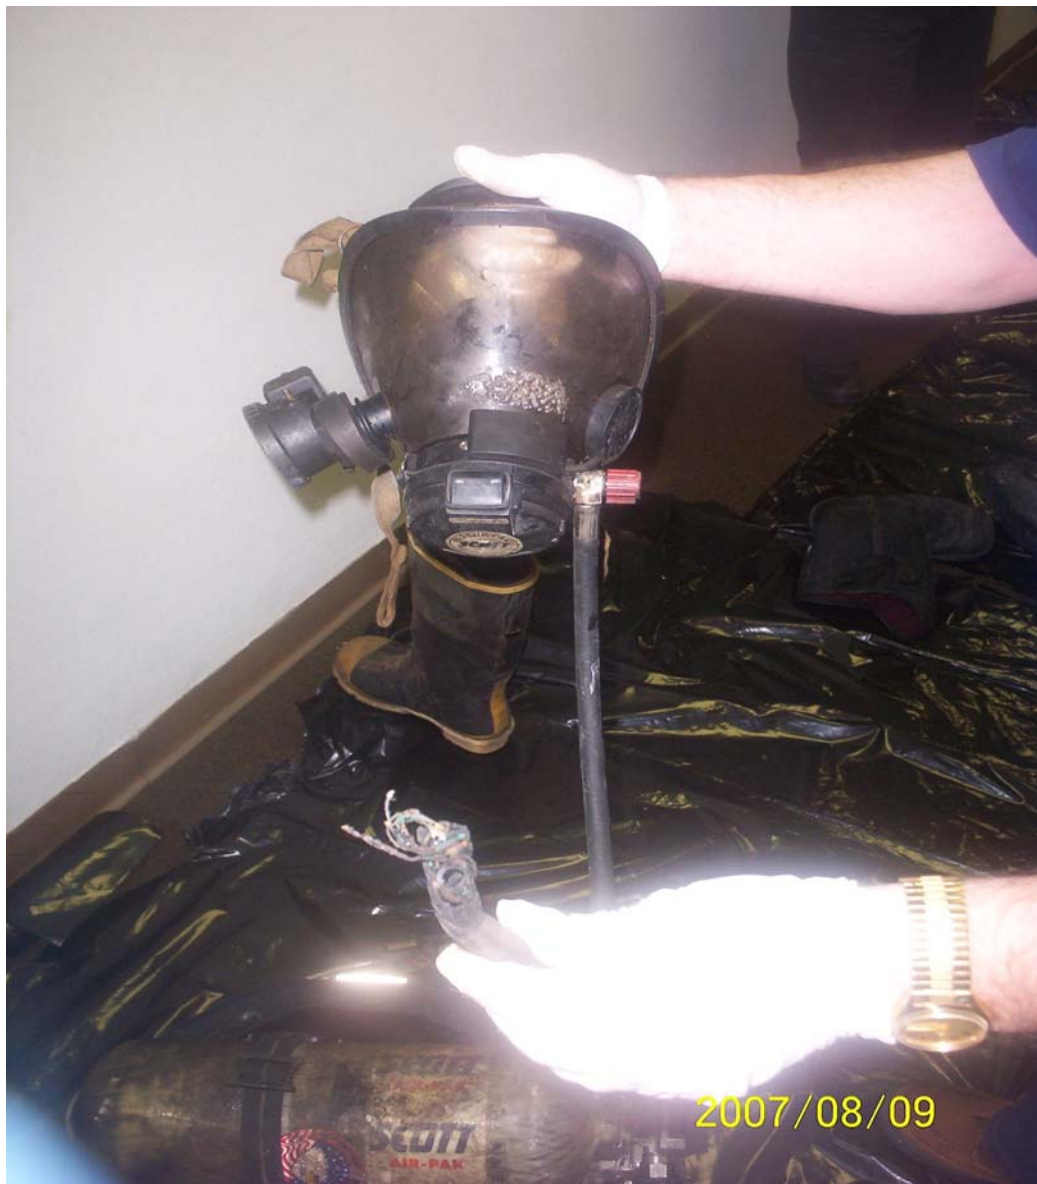
- a) The Luxor air cylinder with serial number E-10915-2216 exhibited signs of heat and smoke exposure. The cylinder pressure gauge was at zero.
- b) The face piece was found to have bubbling from exposure to heat.

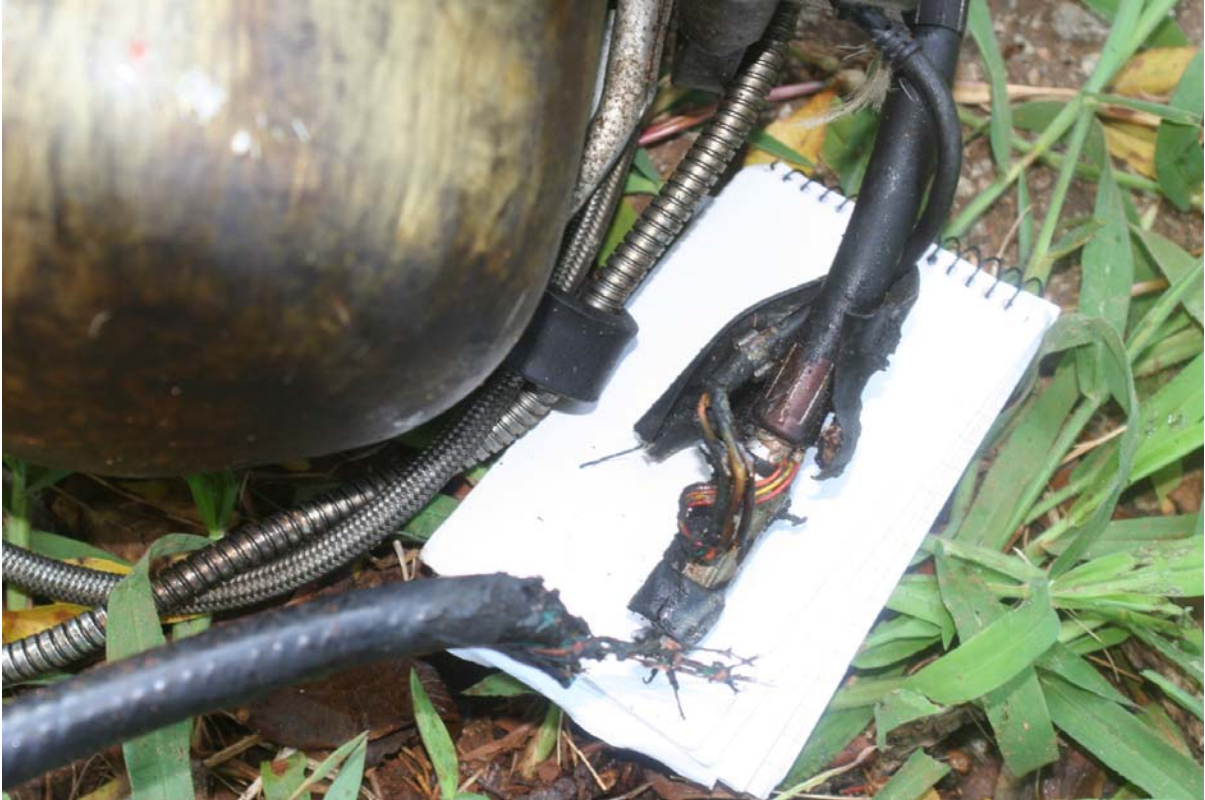
- c) The low pressure hose was severed approximately six inches from the harness connection.
