# CIRCUIT BREAKER

# MYTHS

Mark Goodson, PE  
Mark Hergenrether, MSME  
Aaron Stasonon

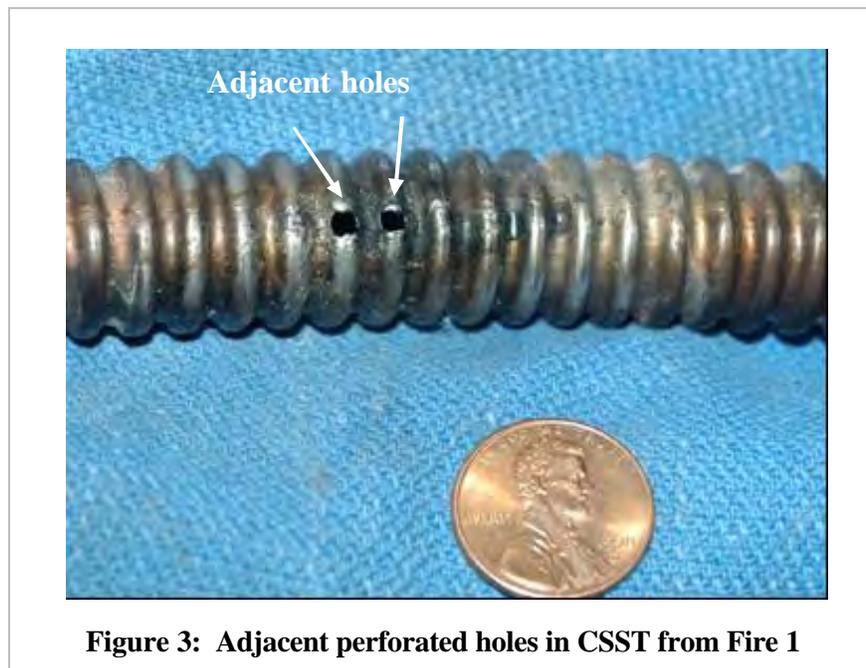
The fire occurred in the wood framed chimney space that had a metal chimney insert. CSST ran through the chimney space to feed the gas igniter. Four perforations were found in the CSST, ranging in size from a pinhole to a hole about 125 mils along its major axis. A STRIKE FAX lightning report showed that 4 hits within 0.1 mile of the house were recorded<sup>11</sup>. Figure 3 shows 2 adjacent holes that were created in the CSST.

**Figure 3: Adjacent perforated holes in CSST from Fire 1**

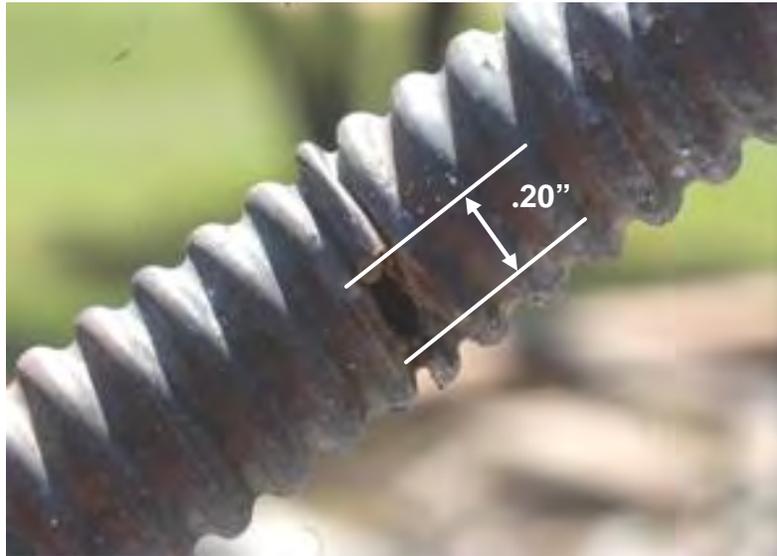
**Figure 4: Perforated CSST pipe from Fire 2**

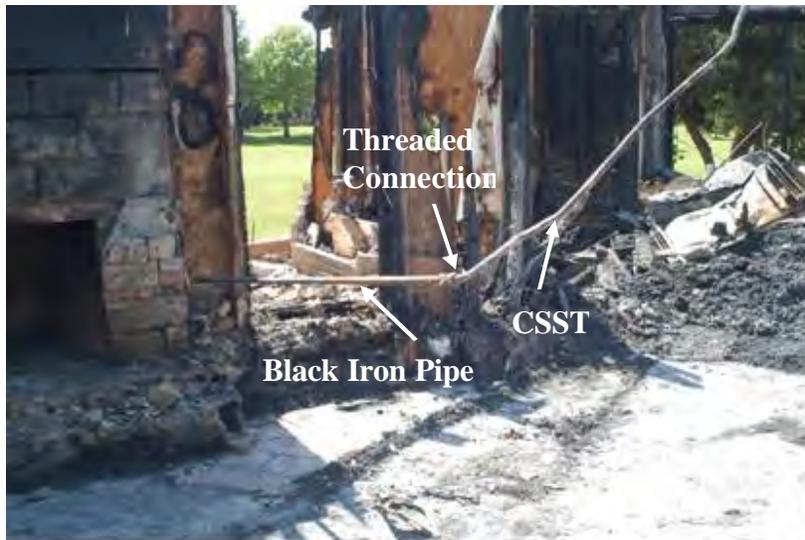
The fire occurred in an expensive house (construction not finished) with a value in excess of 6 figures. The house was a 2 story house, and plumbed with approximately 95% black pipe. Two runs of CSST, each serving a fireplace, comprised the CSST piping in the house. A perforation with its major axis measuring approximately 200 mils was found in one run of the CSST (Figure 4). An interview with a neighbor confirmed that the audible and visual components of the strike were sensed simultaneously. A positive lightning report was obtained, showing 11 strikes within 0.5 mile. Regrettably, the house was razed before the investigation was complete. Figure 5 shows the failed CSST run to the fireplace.

**Figure 5: CSST tied to Black Iron pipe from fireplace**

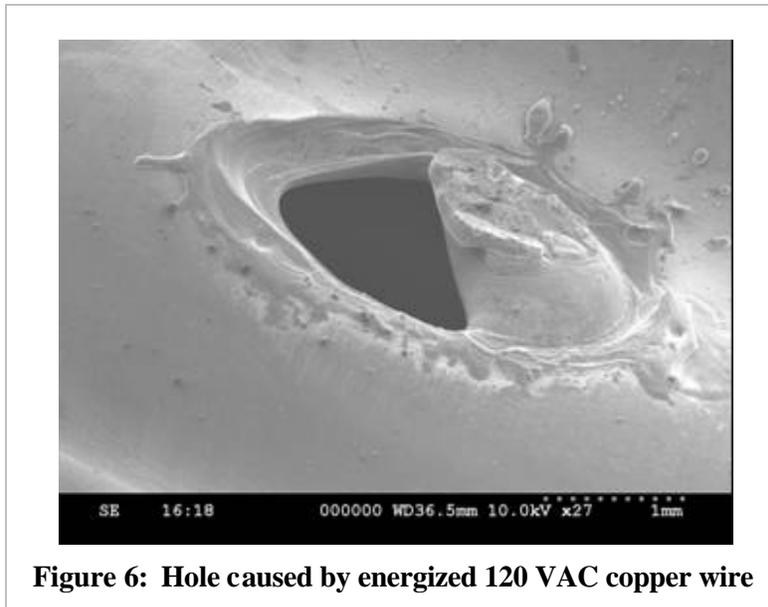
**Figure 6: Hole caused by energized 120 VAC copper wire**

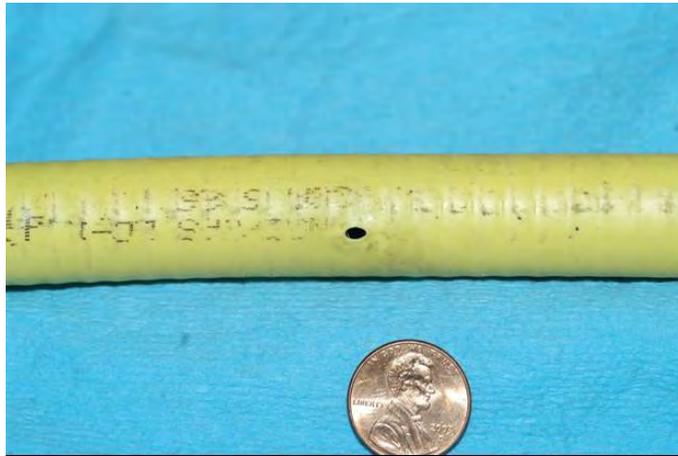
**Figure 7: Photo of perforated CSST without pyrolysis**

To find holes, we recommend an instrumented leak test at ~ 7" WC air. One end of the CSST should be plugged, and each hole sequentially plugged (modeling clay seems to work the best) until the CSST no longer leaks. One of the holes we found in CSST was in an area of tubing where the polymer coating had no pyrolysis (See Figure 7). Also, Figure 8 is a microscopic view of this small leak. As in any fire investigation, the leaks and subsequent flame development must support the area of origin, or the leaks would appear to be of little consequence.

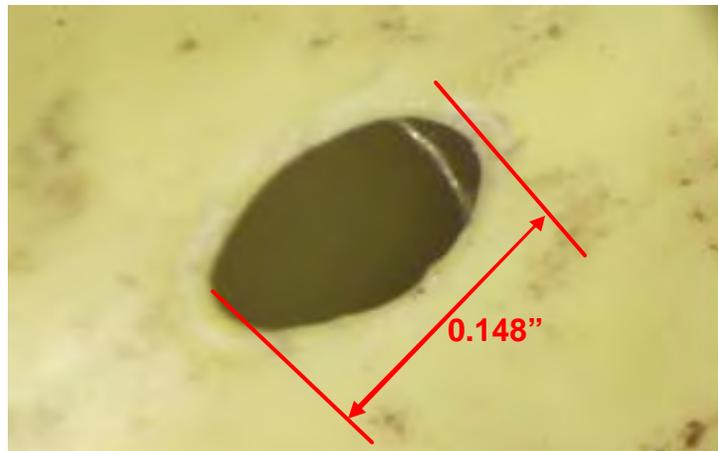
**Figure 8: Microscopic View of Perforated CSST**

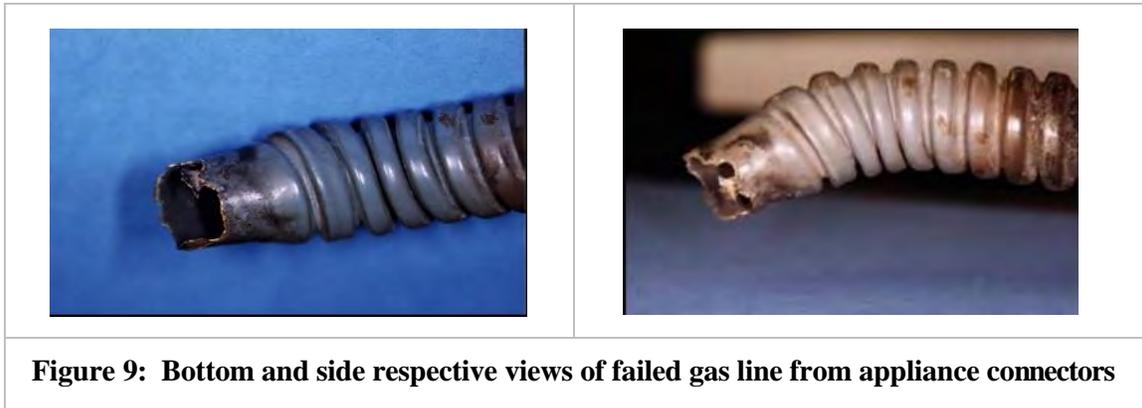
The Frisco Fire Department Report lists escaping gas from the end connectors during lightning events as also being possible sources of ignition<sup>26</sup>. In a previous article written by one of the authors (MEG), this very phenomenon was described on appliance connectors<sup>27</sup>. The fact that a gas line fails at a connection is no surprise, in that gas lines are chosen for mechanical integrity at their junctions, and not necessarily electrical conductivity. Figure 9 shows the end of a failed appliance connector that has arced and caused a fire due to electrical current flow. We might expect to see similar manifestations with CSST at its connectors.

**Figure 9: Bottom and side respective views of failed gas line from appliance connectors**

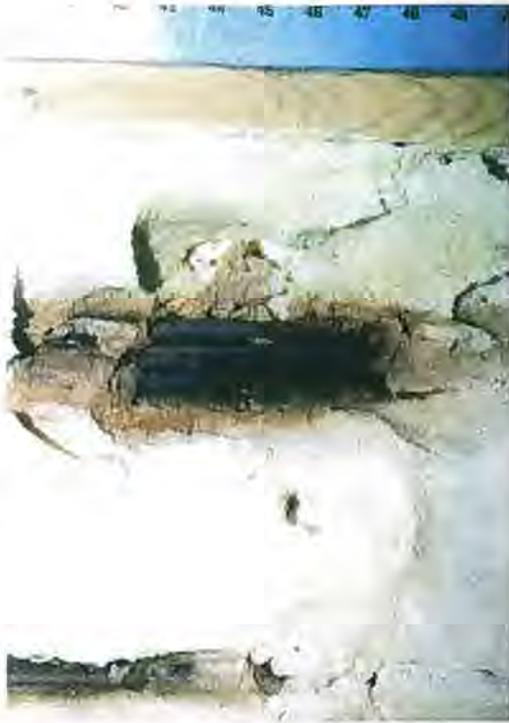
**PHOTO 2—**The 14 AWG test jig carried multiple runs at 120 percent level. After the 3rd and 4th runs, there was substantial charring of the insulation on the cable. When powered at 120 VAC, arcing immediately occurred on the damaged cable.

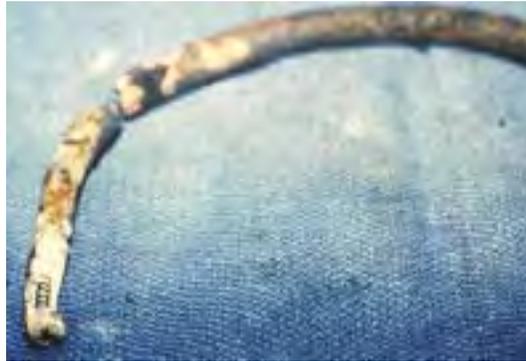
In regards to sheathed heating element failures (Calrod type failures), we should note that we have never seen a sheathed heating element fail (melt) from a fire—this includes heating elements from cooktops, ovens, commercial coffee makers, and hot tubs. Conversely, every instance in which we have found a failed sheathed heating element we have found a fire or thermal event. (Note: we are specifically excluding here failures caused by corrosion, such as in a water heater) The MgO has a melting point of 4100° F, the NiCr has a melting point of 2552° F, and the copper sheath a melting point of 1980° F. These MPs are high enough that most fires will never cause the heating element any harm—after all, the heating elements were intended for high temperature generation. Photo 4 shows a portion of a failed sheathed type element—note the arcing that is present. When these elements fail, a fire is brought about by the spewing of molten products onto combustibles.

Photo 4—Failed sheath heating element.

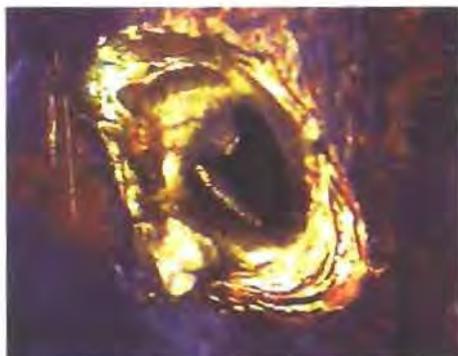
Photo 1. Microscopic view of what was originally believed to be a hacksaw mark.

A photomicrograph of the hacksaw mark is shown in Photo 1, while the flared end of the gas line to the water heater is shown in Photo 2. The hacksaw mark is actually a

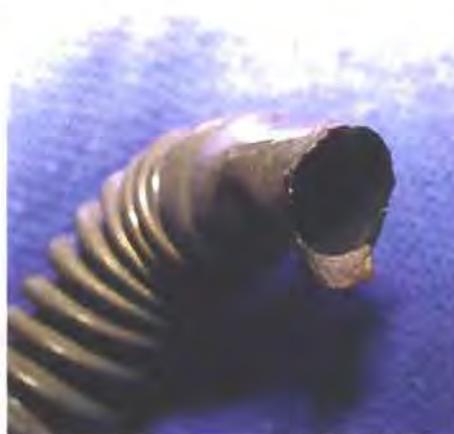
Photo 2. End of flexible gas line with most of the flare having melted due to electrical activity.

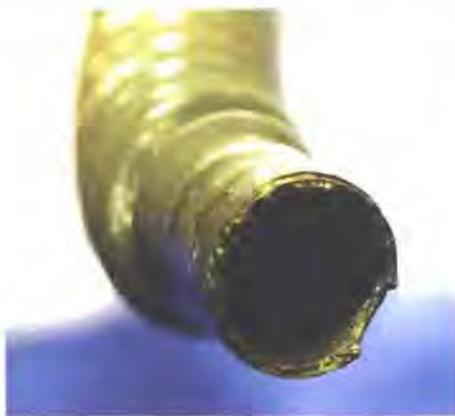
This fire occurred in a heater closet in a residence. The fire was thought to have possible occurred because of some type tampering with the gas lines. The fire originated at a leak in the gas line at the point where the flexible gas line attached to the furnace. Photo 3 shows the end of the flared gas line, it shows almost complete erosion of the flare.

Photo 3. End of gas line with flare being destroyed by electrical activity.

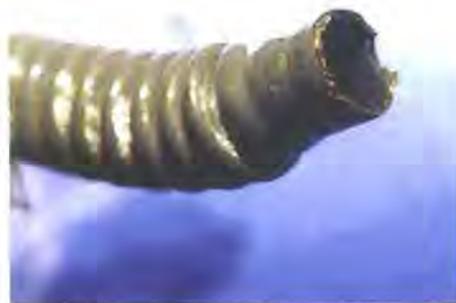
Examination of the meter base showed extensive melting of metal where one of the hot leads from the service drop had contacted it. This shorting and arcing was the cause of the fire at this location. The damage caused by the limbs had pulled the neutral off of the meter base, and the voltage now applied to the meter base by one of the hot leads energized the ground system in the residence. This ground system included the water heater and its gas line. The flex gas line and its flared end are shown in Photo 3; as before, the electrical erosion of the flared end is extensive. Examination of the house showed that it did not have a cold water ground or ground rod; thus, the gas line served as the grounding system.

Photo 4. Side view of gas line in Photo 3, with the polymer coating still relatively intact because of protection provided by the brass nut.

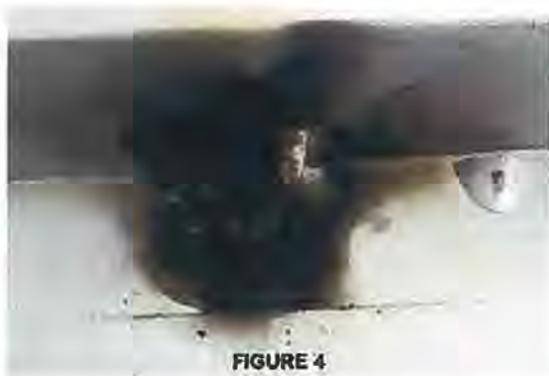
FIGURE 4

tinue for several minutes, and at other times the arcing would cease until the bulb was again misaligned. The most fearful set of circumstances was brought on when the arcing had ceased for several hours, and then would begin again without manual intervention. Examination of the lampholders showed that they had been severely degraded by the arcing process. Figures 4 and 5 show the resultant lampholders.

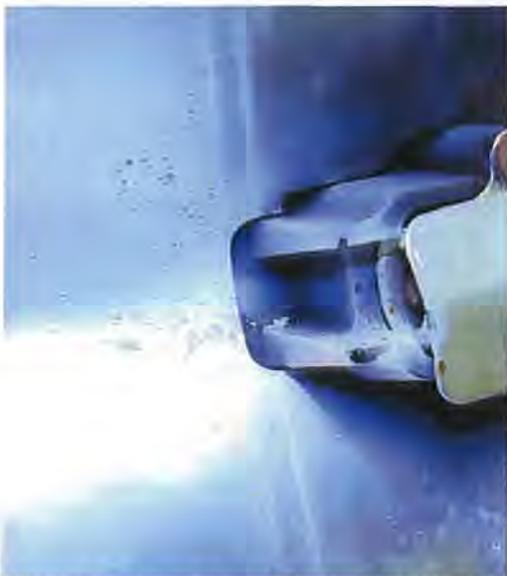
(PHOTO 4)—Shows a contact at the right end of a 300 watt fixture beginning to arc, spewing off molten copper.

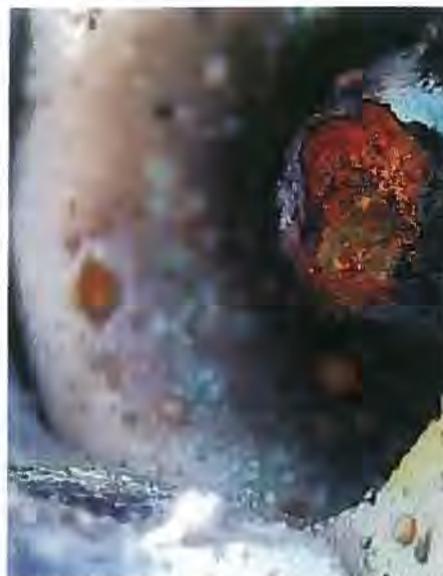
(PHOTO 5)—Microscopic view of the end of a contact of a 500 watt fixture showing arc by-products.

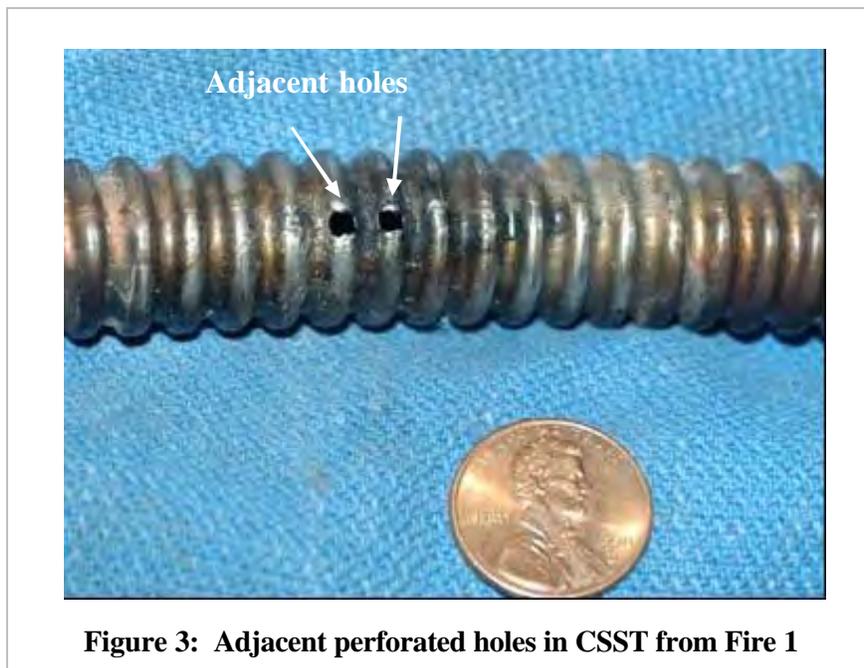
**Figure 3: Adjacent perforated holes in CSST from Fire 1**

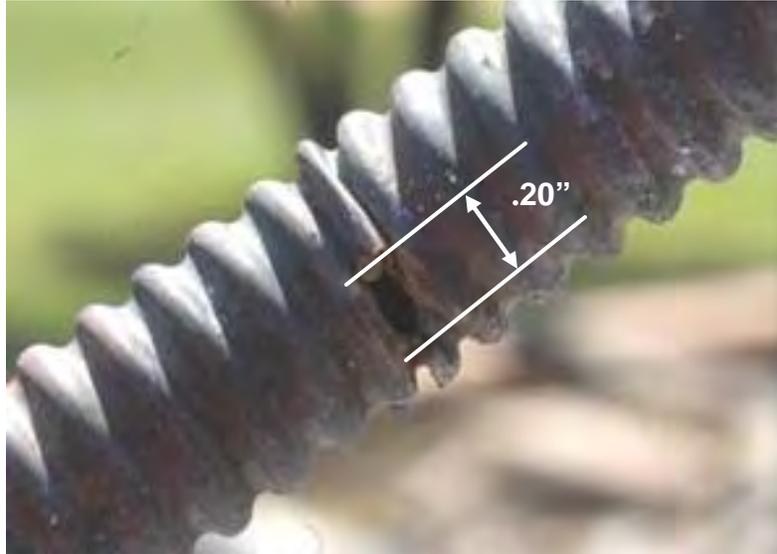
**Figure 4: Perforated CSST pipe from Fire 2**

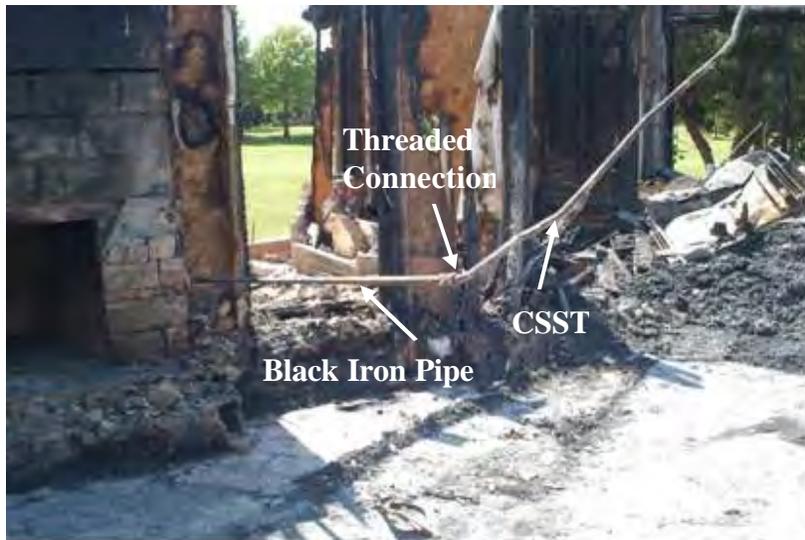
**Figure 5: CSST tied to Black Iron pipe from fireplace**

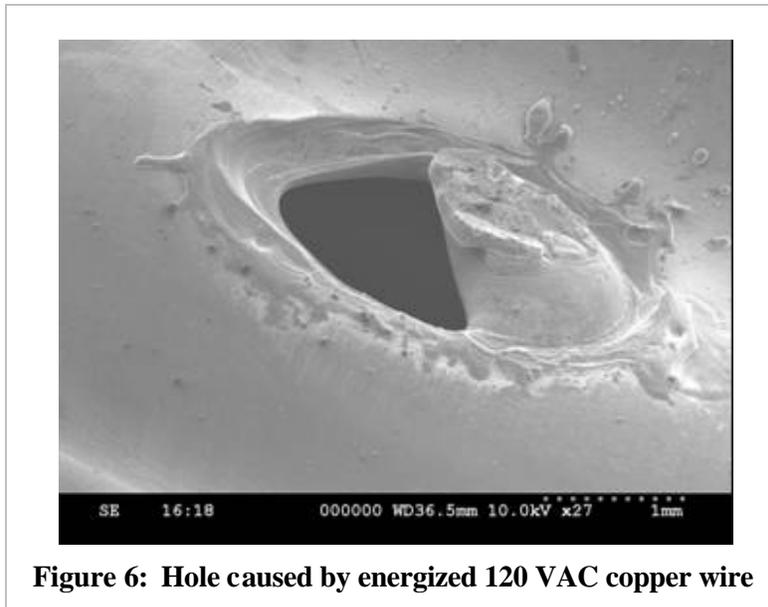
**Figure 6: Hole caused by energized 120 VAC copper wire**

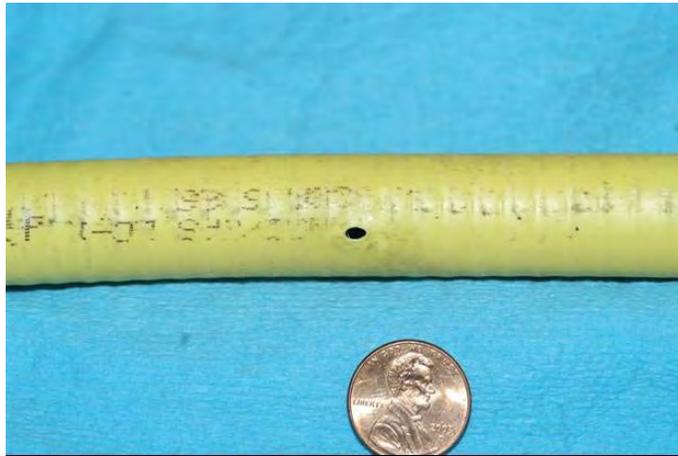
**Figure 7: Photo of perforated CSST without pyrolysis**

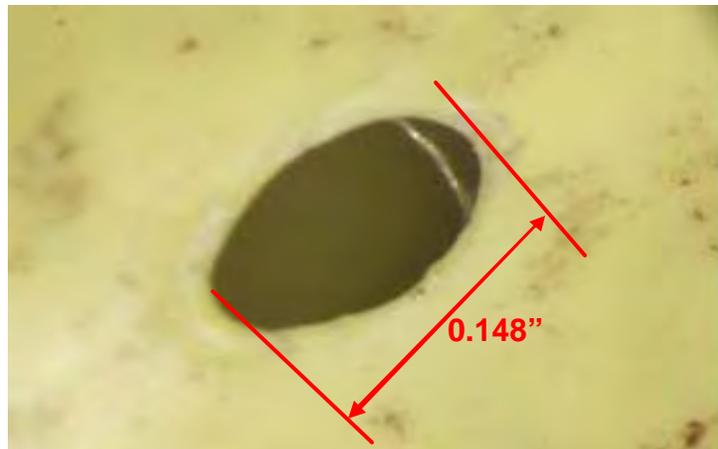
**Figure 8: Microscopic View of Perforated CSST**

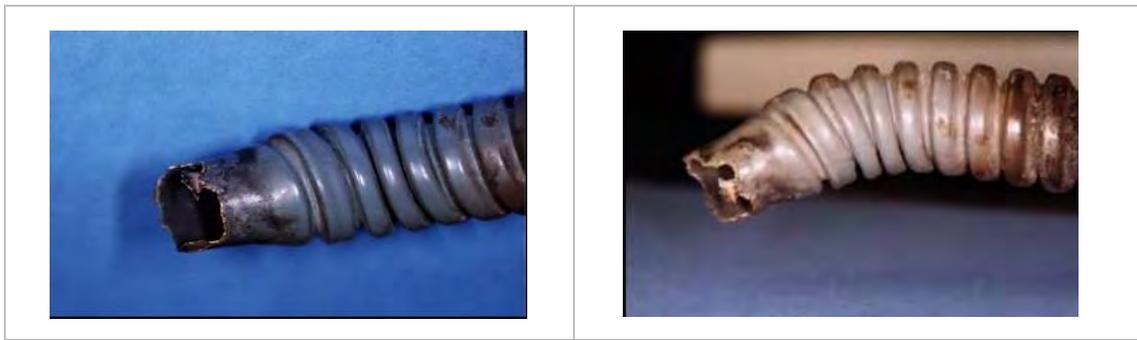
**Figure 9: Bottom and side respective views of failed gas line from appliance connectors**
