STATE FIRE MARSHAL'S OFFICE

Line of Duty Death Investigation

Investigation Number 02-50-10

Captain Jay Jahnke

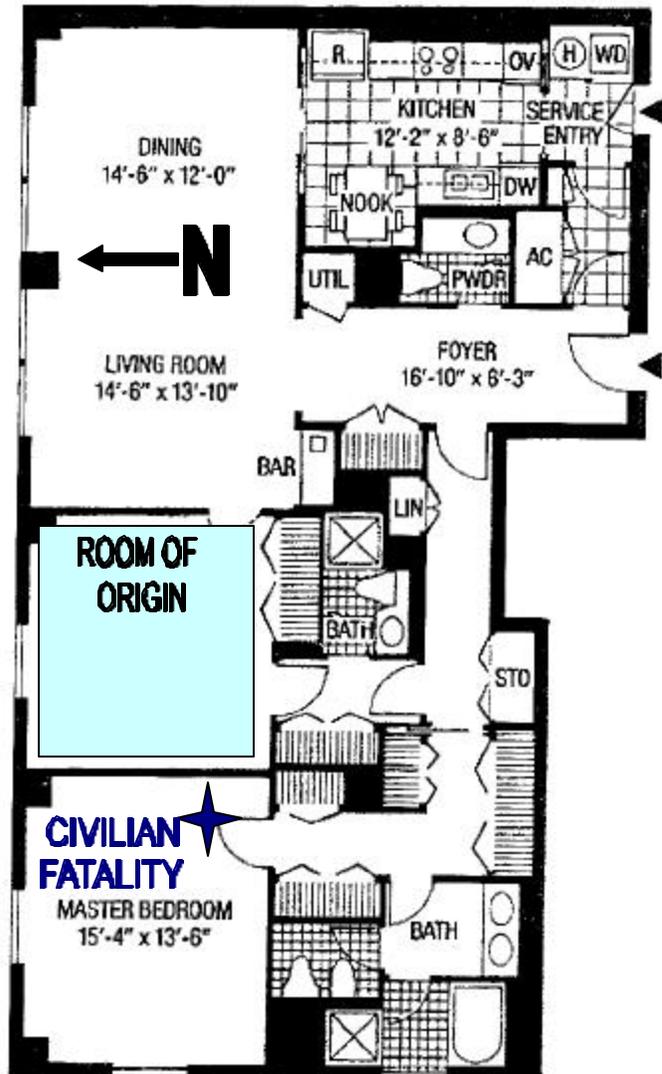
Figure 1-Unit 52

The HFD Arson Bureau had almost completed the scene excavation portion of their origin and cause investigation prior to the arrival of SFMO investigators. SFMO did not participate in the scene excavation or in the follow up phases of the investigation. HFD investigators determined the fire originated in a bedroom of Unit 52 used as a television and computer room. **(Figure 1)**

On April 2, 2002 the HFD Arson Bureau ruled the fire as accidental in origin, with the probable cause being carelessly discarded smoking materials ¹. The origin and cause report reported an ashtray was located near a sofa in the area of origin in the television room. Additional testing of electronic equipment in the room of origin may be conducted by an outside research firm at a later date.

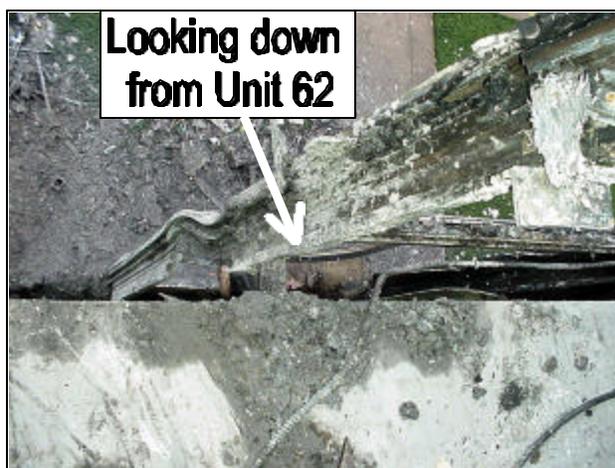
Figure 2-Northwest Corner of Building **Figure 3-Curtain Wall-Floor Slab Gap**

The fire and products of combustion began to spread vertically through openings between the concrete floor slabs and the glass curtain wall. In addition, some flame and smoke spread may have occurred through unsealed vertical floor openings between the fifth and sixth floor. The openings, which may have been made during initial construction, were located in the bathrooms, near heating and air conditioning units, and in other areas. The openings were exposed when the gypsum board ceilings of Unit 52 failed. **(Figure 9-unsealed vertical penetration from Unit 62 bathroom looking down into Unit 52 bathroom)** These unsealed penetrations were found in several areas of the building. Unsealed openings, in combination with the lack of sprinkler protection, can allow flames and products of combustion to spread rapidly, endangering residents above the fire.

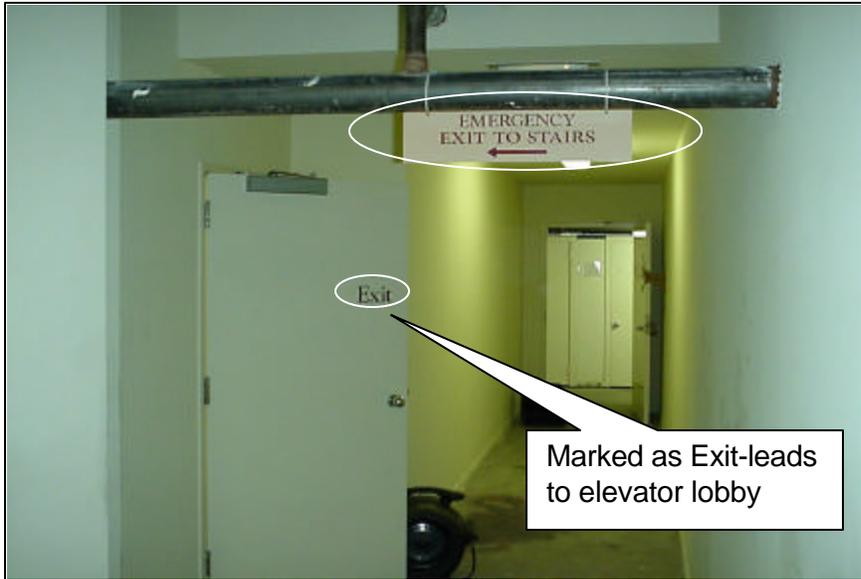
Users of Stair C must negotiate a winding path through an exit passageway to reach the exterior. The path begins at the end of stairway C on the second floor and travels through the second floor to reach the top of a straight run of stairs that discharges directly to the outside. This winding 100'+ path includes three 90-degree left turns and one 90-degree right turn combined with inadequate and confusing exit signage. (Figure 4)

Figure 4-Confusing and inadequate exit signage in Stair C exit pathway

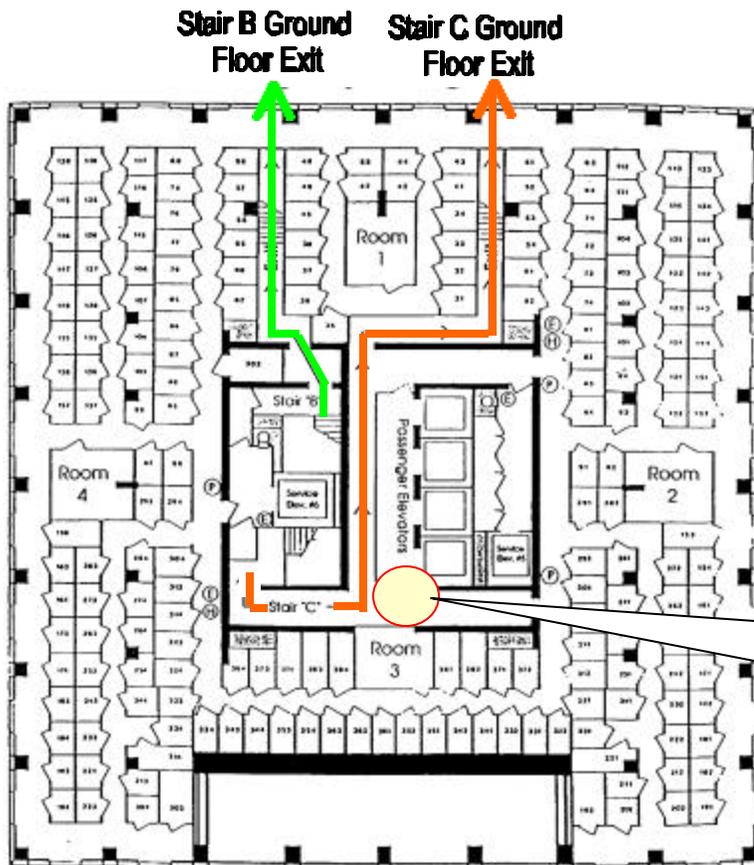
Figure 5-Second Floor Exit Routes

Both firefighters and residents reported confusion in traveling through this area, aggravated by smoke^{2,3,4}. (Figure 5)

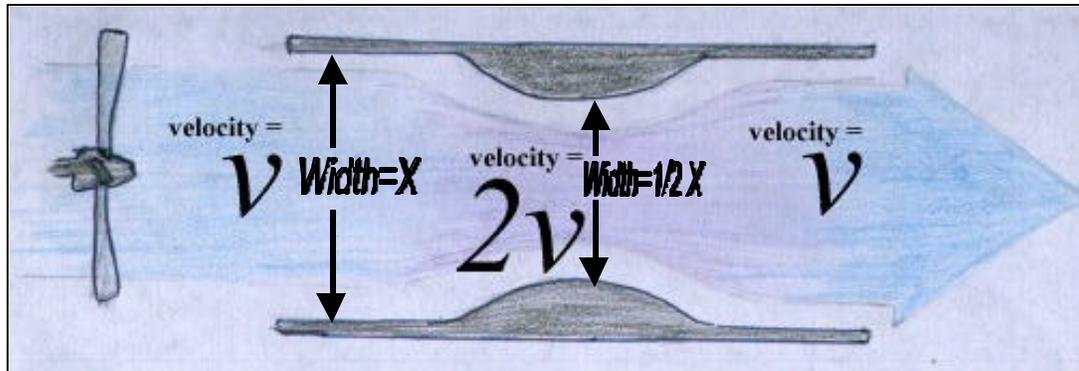
Figure 6-Illustration of Venturi Effect

This intensification in heat may be due in part to the Venturi Effect. The gusty north winds entering the large opening created by the broken north and west windows would tend to accelerate as the air currents passed through the significantly smaller door opening into the corridor. The rate of wind acceleration is inversely proportional when comparing the speed of the wind passing through the large open windows to the speed of the wind passing through the small doorway opening. **(Figure 6)**

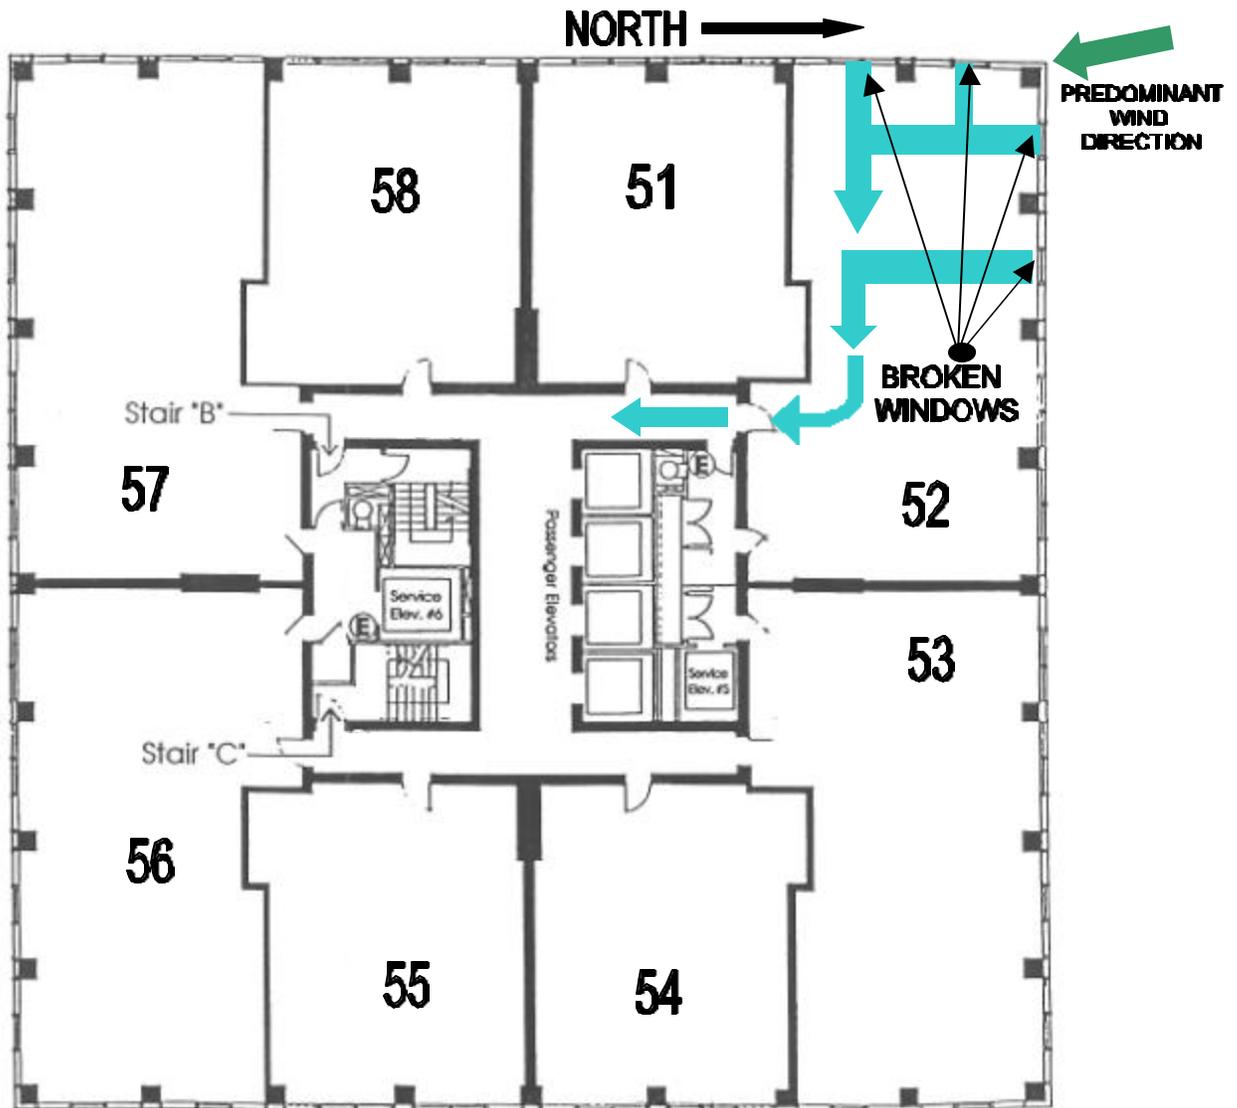
Figure 7-Wind driven air currents in Unit 52 and corridor

For example: Under laboratory conditions, a 30 mph wind passing through a 60 square foot opening into a confined area would tend to accelerate to 90 mph when passing through a 20 square foot opening at the other end of the confined area (30/60 → 90/20.) As the air moving through the doorway of Unit 52 into the corridor increased in velocity, the air at the doorway would decrease in pressure, causing even more heat, smoke, and fire gases to be pulled from the interior of the condominium and expelled into the corridor. **(Figure 7)**

The Venturi Effect may be partially responsible for the amount of smoke that quickly filled the main corridors of the fifth floor and entered the B stairway, overcoming the protection provided by the vestibule exhaust and stairway pressurization fans. News video footage shows pressurized smoke venting from the stairway exit at grade level ¹². Firefighters and residents reported they experienced near zero visibility inside stairway B.

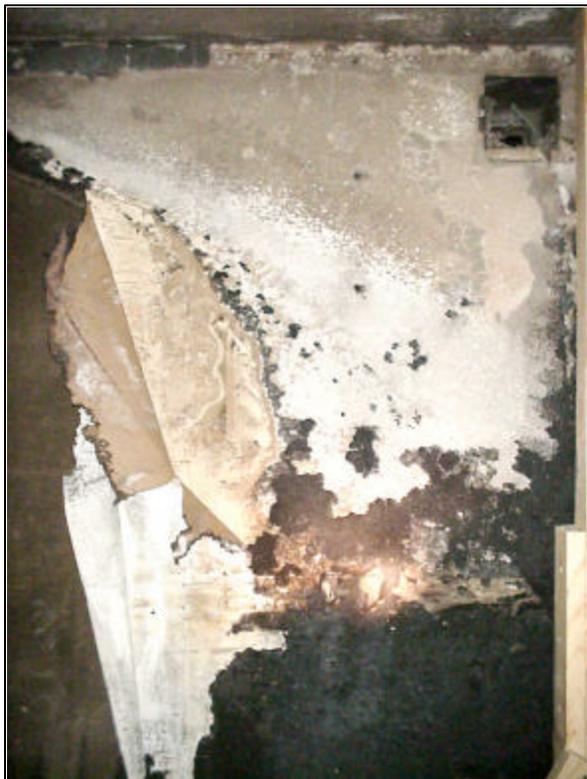
Figure 8

When the initial attack group withdrew from Unit 52, they left their hose line in place in the entry foyer¹⁴. This prevented the self-closing solid core door from closing, allowing flames and smoke to enter the corridor. A fire sprinkler head in the corridor, located approximately 88 inches from the door to Unit 52, fused and prevented any further flame damage in the corridor. There is a clear line of demarcation in damage to the vinyl wall covering in areas wetted by the sprinkler spray as compared to non-wetted areas. **(Figure 8)**

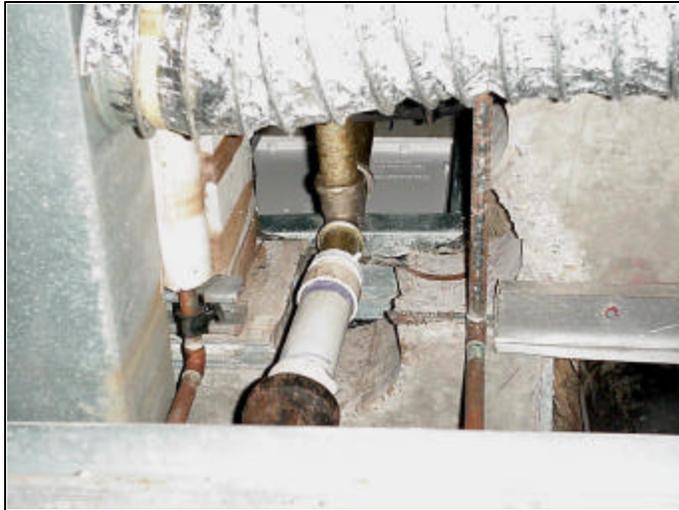
Figure 10

Unsealed vertical penetrations were observed in other condominiums, indicating that this was a common practice when the building was constructed. **(Figure 10-looking up into ceiling/floor penetration)**

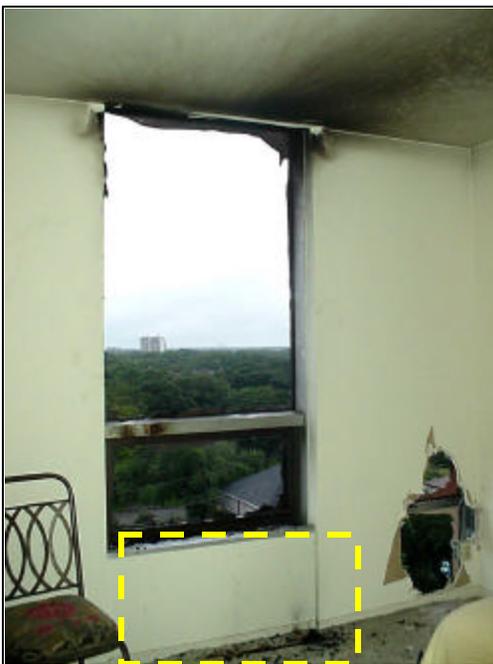
Figure 11

As fire and smoke spread vertically from Unit 52, contents of Unit 62 ignited, resulting in heavy damage to that unit. Flames continued to spread vertically and began to enter Unit 72, resulting in broken windows and scorching of carpet in areas where the curtain wall-floor slab gap was sealed with lightweight materials. **(Figures 11 and 12)** The vertical spread of fire was stopped at this level by both a master hose stream from an aerial platform and the use of a standpipe cabinet hose by firefighters checking for extension from the sixth floor.

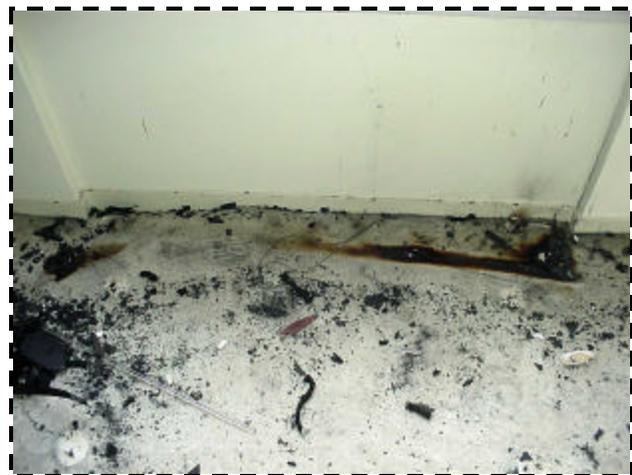
Figure 12-close-up of scorched carpet in dashed area from Figure 11

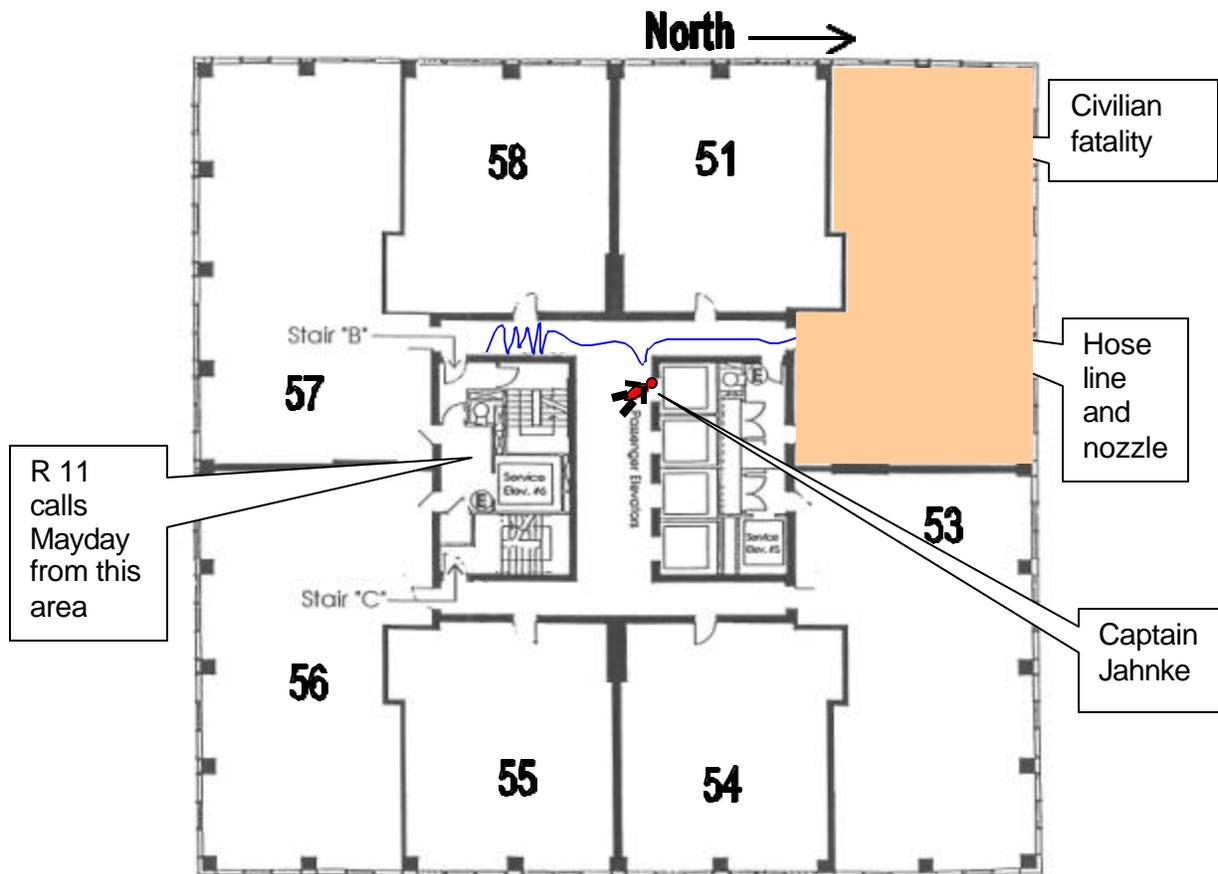
Figure 13-Fifth floor layout. Locations of civilian victim, Captain Jahnke, and fire hoseline are approximate and based on firefighter interviews.

Approximately 5:30 AM, Jahnke was located by the rescue team of Mathison, Kahney, and Parry in the elevator lobby, halfway between Unit 52 and the exit stair door. He was approximately 25 feet from the B stair vestibule door and 50 feet from the C stair door. (Figures 13 and 14)

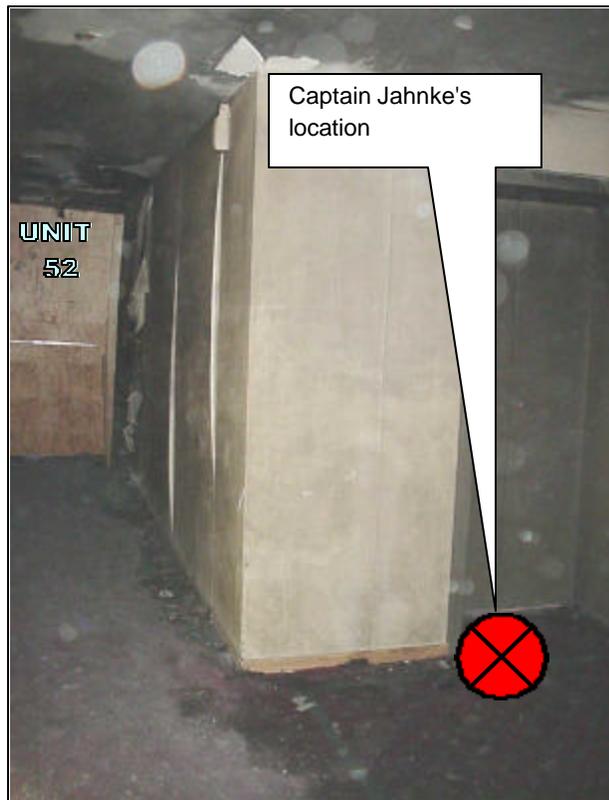
Figure 14-Approximate location where Captain Jahnke was found.

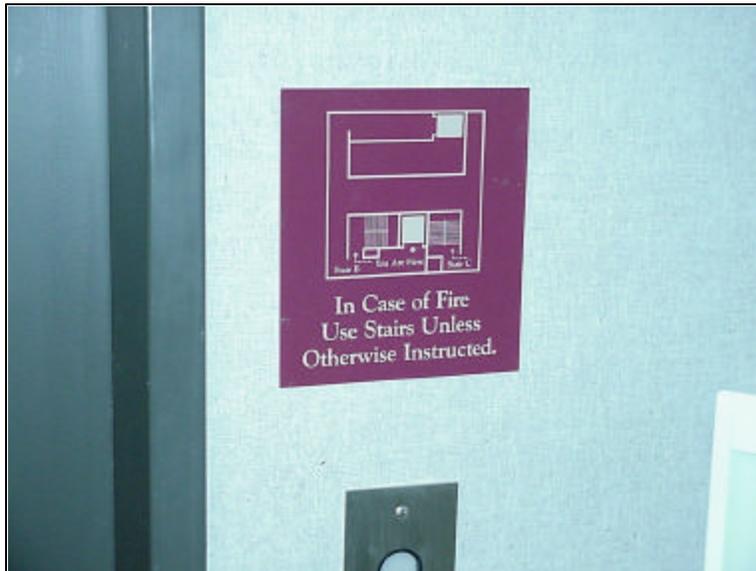
Figure 15-Floor plan sign located in all south service elevator lobbies.

AT 05:35:41 HFD Dispatch tried to call R11 on channels A2 and A4 and received no response. As he searched for the exit, Kahney found a building floor plan adjacent to the service elevator **(Figure 15)** and used it to reorient himself and he then led Mockler to the door from the service lobby to the vestibule. Kahney recalled that there was a large group of firefighters in the vestibule area and that he and Mocker were pushed into the stairway. Kahney and Mocker made their way to the outside of the building without assistance.
