TEXAS STATE FIRE MARSHAL'S OFFICE

Firefighter Fatality Investigation

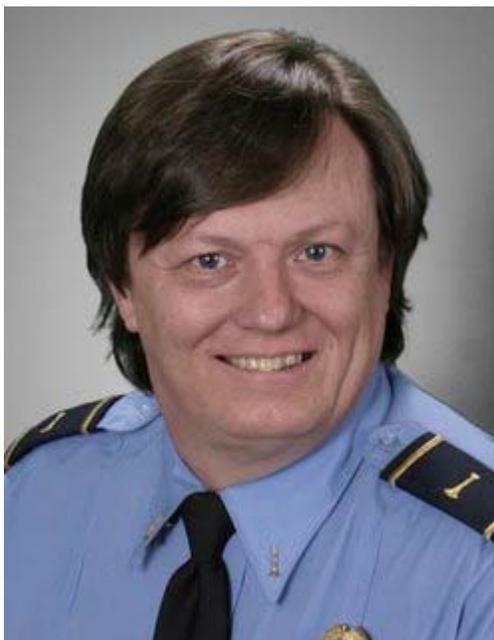
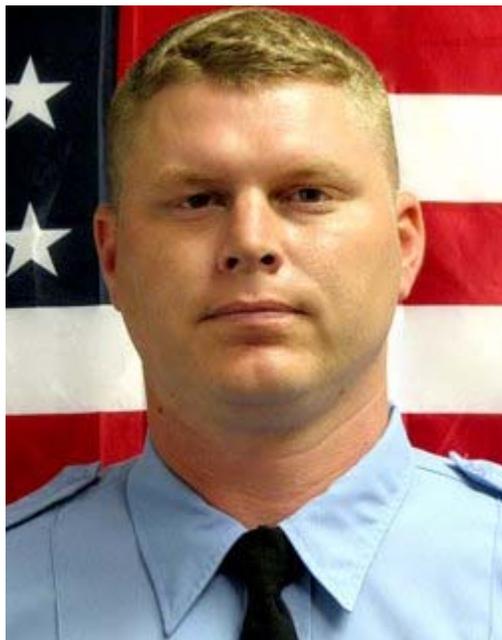
Captain Harlow, a 50-year-old, 30-year veteran of the Houston Fire Department, made Captain in 2004. He is survived by his wife, daughter, two sons, four grandchildren, and his parents. Firefighter Hobbs, a 29-year-old rookie firefighter and 10-year military veteran, was responding to his first house fire. He is survived by his parents, three sisters, two step-sisters, and a step-brother.

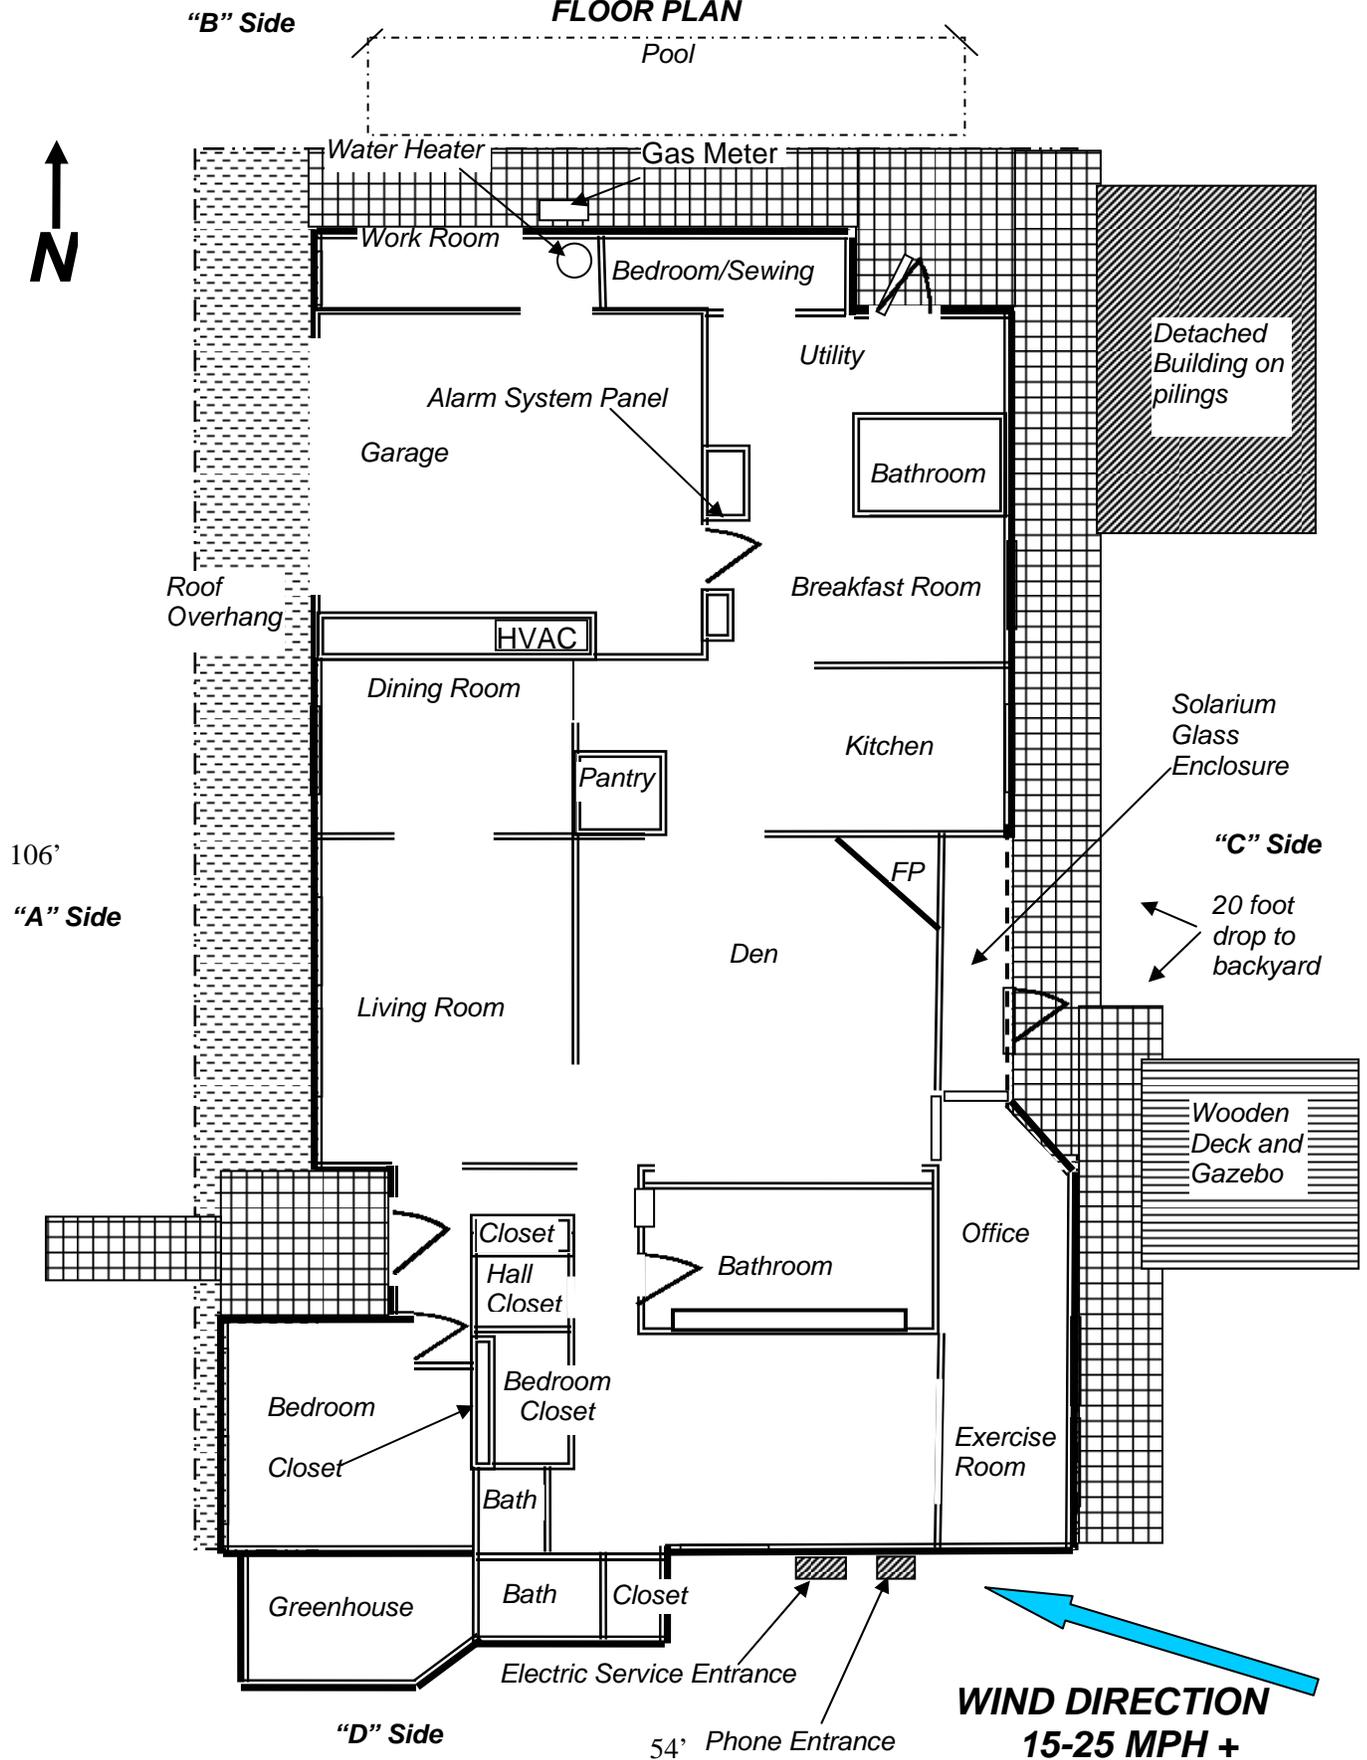
**Diagram 1
FLOOR PLAN**

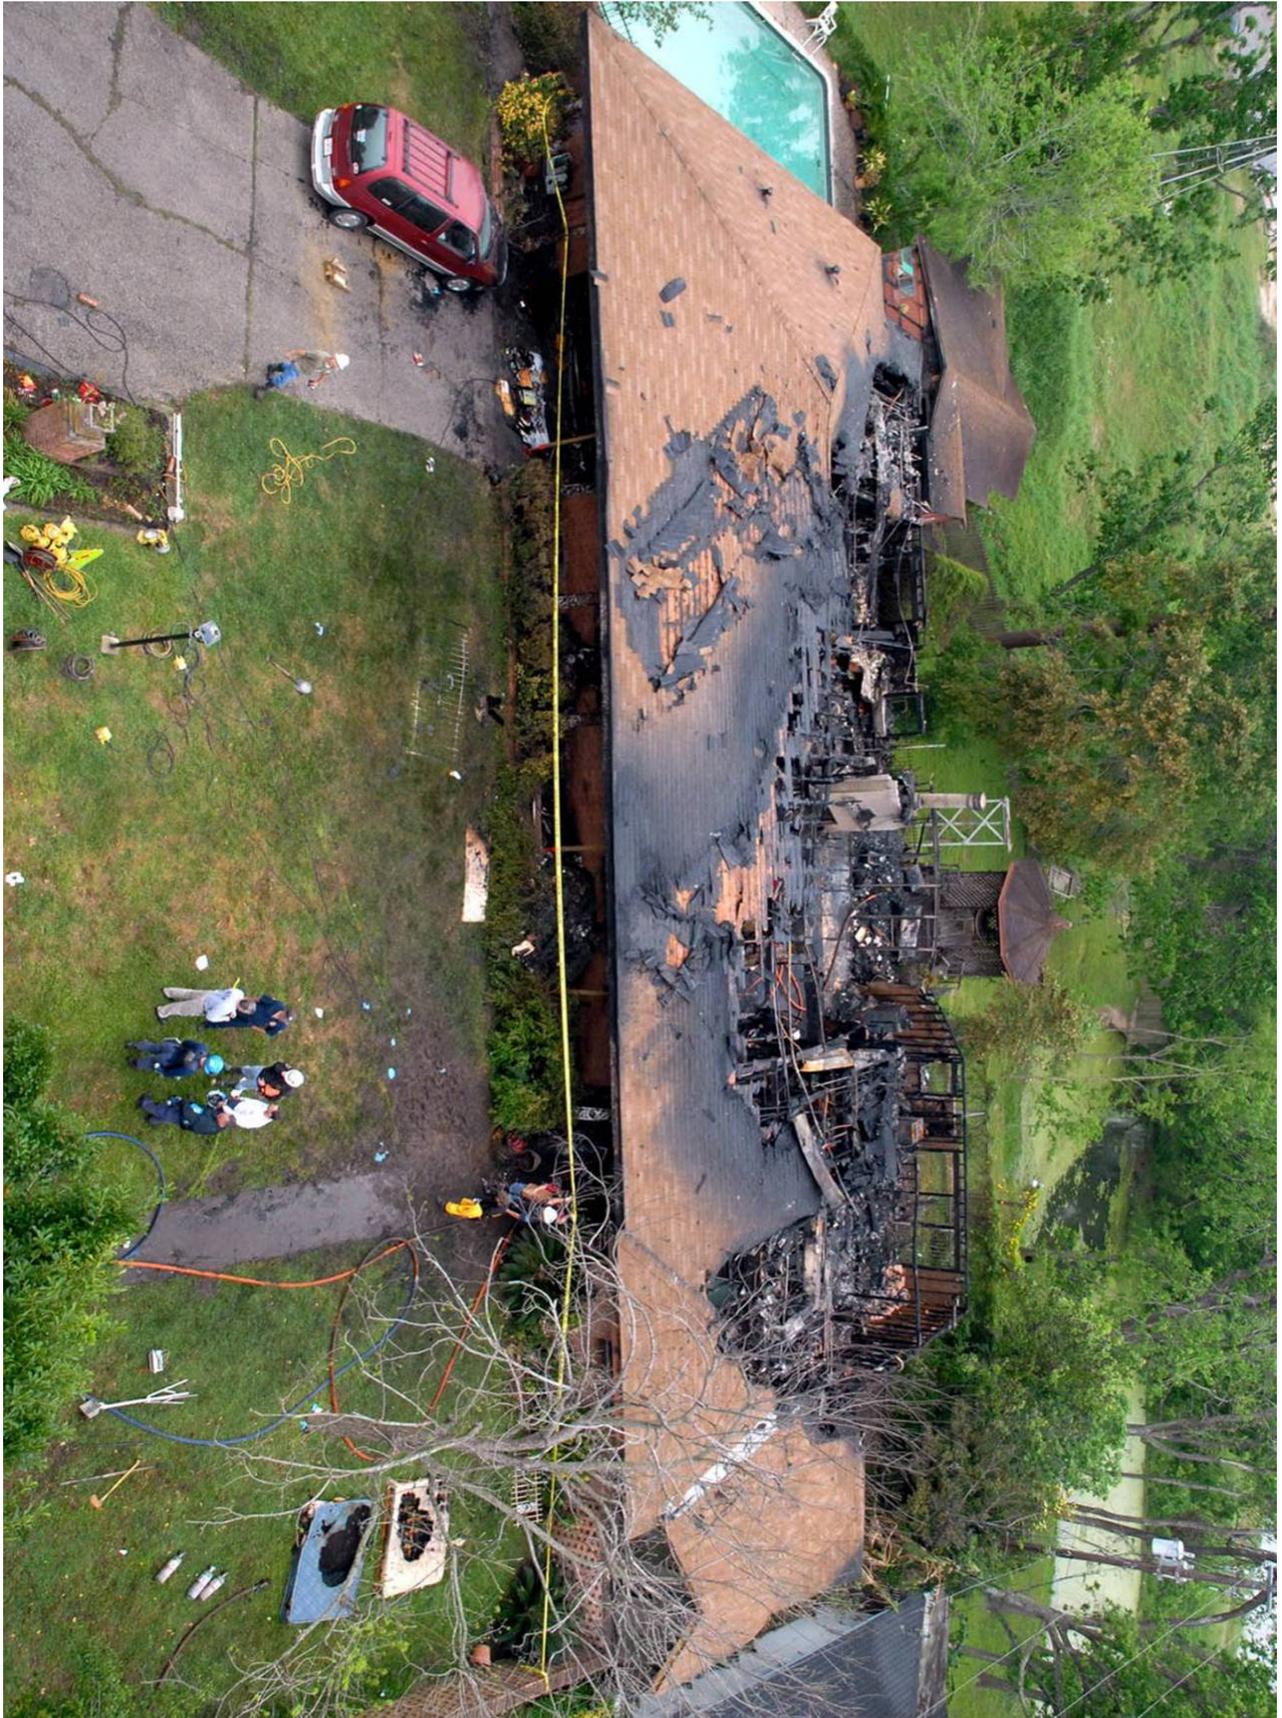
The construction type and condition of the building is shown in this post-fire photograph provided by the Houston Fire Department.

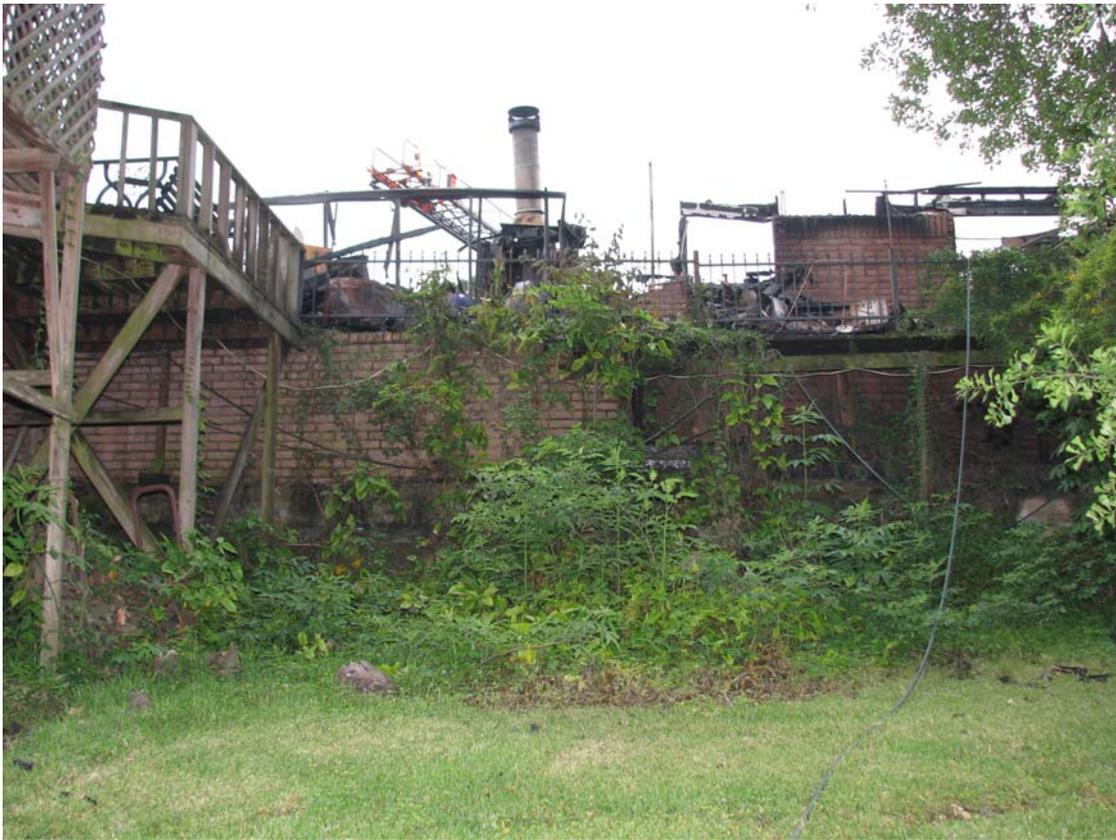
View of the back looking up from the backyard showing part of the solarium framing and chimney flue in the den. The 15-25 mph wind came from this direction. Photo by SFMO.

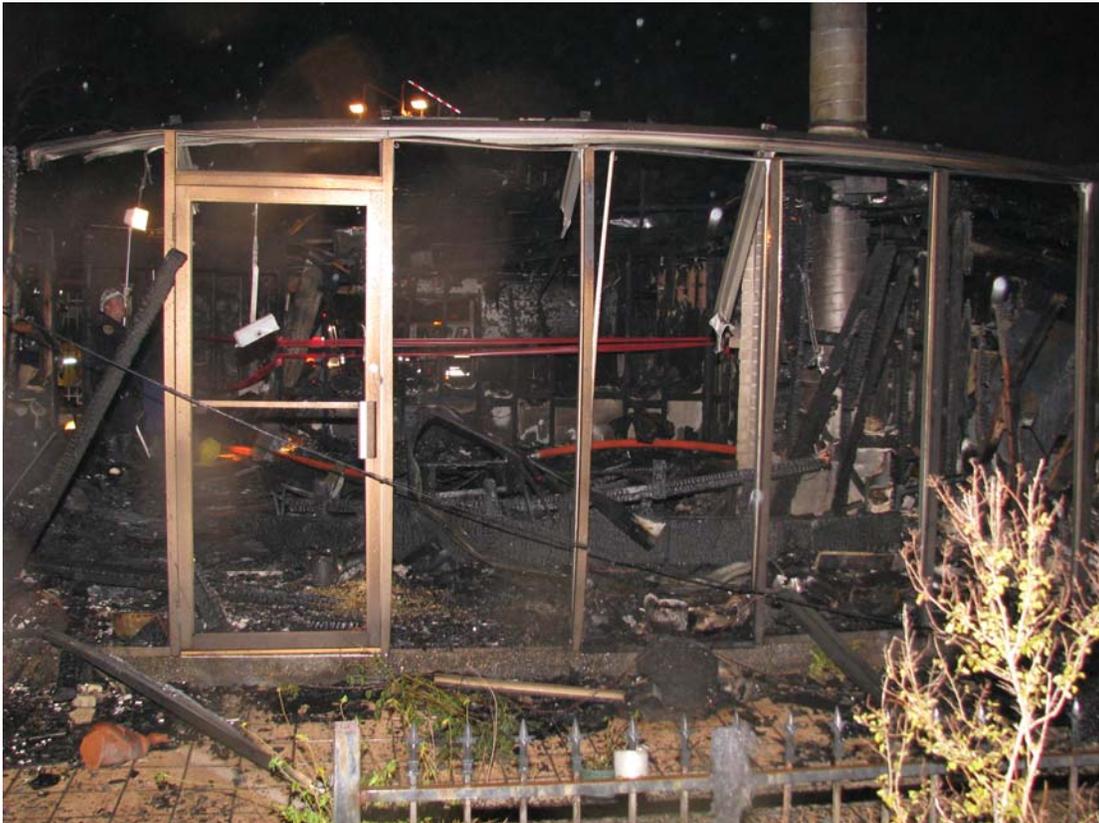
This is the view into the den through the solarium from the patio. Photo by SFMO.

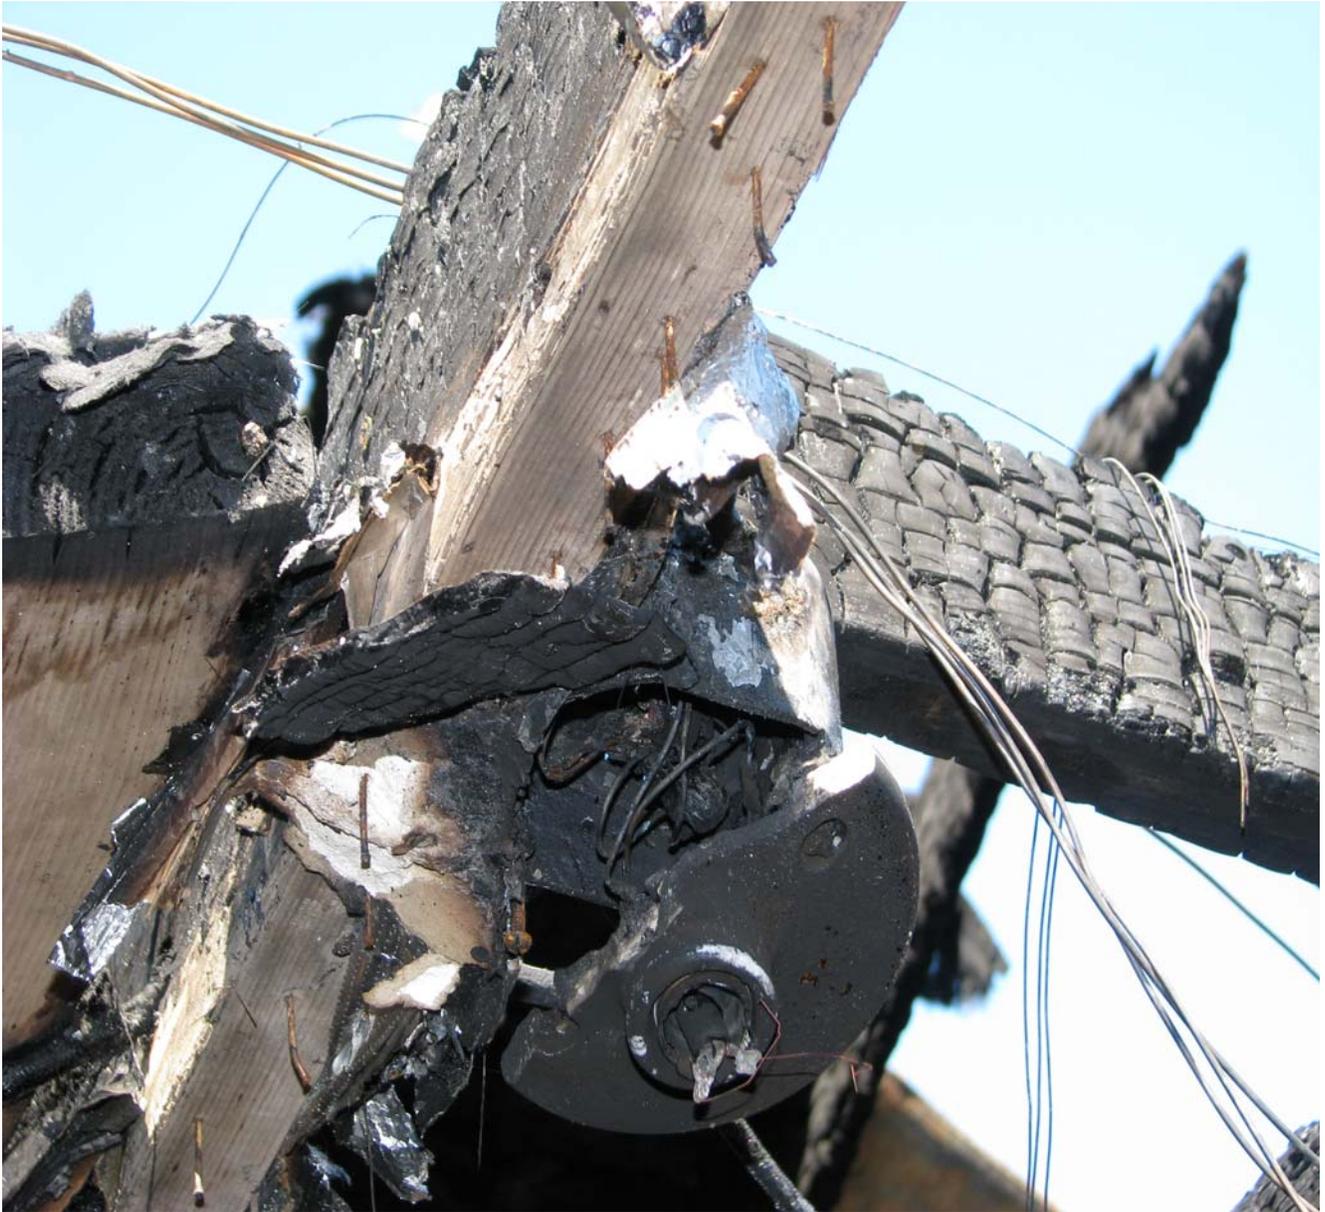
Photo of the hallway closet ceiling light fixture and damage to the junction box and ceiling joists. SFMO photograph

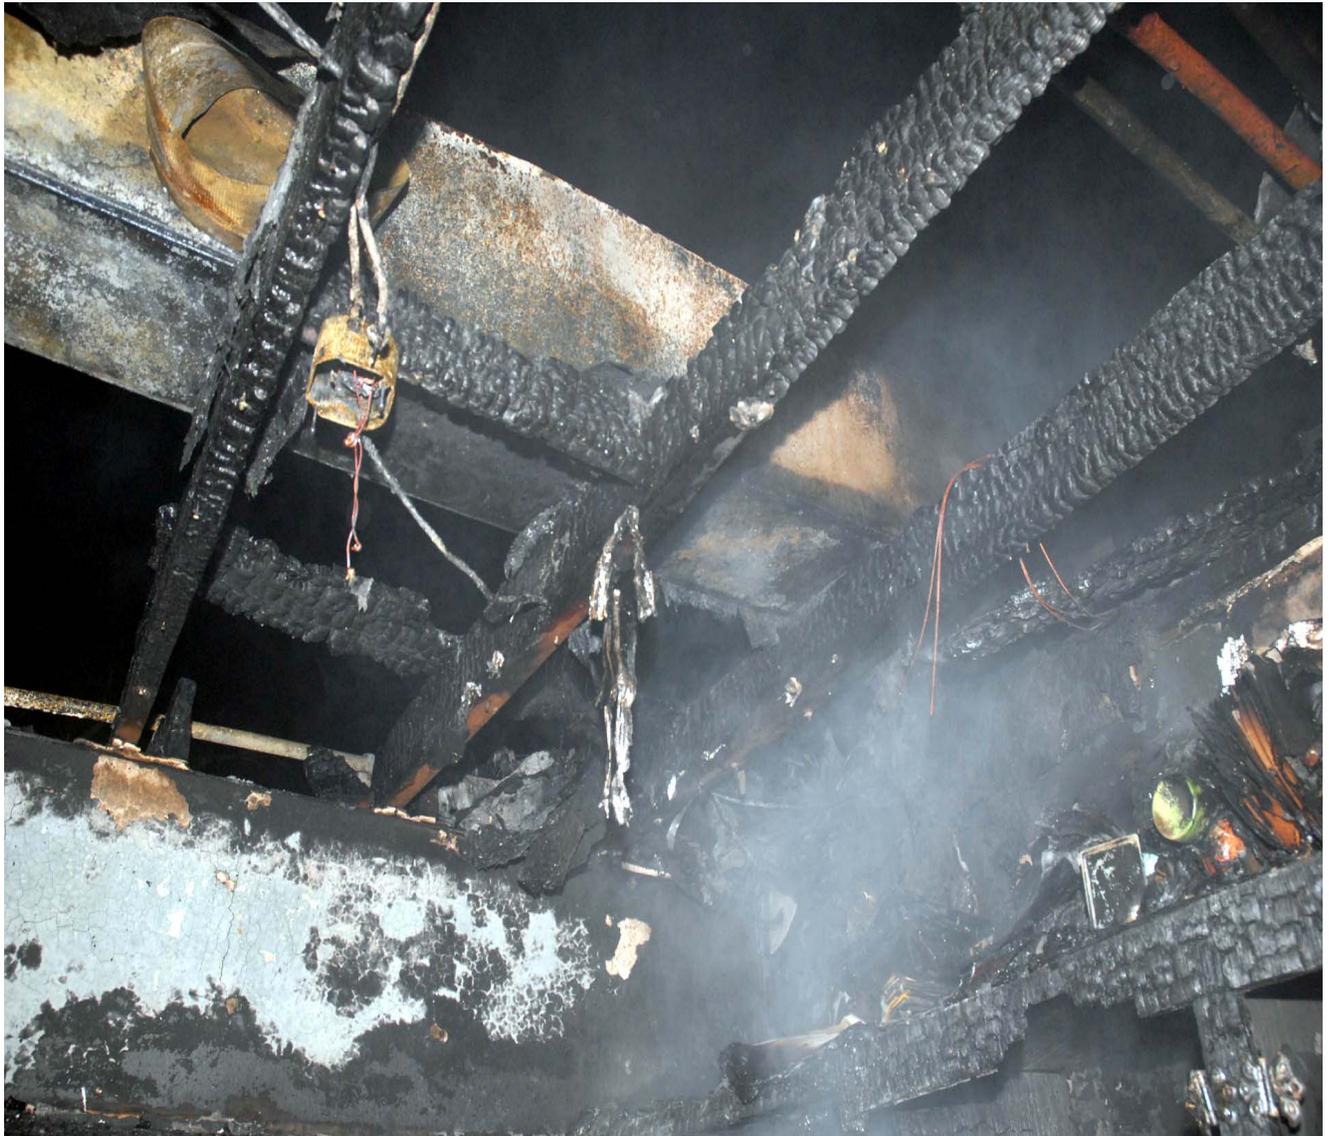
**Photo of the bedroom closet ceiling showing the light fixture at the point of origin.
Photo by Houston FD**

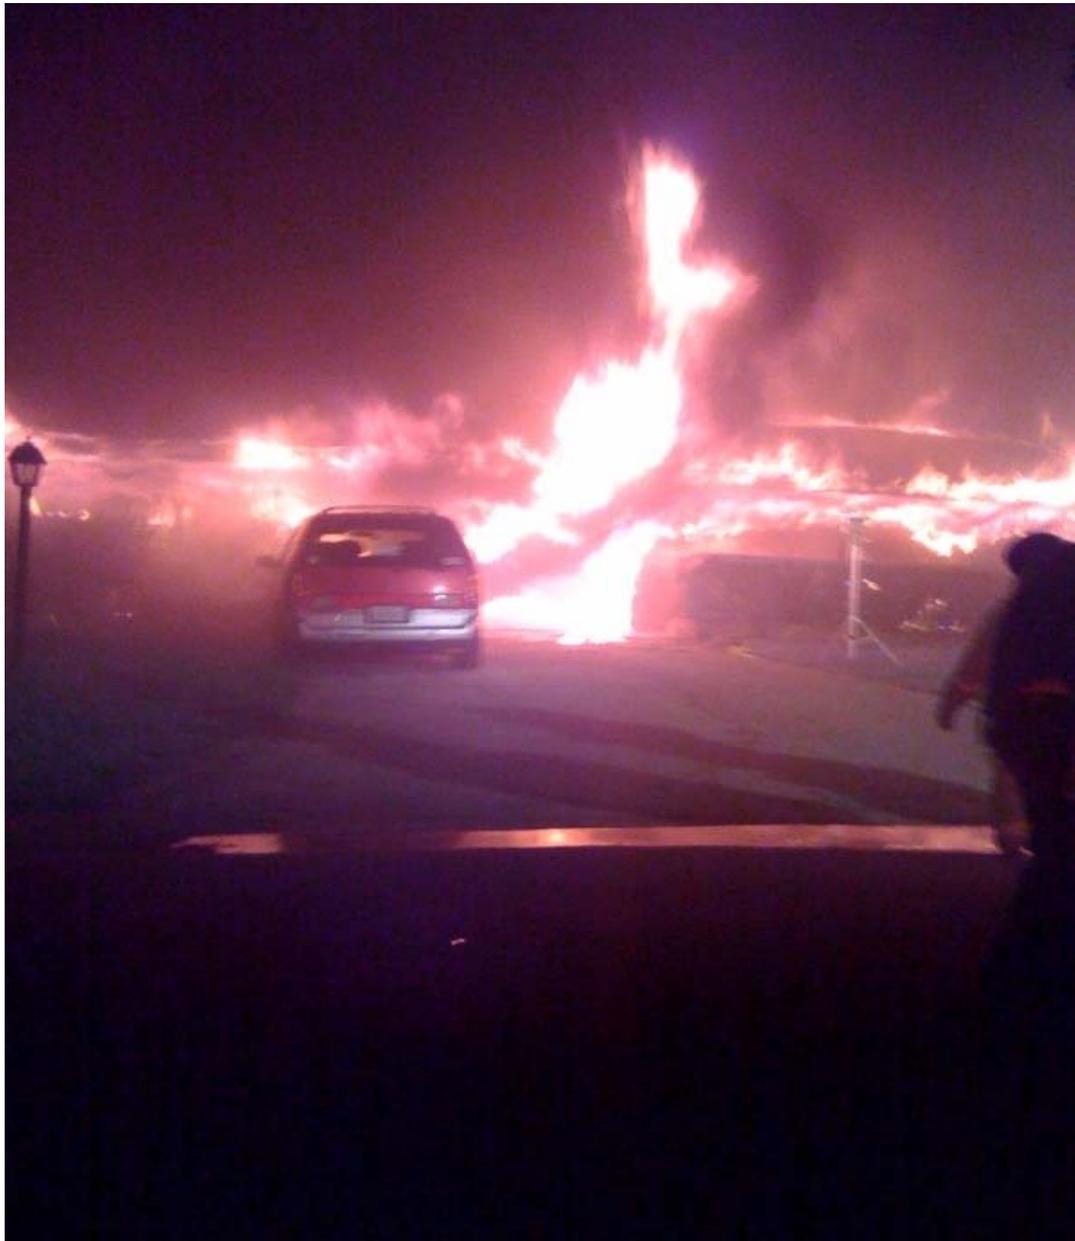
This photo, taken at 00:26 with a cell phone camera, shows the intense fire created by the strong winds exiting the garage and front windows. Photo courtesy of the Houston FD

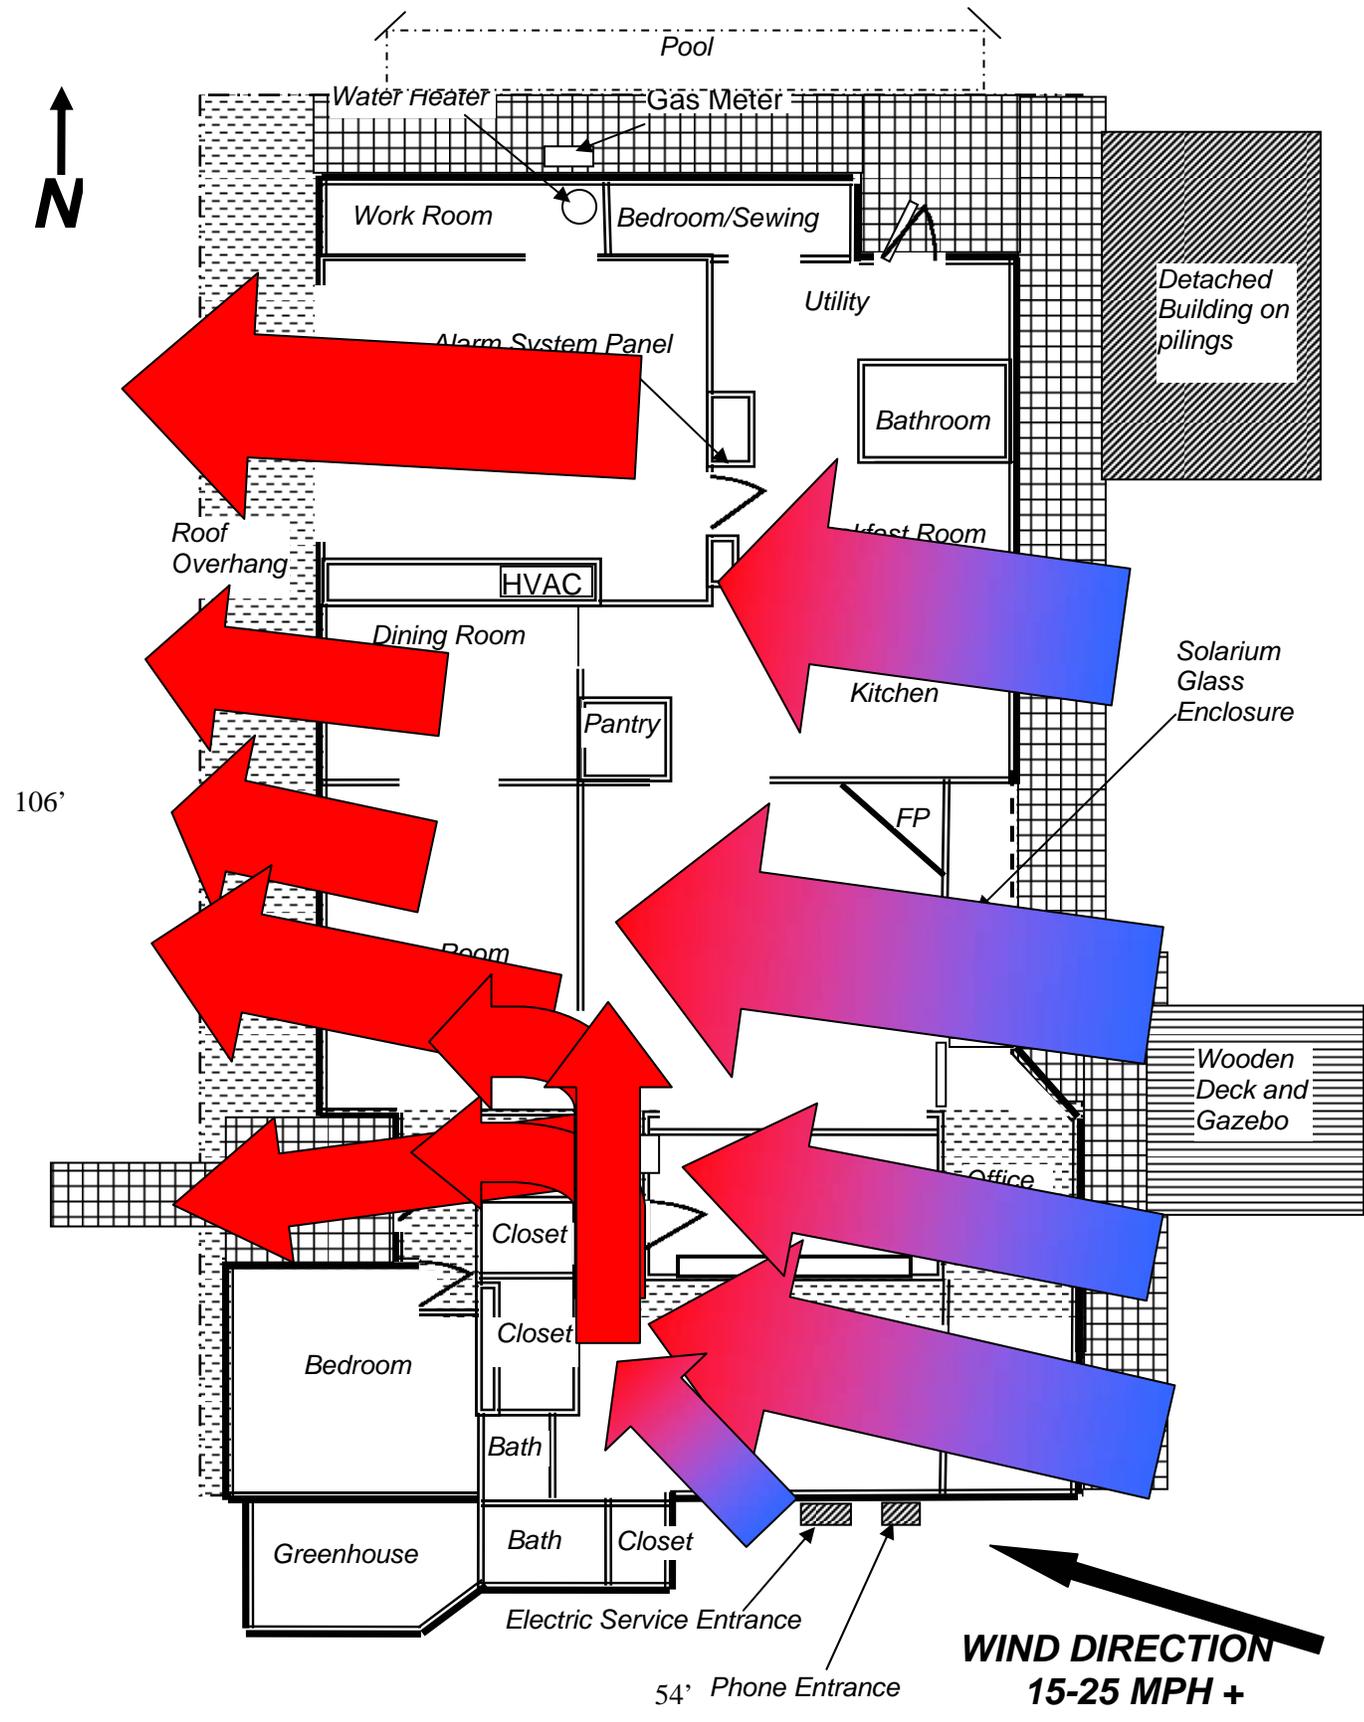
Personal Protective Equipment Evaluation
