# TEXAS STATE FIRE MARSHAL'S OFFICE

## Firefighter Fatality Investigation

Investigation Number FY 10-01

**Captain Thomas Araguz III**

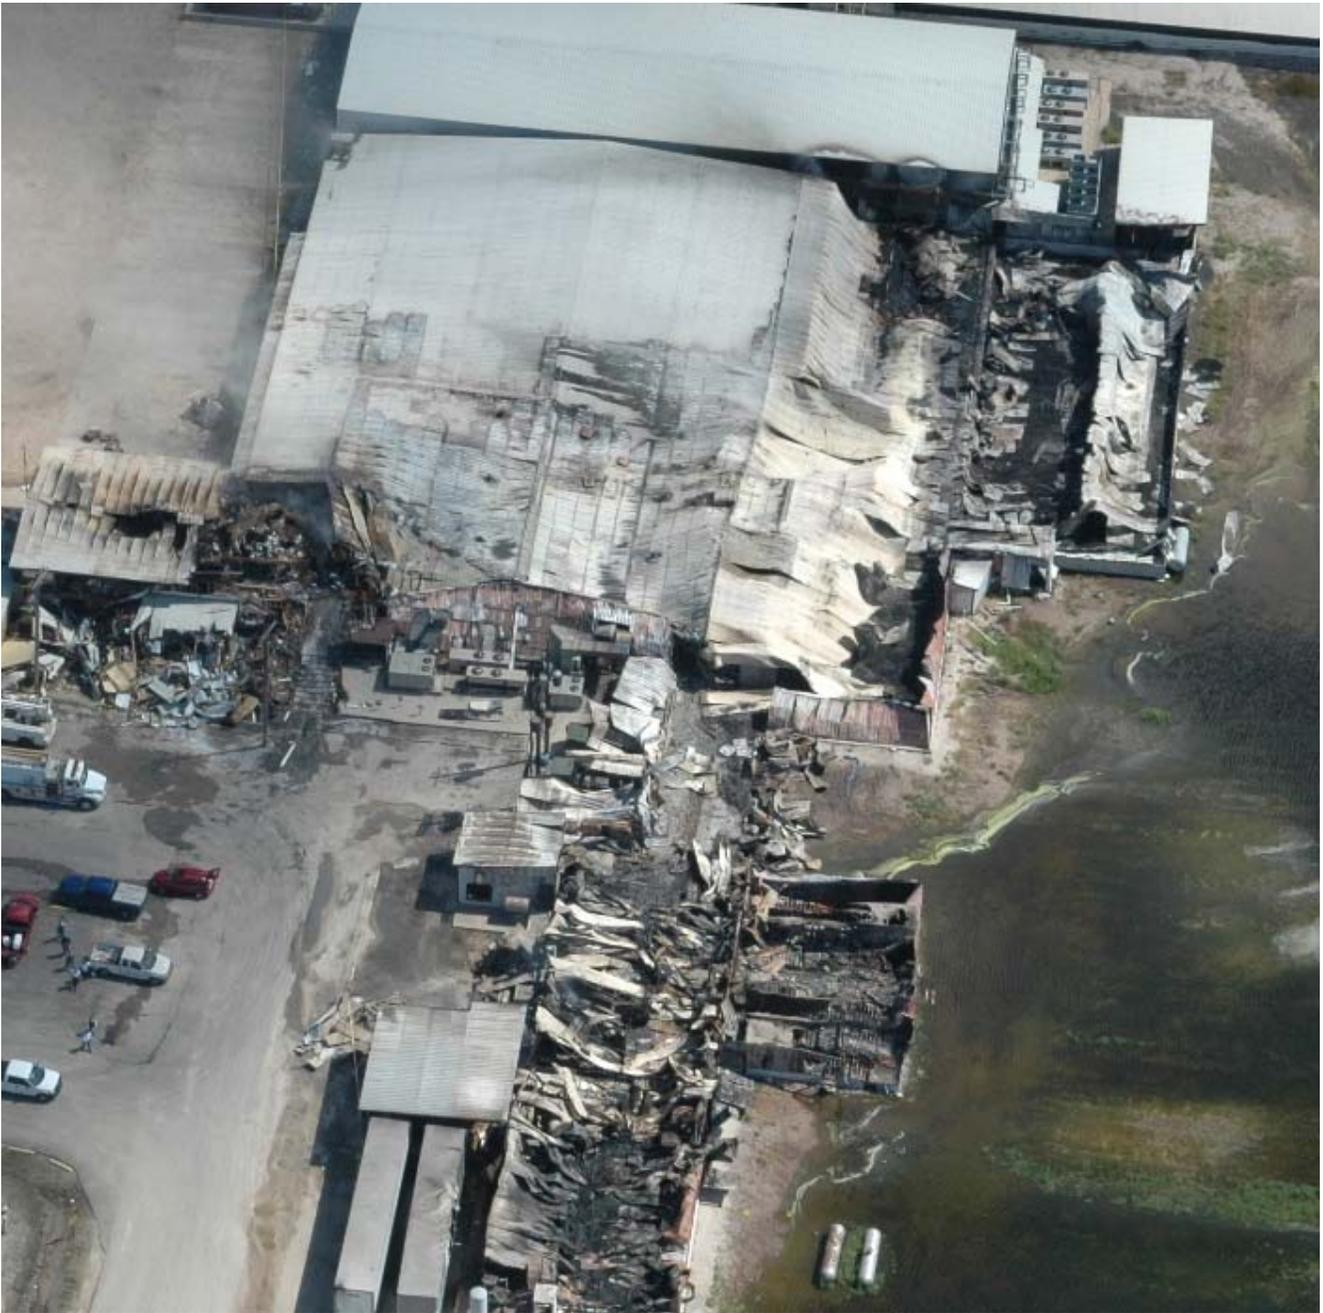
*South aerial view of the egg processing plant*

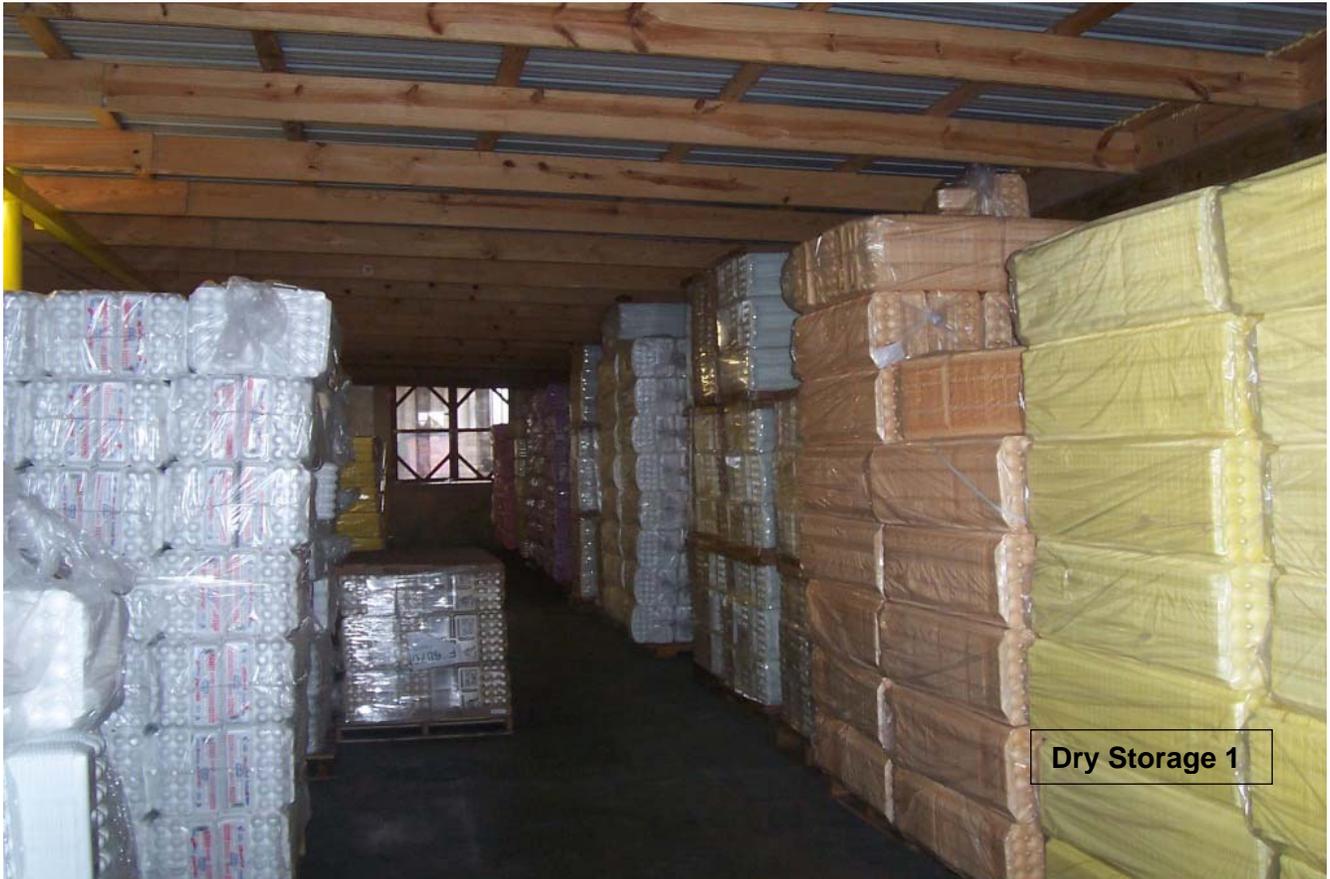
***Pre-fire photo of Dry Storage 1 looking north from the bottom of the south ramp toward the north ramp leading to the loading dock***

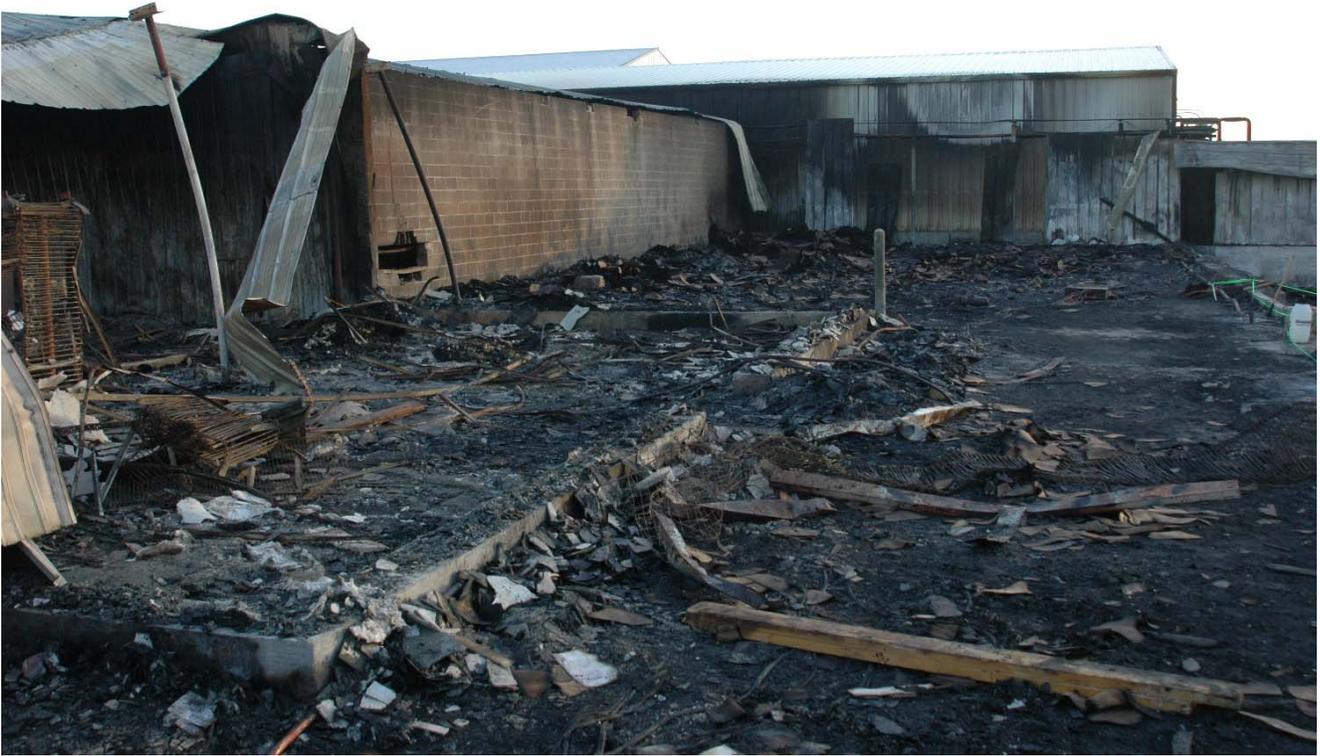
***Dry Storage 2 is in the background with the processing room extension and stem wall in the foreground. Dry Storage 1 is to the right.***

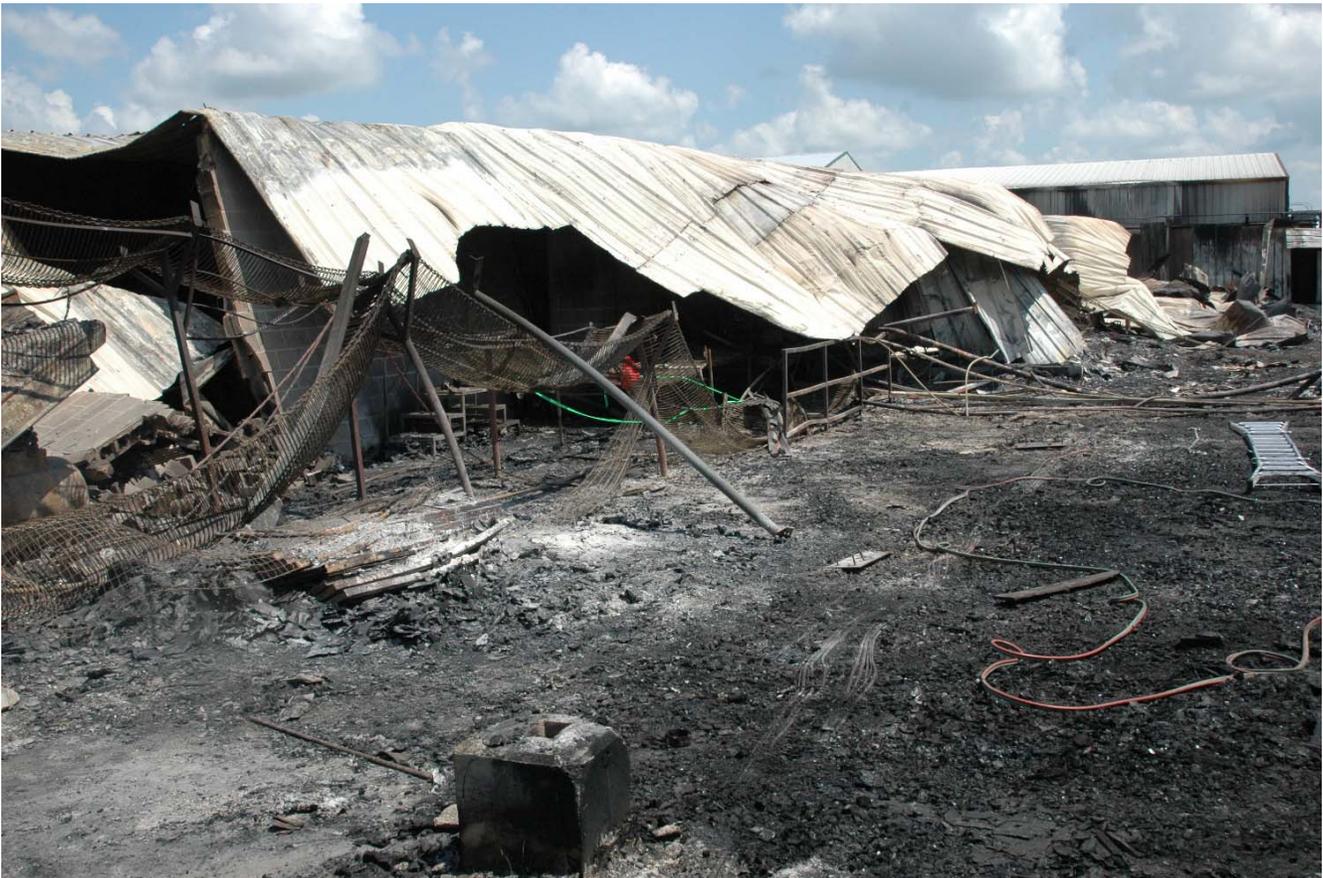
*The East Hallway showing the CMU west wall and the conveyors*

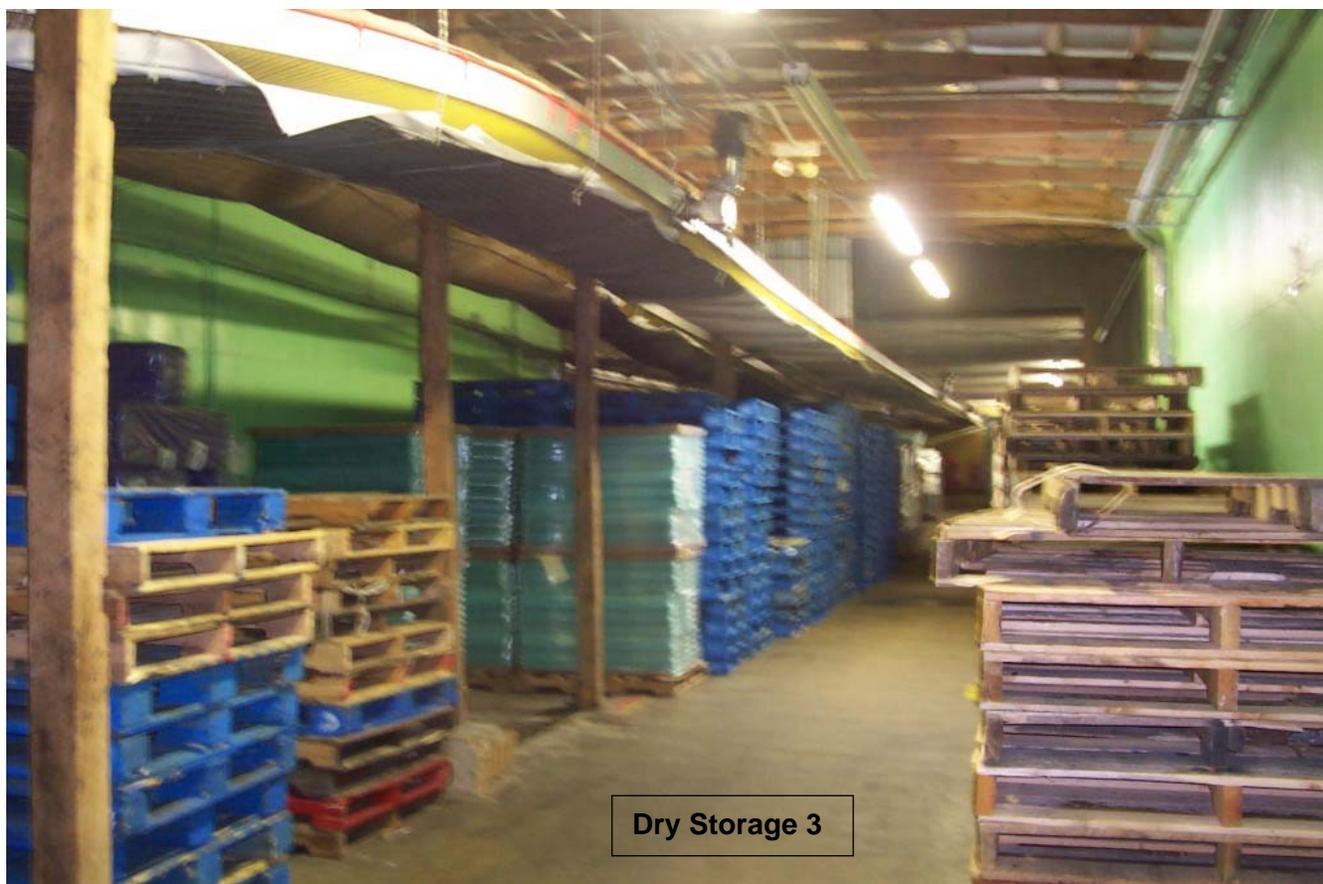
***Pre-fire photo of Dry Storage 3 looking south from the swinging double doors of the processing room at the area where Captain Cano was rescued***

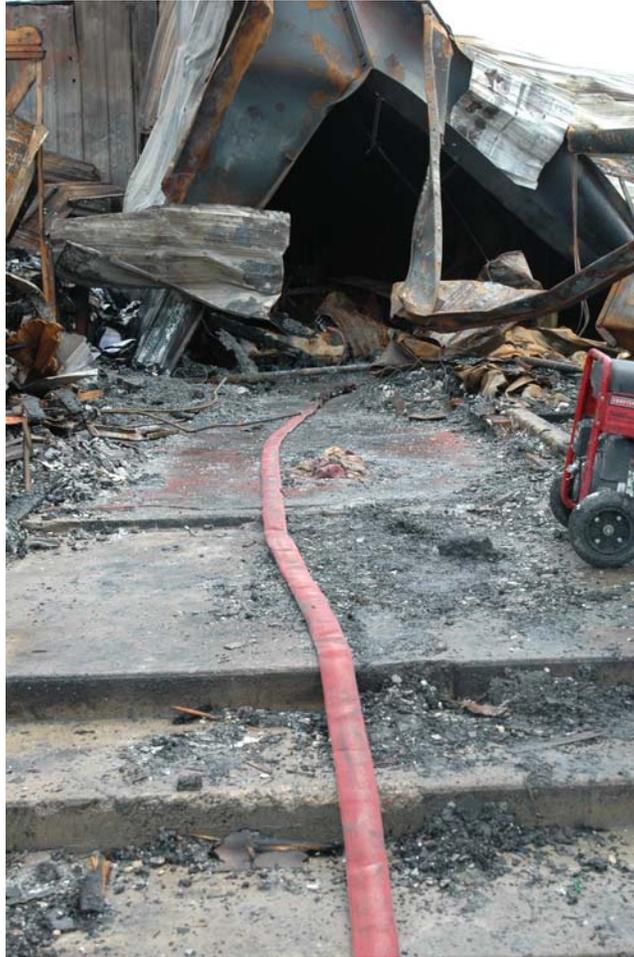
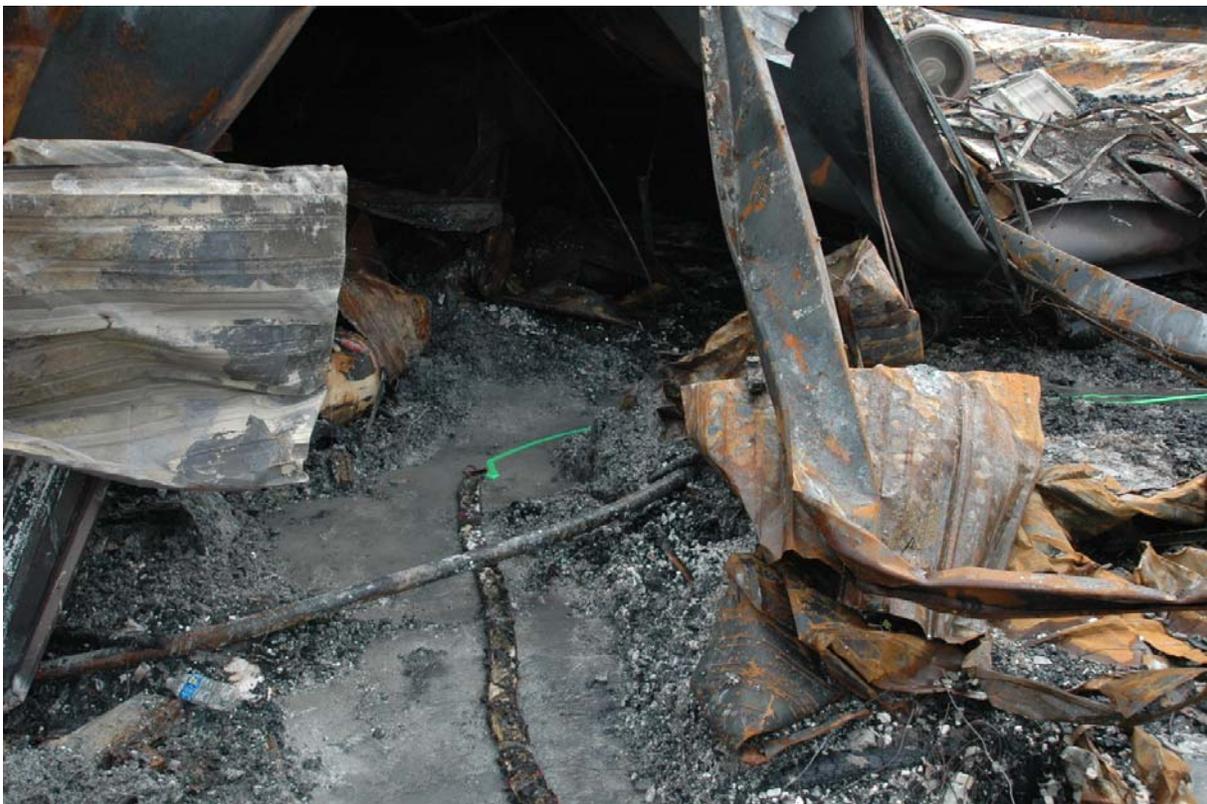
***1130 hose-line up steps into processing room entry door***
