STATE FIRE MARSHAL'S OFFICE

Line of Duty Death Investigation

Investigation Number 02-251-02

Fire-Rescue Officer Vincent Davis

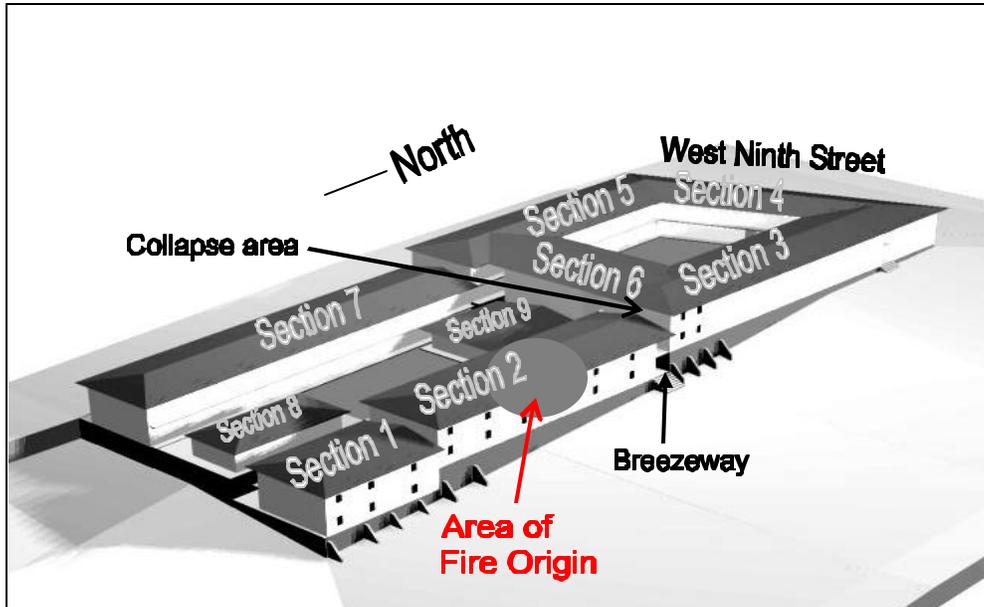
**Figure One. Rendering of apartment complex.
Courtesy of Dallas Fire-Rescue.
Notations by SFMO.**

The apartment complex is located on sloping ground (14.2% to 16.6% grade) with the north side being the lowest side. For report purposes, the building has been divided into nine sections. This roughly "figure 8" shaped building has both enclosed and open courtyards. **(Figure One)**
