Firefighter Fatality Investigation

Investigation Number 05-127-12

Firefighter Nito R. Guajardo

December 20, 2004

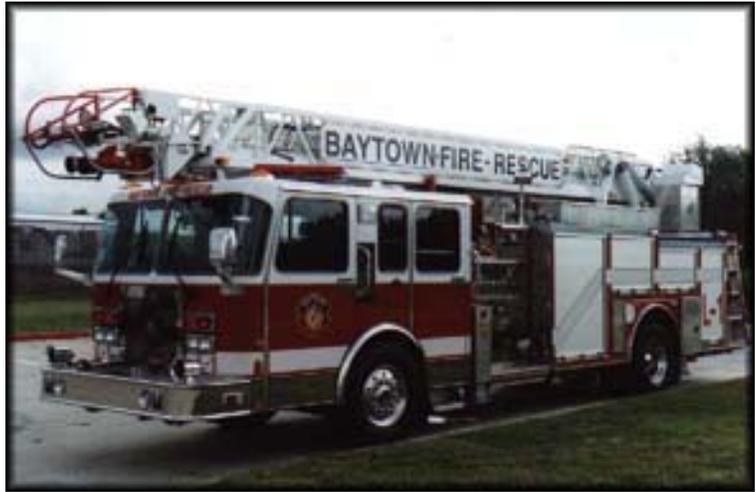
EL1 is a 1993 Smeal 1,500 GPM pumper with a 75-foot rear mount aerial ladder. On the day of the fire, EL1's crew was staffed with a Lieutenant (LT) Richard Lopez, Equipment Operator Frederick Spencer, firefighter (FF) Nito Guajardo, and FF Robert Lopez. EL1 was dispatched on the first alarm assignment and arrived at approximately the same time as BC Burns in B1.

Upon arrival, LT Richard Lopez stated he saw light to medium gray smoke coming from the residence. FF Robert Lopez observed light smoke from the rear of the residence and the right (west) side. EL1 Equipment Operator (E/O) Spencer described heavy brown smoke coming from the eaves of the building.

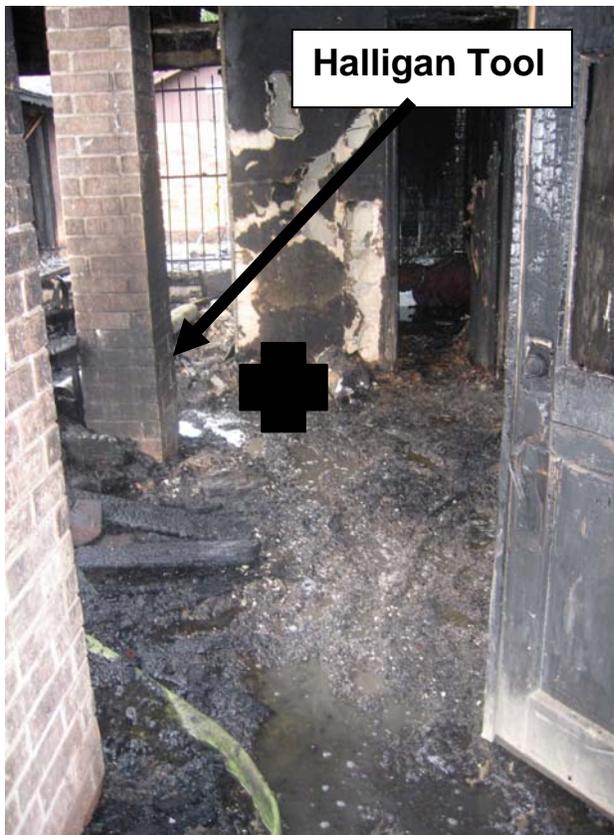
Command instructed LT Thomas Carr to obtain an additional firefighter to team up with and attempt to make entry into the building to locate FF Guajardo. LT Carr took E/O Mahoney and moved to the front entrance where three firefighters were operating a hose line. LT Carr described smoke conditions as heavy at the doorway.

LT Carr and E/O Mahoney entered the building and turned to the right. Carr stated it appeared E/O Mahoney had found something about six feet to the right of the front door. LT Carr stated he could feel an SCBA cylinder. After moving some debris to the side, they were able to determine it was FF Guajardo. Firefighter Guajardo was prone, facing toward the front (north) of the structure.
