TEXAS STATE FIRE MARSHAL'S OFFICE

Firefighter Fatality Investigation

Investigation Number FY 11-07

Lt. Todd Krodle

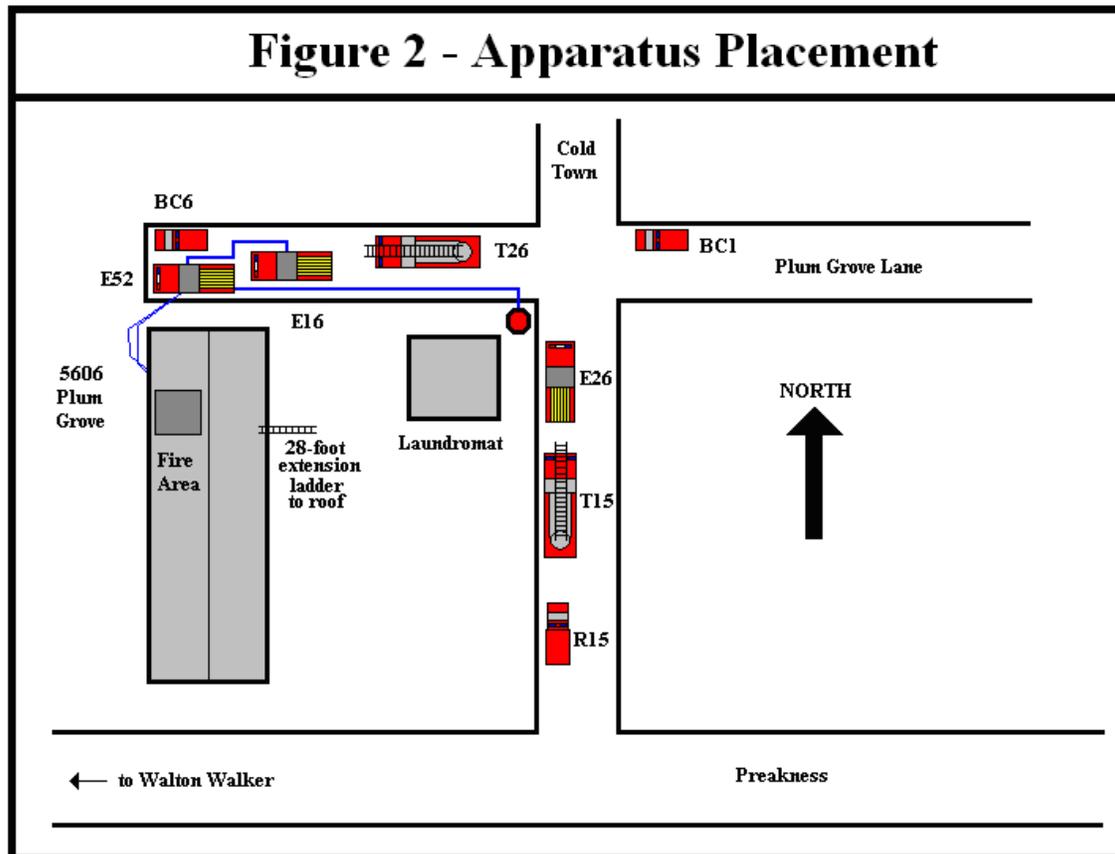
Figure 2 - Apparatus Placement

BC6 assumed a mobile command and was at the building assessing conditions. He noted no fire venting from any windows but saw fire at the eaves on the Alpha side and indications that fire was in the attic. He ordered Lt. Krodle of L26 to vent the roof and ordered Engine companies on scene to get in the attic by pulling ceiling on the second floor.

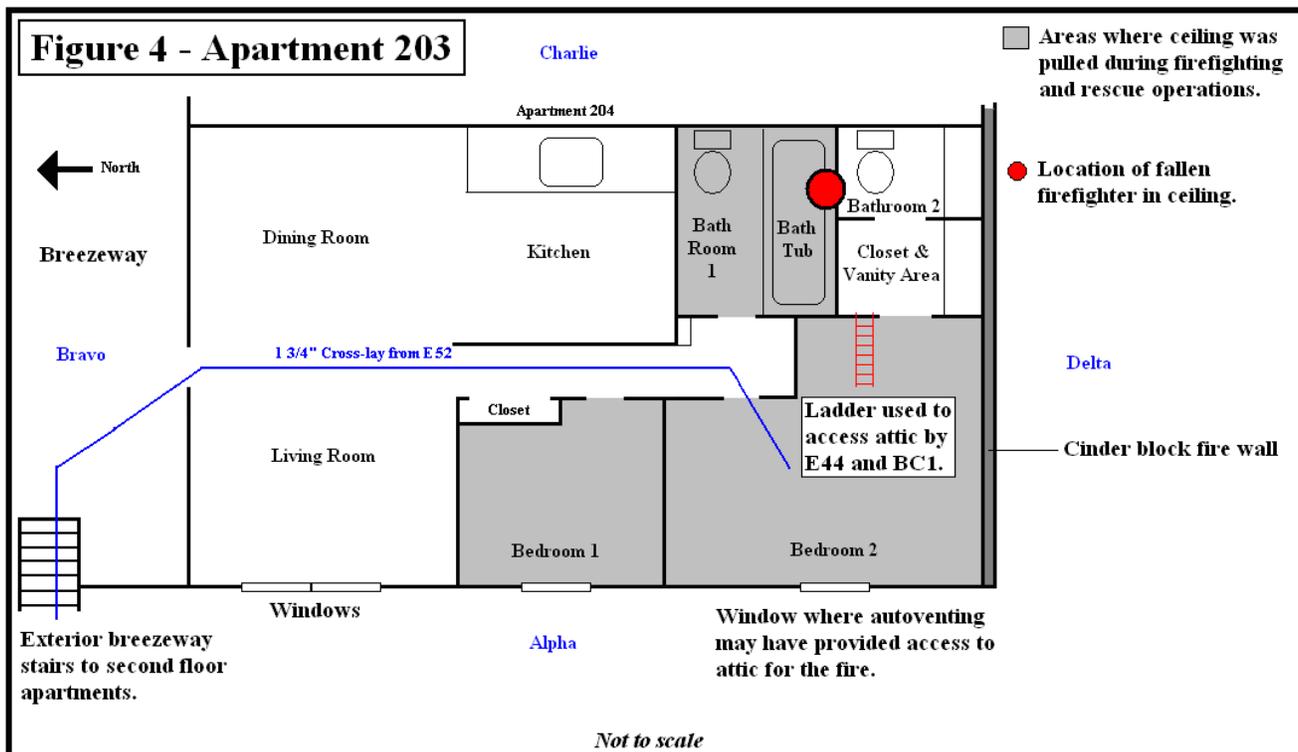
Figure 4 - Apartment 203

A gas powered chainsaw was used to cut structural members on either side of Lt. Krodle in the effort to free him from the attic space. Several cable conductors were entangling Lt. Krodle and preventing extrication from the attic space. Several firefighters were within the confined space of the small bathroom during the extrication process and the use of the chainsaw. The reported limited visibility and crowded conditions became a safety concern as one firefighter stated the long bar chainsaw came very close to his arm during the extrication effort. The rescue effort was not suspended and the focus remained on extricating Lt. Krodle.
