## Firefighter Fatality Investigation

### **Volunteer Firefighter James McMorries**

Howardwick Volunteer Fire Department

Date of Incident: March 12, 2006

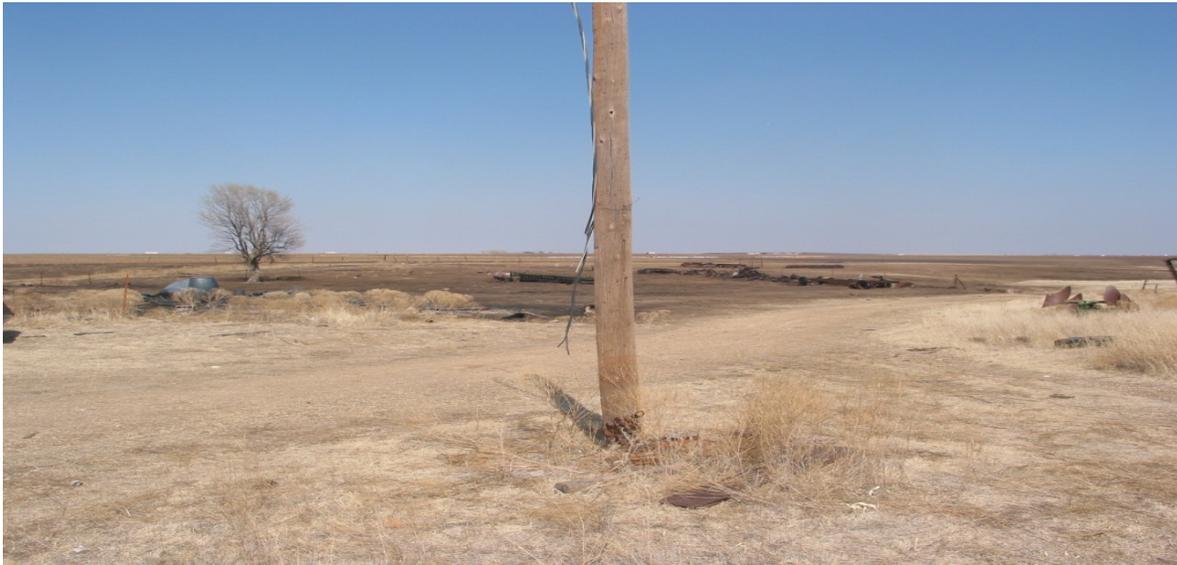
**Area of Origin**

Deputy State Fire Marshal Kelly Vandygriff conducted an origin and cause investigation on March 24, 2006. Vandygriff concluded that the fire originated on property owned by Dan Steed of Groom, Texas approximately six miles east of the city of Groom and one mile south of Interstate 40 in Donley County. Vandygriff concluded the fire was the result of electrical wires touching causing arcing in forty to fifty mph winds.
