# STATE FIRE MARSHAL'S OFFICE

## Line of Duty Death Investigation

**Investigation Number 03-193-01**

**Firefighter Gary L. Staley**

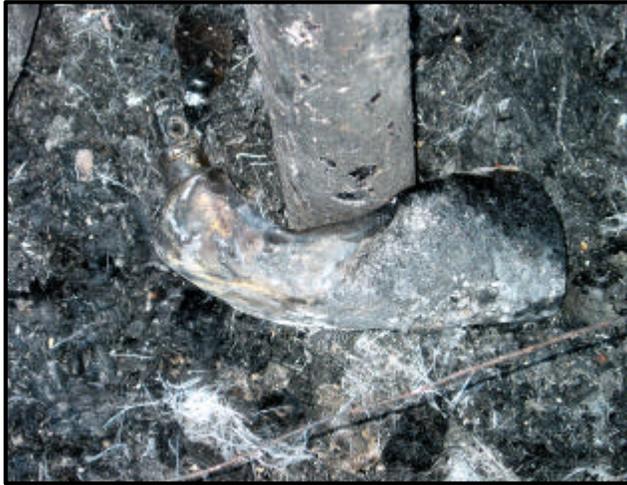
During the fire a nitrous oxide cylinder exploded and fragmented causing extensive damage to a Chevrolet Monza race car. The deceased firefighter sustained some trauma from the explosion, but at this time it is not known if this was the primary cause of the firefighter's death.

The hose line nozzle was found in the area next to the blast-damaged race car. The force of the explosion was sufficient to propel a fire extinguisher through the side of the car and wrap it around a metal support post.

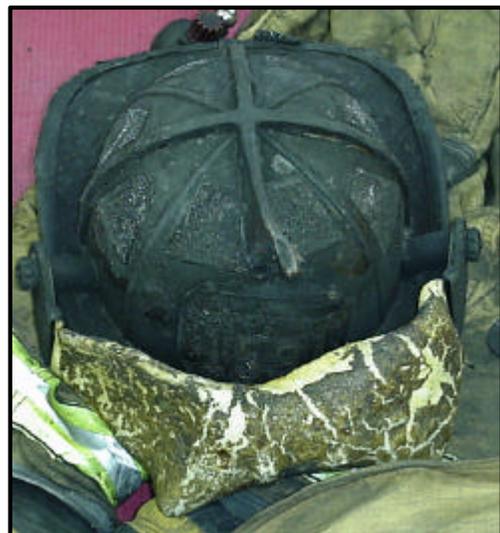
became disoriented and escaped the building with serious burns. All three were wearing full NFPA-compliant protective ensembles and SCBA. The helmets of the two most seriously burned firefighters, Chapa and Haynes, showed evidence of extreme heat exposure, with face shields burned and deformed, but helmet shells, although burned, were intact.
