# CIRCUIT BREAKER

# MYTHS

Mark Goodson, PE  
Mark Hergenrether, MSME  
Aaron Stasonon

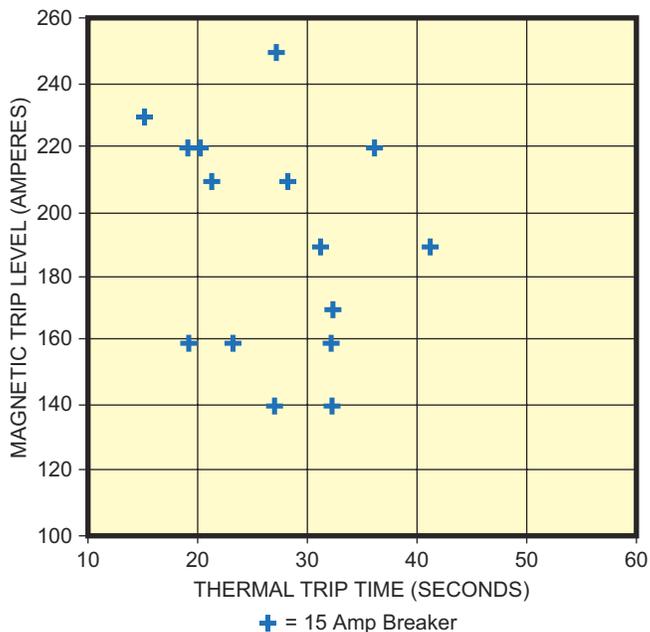
**FIGURE 3: MAGNETIC TRIP LEVEL vs THERMAL TRIP TIME FOR 15 AMP BRAKER**

FIGURES 3, 4, and 5 show the thermal characteristics (trip time) for each breaker as the independent variable, and the trip level (instantaneous) in amperes given as the dependent variable. As is readily apparent, there is no correlation between thermal trip times and instantaneous trip levels.

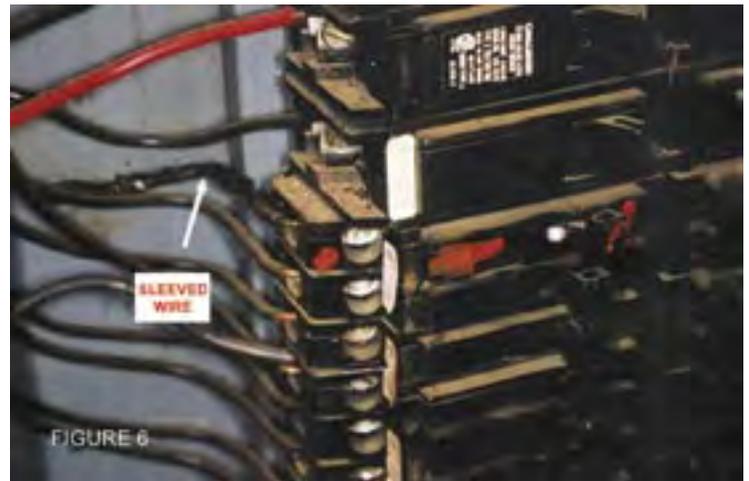
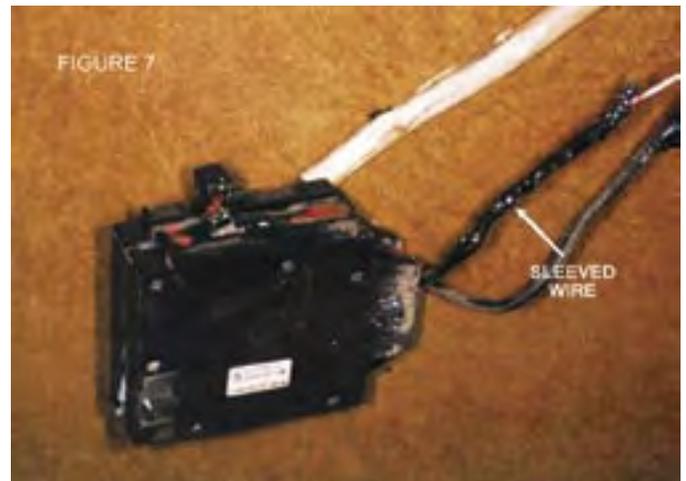
- (1) A homeowner had done wiring on a porch light, accidentally shorting the hot lead to the ground. The type NM cable, when shorted, allowed about 90 amperes to flow on the hot and return on the ground conductor. The light switch to the porch light was turned on, and a resulting fire ensued. The hot conductor (black lead of the NM) was "sleeved" along its length in the breaker box. (*Sleeving is a condition*

in which there is damaged insulation on a conductor caused by excess current flow. A wire that is sleeved will have insulation that is charred, bubbly, and has started to deform.) The fire broke out in the attic, along the same run of NM. The breaker serving the NM would not thermally trip when tested in the lab. FIGURES 6 and 7 depict the breaker and a portion of the load wiring. The breaker is a dual breaker, and only one of the poles (the one serving the porch light) shows evidence of the overload.

(2) A new house had its electric meter installed less than one hour prior to a fire being discovered. A 20 ampere breaker fed a length of type NM (12 AWG) that served a bedroom and ran through the attic space. Fire broke out in the attic. In the breaker box, the hot lead of the type NM was severely charred, while the conductors serving other breakers had no thermal damage. The exact fault in the attic was never identified. Regardless of the initial cause of the fault, however, the breaker never cleared the fault. Lab testing confirmed that the breaker would never trip.

Even though we have seen breaker malfunctions on very few occasions, our advice is to collect the breaker(s) at a fire scene, if it

is supplying power to a suspect appliance or branch circuit wiring. Moreover, we also ask that several inches of load wire be collected from the panel. In this way, one could look at the conductor and determine if it is appropriately sized, and also if it has received damage from excess current values. Given that it is easy to inadvertently move a breaker handle during an investigation, we also routinely photograph and then mark (with a paint marker) the position of all breakers prior to opening a breaker panel to inspect it internally.

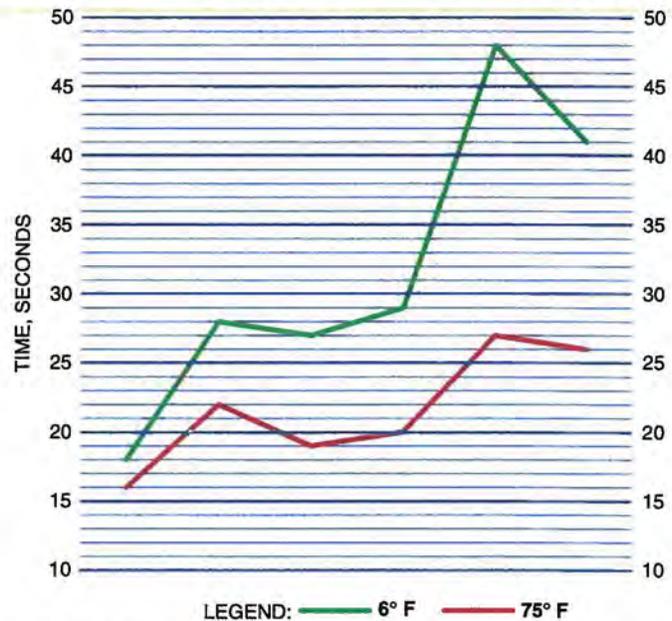
**TABLE 2**  
**MEASURED TRIP TIMES OF 15 AMPERE BREAKERS, 2X CURRENT FLC**

The writers conducted a series of tests on a total of 30 circuit breakers rated at 15 and 20 amperes, all in atmospheres less than 23 degrees Fahrenheit. Table 2 shows the results of these tests. In general, breakers which responded with mean or average trip times of 20 seconds at the 2x current level at 75 degrees Fahrenheit then had trip times that averaged 32 seconds at temperatures of about 6 degrees. These tests show that breaker trip time is retarded by the presence of the cold atmosphere, as would be expected. In these tests, however, the trip times were still below the 120 second trip time allowed per NEMA AB1<sup>4</sup>.

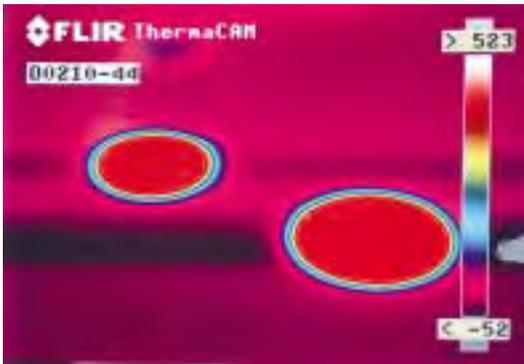
The glass cooktops we have tested all show very localized heating. That is to say, a burner that is ON and serves the right rear burner position is not going to ignite a rag or cloth accidentally left on the right front burner. Photo 5 shows a thermogram of a cooktop with the left rear and right front burners on HIGH, and the other two burners OFF. It is obvious that there is little heat conduction to adjacent burner sights.

Photo 5—Thermogram of 2 burners on a glass cooktop, showing a lack of heat transfer to other burner locations.

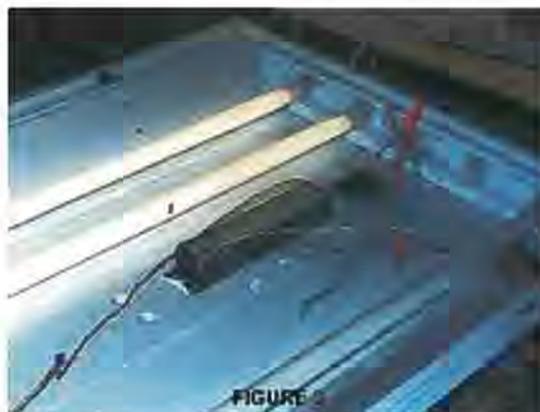
A second factor in this scenario is related to the use of high frequency. For conventional AC line frequency (60 Hz), the arc extinguishes (quenches) 120 times per second, each time there is a zero crossing. As zero is crossed, the arc temporarily extinguishes and begins to cool. With the electronic ballast, however, the transition through zero is so quick (due to the high frequency) that the arc does not extinguish. In fact, the high frequency serves to stabilize the arc, allowing a continuous plasma. This characteristic of the electronic ballast helps sustain arcing between lamp pins and lampholder contacts. Figure 3 shows a 2 x 4 troffer, with the inner 2 bulbs illuminated.

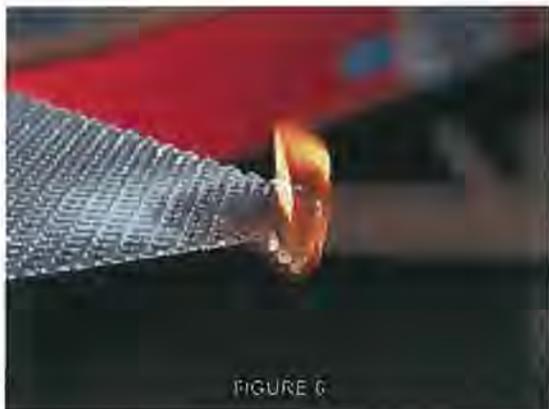
FIGURE 6

A very pertinent question to all this examination relates to the first material ignited. The diffuser (lens cover) that is present on many lamp fixtures has no UL 94 rating. Testing of the diffuser shows that it both sustains combustion and drips molten (and flaming) plastic. Figure 6 shows combustion taking place on such an acrylic diffuser. Our own testing was done without a diffuser, and it achieved ignition of the lampholder on numerous occasions. We can easily envision a scenario where the ignition of the lampholder ignites the lens diffuser.

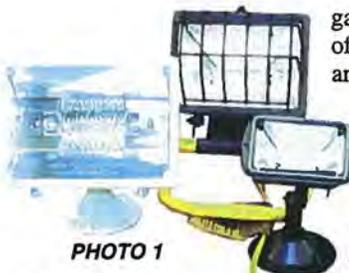
PHOTO 1

Several new fixtures were purchased, in both a work light configuration and fixtures meant for permanent mounting. (Photo 1) We noted that the two “permanent” fixtures (rated at 150 and 500 watts) were not intrinsically tight or intrinsically rated. They are listed for use in wet locations, however. On the work light (rated 500 watts), there was a gasket around the glass shield and also around the switch compartment giving some appearance of being intrinsically safe. A pilot hole was drilled in the body, and air pressure applied. We noted that despite the gaskets, the work light is not airtight—air leaked out at the

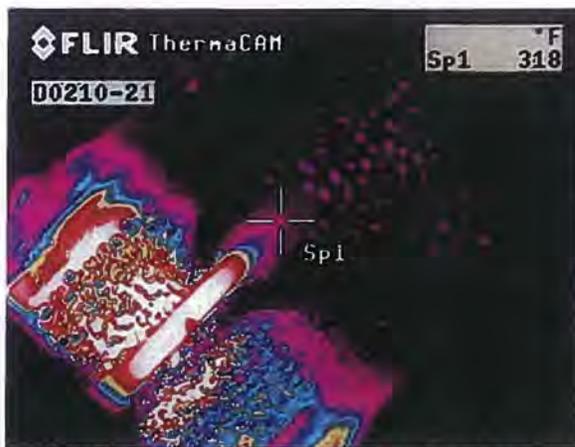
(PHOTO 2)—Thermogram of a 500 watt work light. The Spot Temperature (Sp 1) was measured at 318° F.

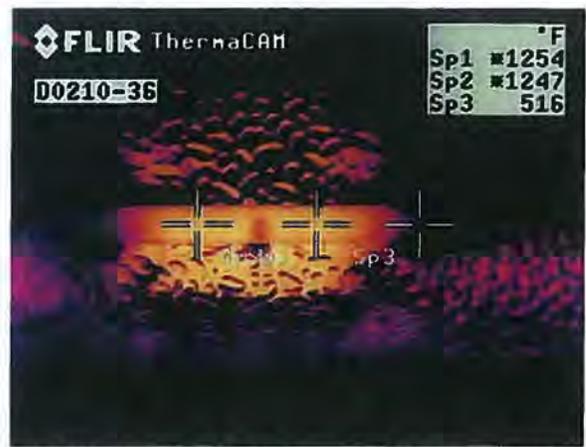
(PHOTO 3)—Shows bulb envelope temperature at two different points, Sp 1—1239° F and Sp 2—1255° F.
